# CESSNOCK LGA SKATE PARKS AUDIT REPORT

MAY 2020

CESSNOCK CITY COUNCIL

DOCUMENT: CESSNOCK LGA SKATE PARKS AUDIT REPORT

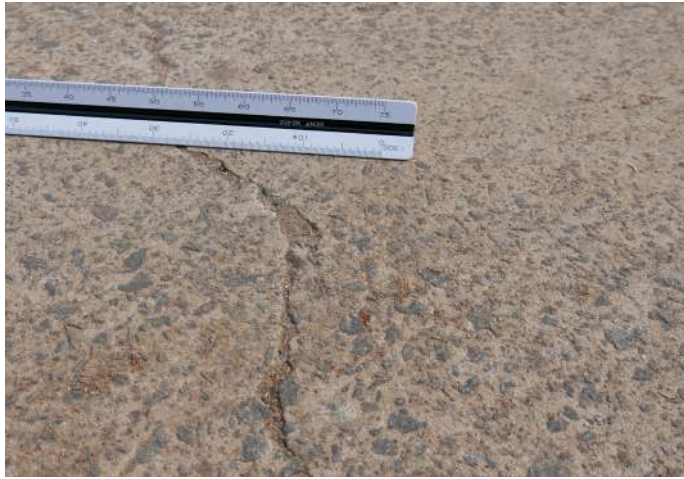
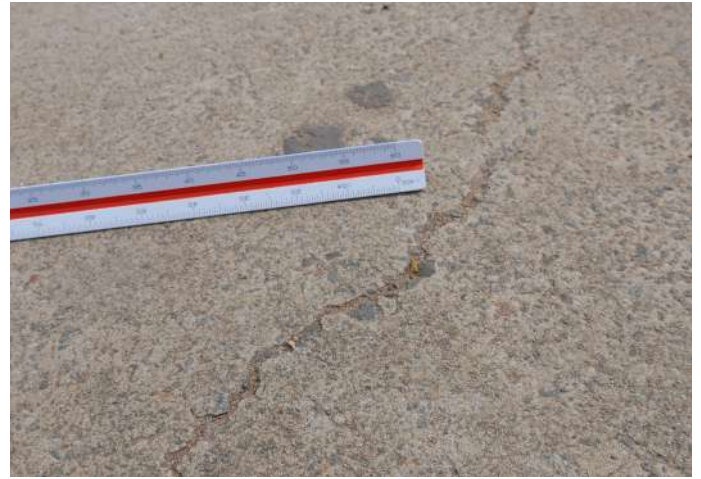
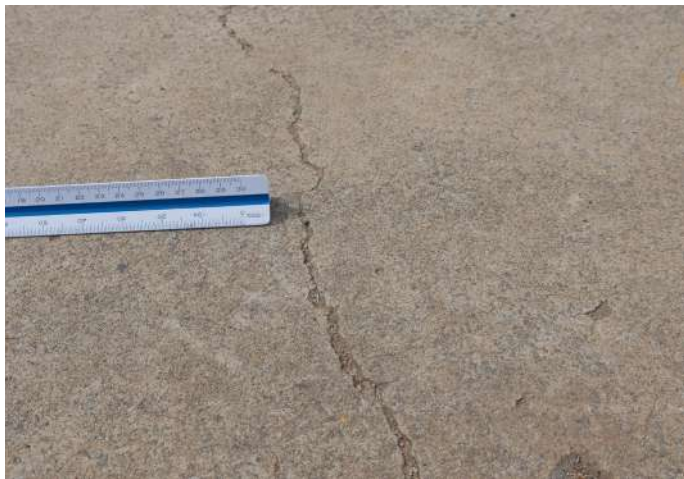
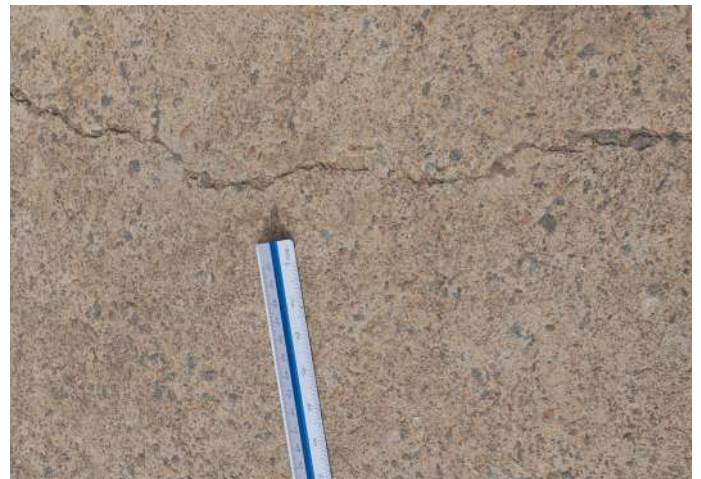
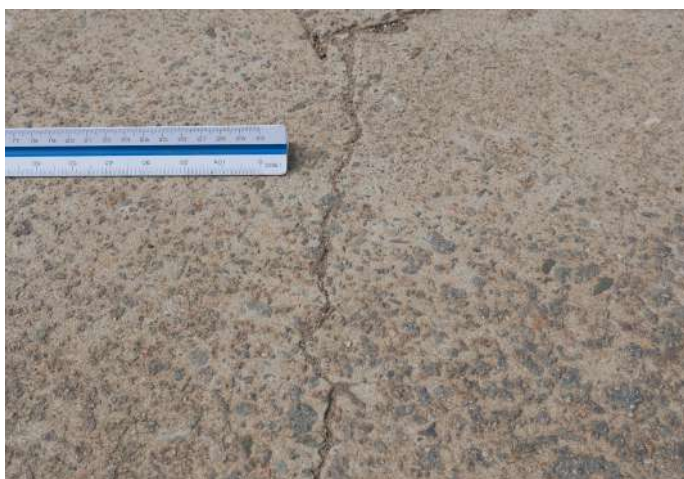
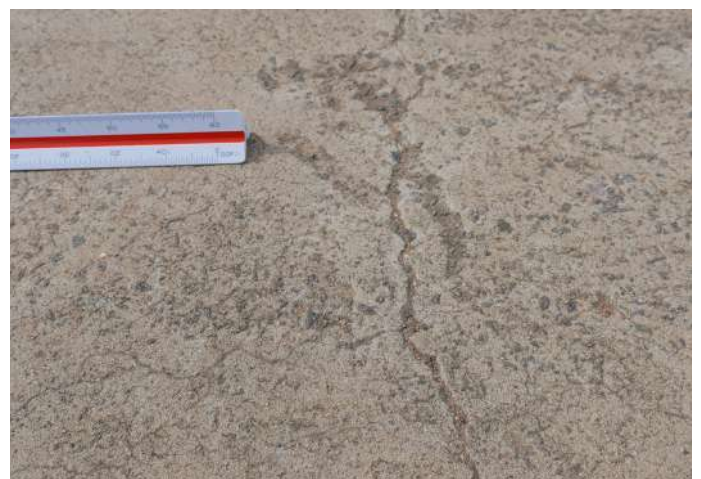
## CONDITION ASSESSMENT - MINOR CRACKING

The concrete slabs are showing signs of minor cracking in a number of locations across the facility. This cracking could be due to earth movement, or general deterioration due to the age of the concrete. While currently minor, if left unaddressed the cracking has the potential to develop further, resulting in major cracking, or leading to an uneven skate surface that is prone to chipping.

| GRETA SKATE FACILITY | | | | |
|---|---|---|---|---|
| MINOR CRACKING | DETERIORATION AGE | LOW | SPECIALIST CRACK INJECTION REPAIRS. | 6 MONTHLY |

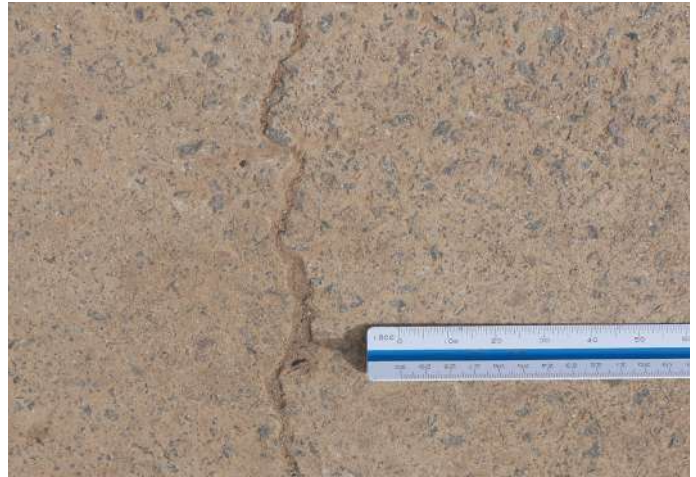
## CONDITION ASSESSMENT - MAJOR CRACKING

There are some incidence of major cracking in a number of locations across the facility. Major cracks present a hazard on the skate area where the smaller wheels of scooters and skateboards can become lodged in the cracks while the user is travelling at speed, consequently throwing the rider off their vehicle. Unexpectedly being thrown while travelling at speed has the potential to result in serious harm to the user.

| GRETA SKATE FACILITY | | | | |
|---|---|---|---|---|
| MAJOR CRACKING | HAZARD DETERIORATION AGE | HIGH | CHASE OUT CRACK, CLEAN RECESS, FILL WITH MULTI-PURPOSE EPOXY ADHESIVE REPAIR PASTE, AND SAND BACK SMOOTH TO EXISTING SURFACE LEVELS. | 6 MONTHLY |

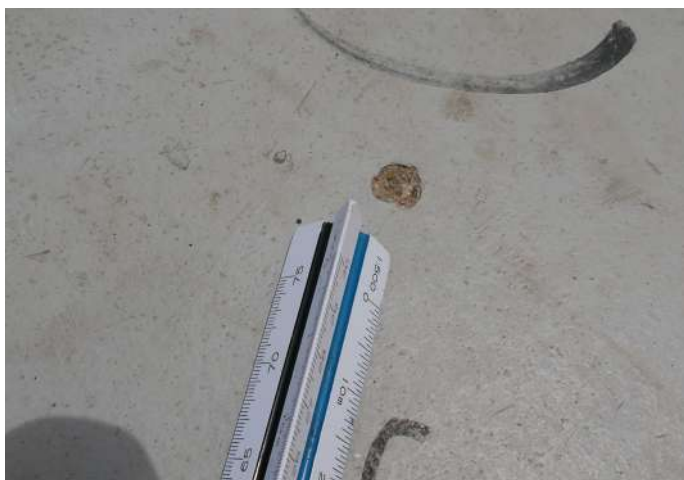
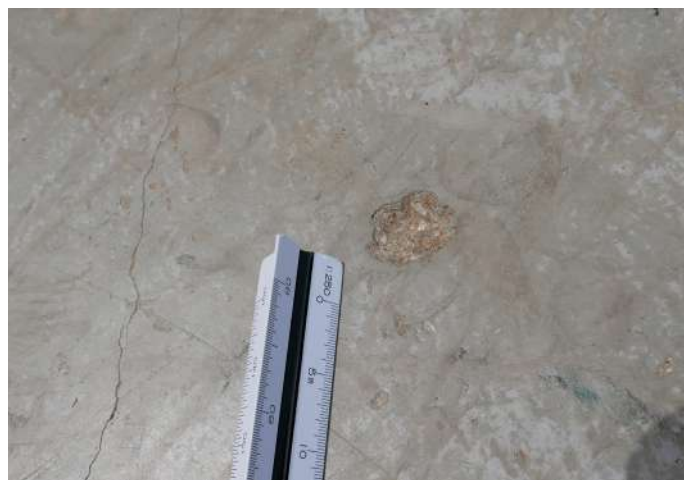
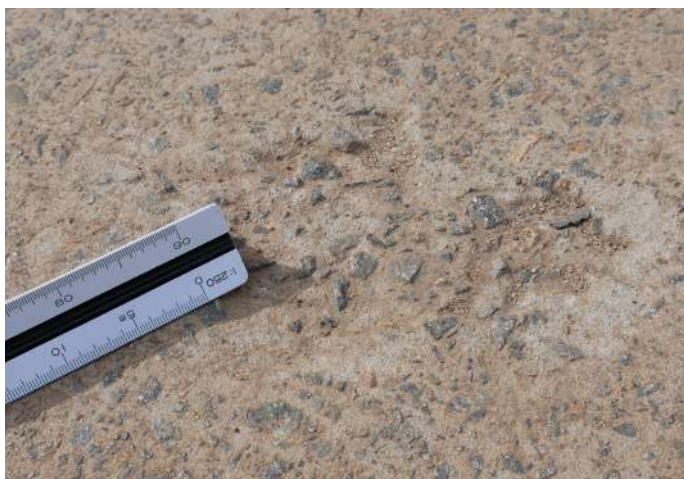
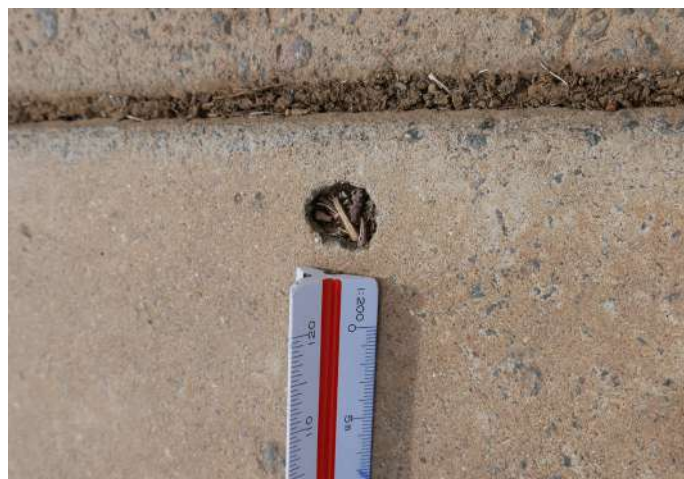
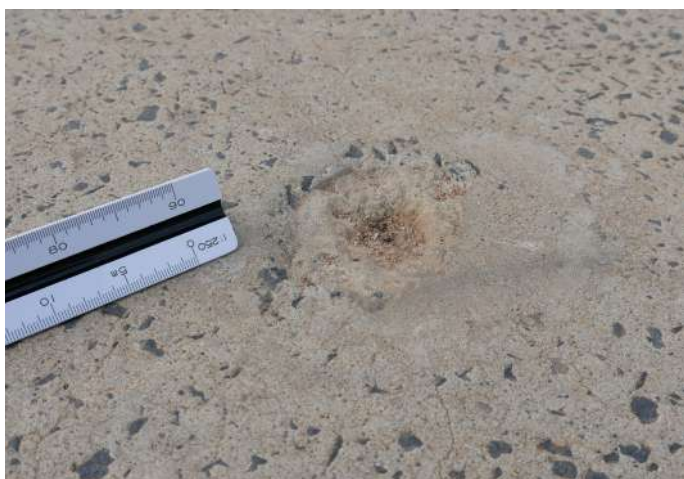
## CONDITION ASSESSMENT - SURFACE CHIPPING

The concrete slabs have a number of areas suffering from surface chipping. Chipping is the result of wear and tear from general use, and is common in parks of this age. Surface chipping presents a hazard on the skate area where the smaller wheels of scooters and skateboards can become lodged while the user is travelling at speed, consequently throwing the rider off their vehicle. Unexpectedly being thrown while travelling at speed has the potential to result in serious harm to the user.

| GRETA SKATE FACILITY | | | | |
|---|---|---|---|---|
| SURFACE CHIPPING | HAZARD DETERIORATION AGE | HIGH | GRIND BACK CHIPPED EDGE, CLEAN OF ALL DEBRIS AND DUST, FILL WITH MULTI PURPOSE ADHESIVE REPAIR PASTE, AND SAND BACK SMOOTH TO EXISTING SURFACE LEVELS. | 6 MONTHLY |

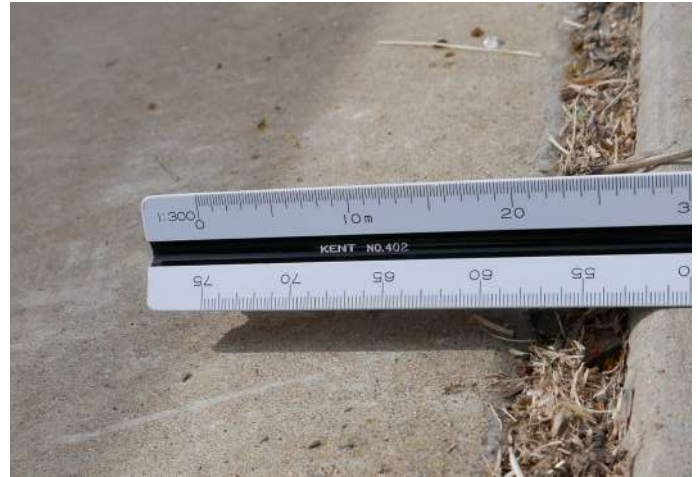
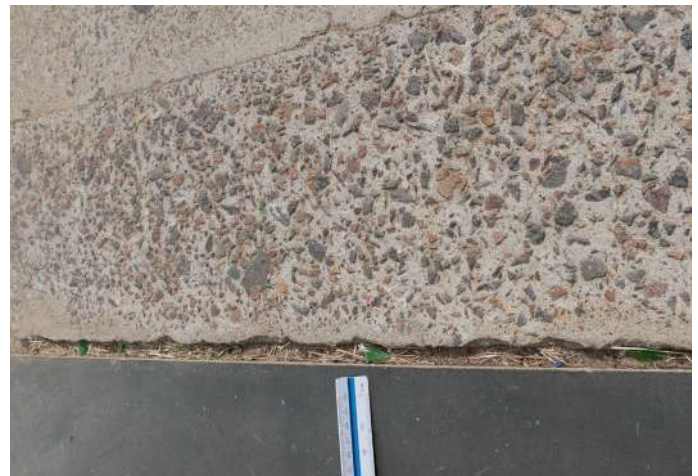
## CONDITION ASSESSMENT - DIFFERENTIAL SETTLEMENT

Differential settlement occurs where a slab has shifted either horizontally or vertically, independent of the adjacent slabs. This results in an edge at the abutment of the two slabs, and presents an opportunity for scooter or skateboard wheels to catch on the edge. Differential settlement in this case has occurred along the connection between the original slab and the new slab, as well as at the base of the features in the southern end of the facility. These locations are where users are travelling at speed, and as such the potential for harm to users is high.

| GRETA SKATE FACILITY | | | | |
|---|---|---|---|---|
| DIFFERENTIAL SETTLEMENT | HAZARD | HIGH | GRIND BACK CONCRETE SURFACE OF HIGHER SIDE OF SLAB TO SMOOTH AND TAPERED FINISH, ALLOWING SURFACE TO SMOOTHLY GRADE BETWEEN LEVELS. | 6 MONTHS |

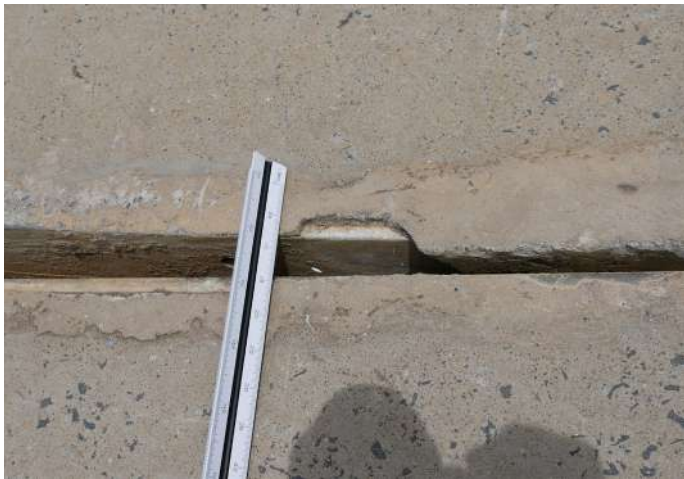
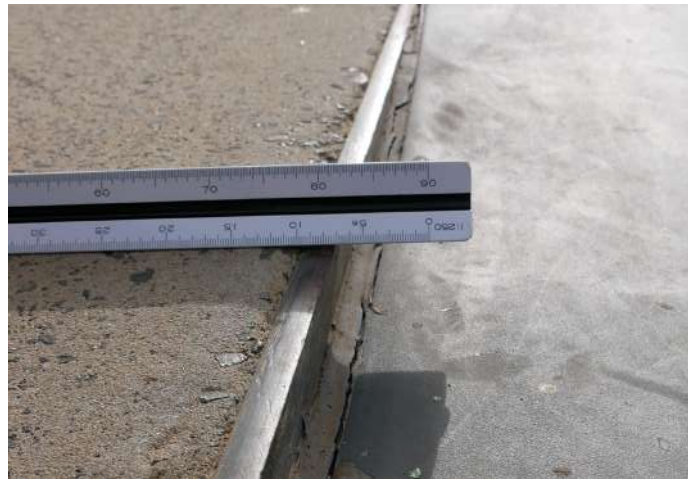
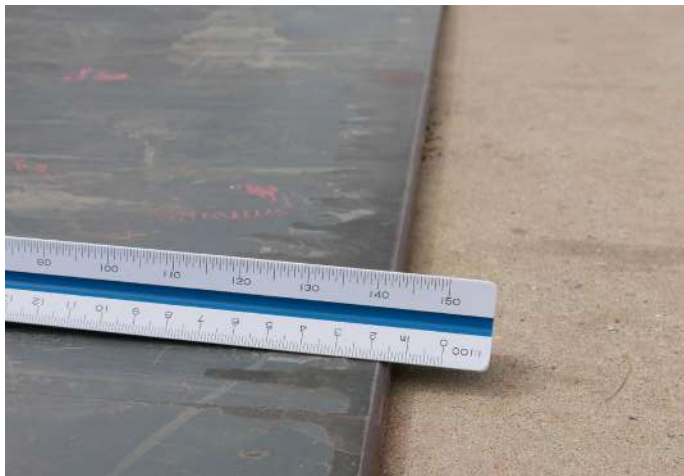
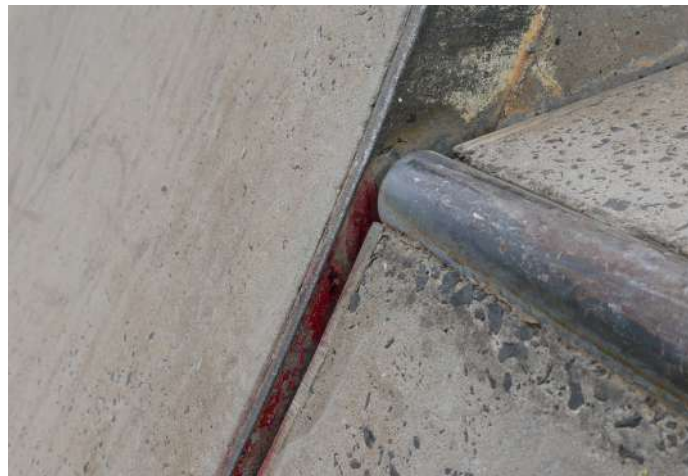
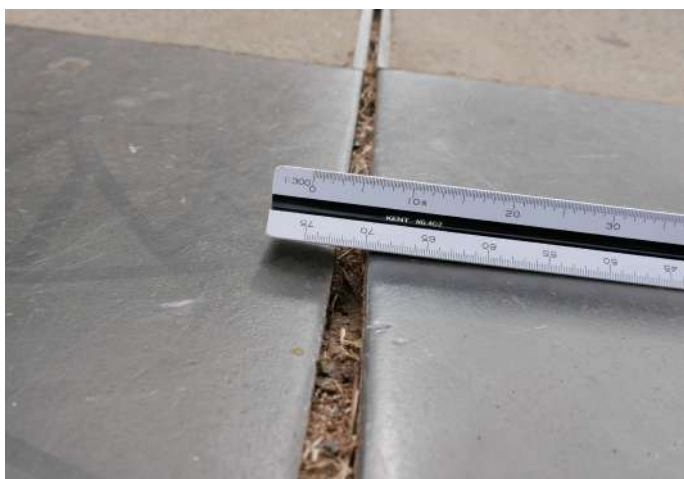
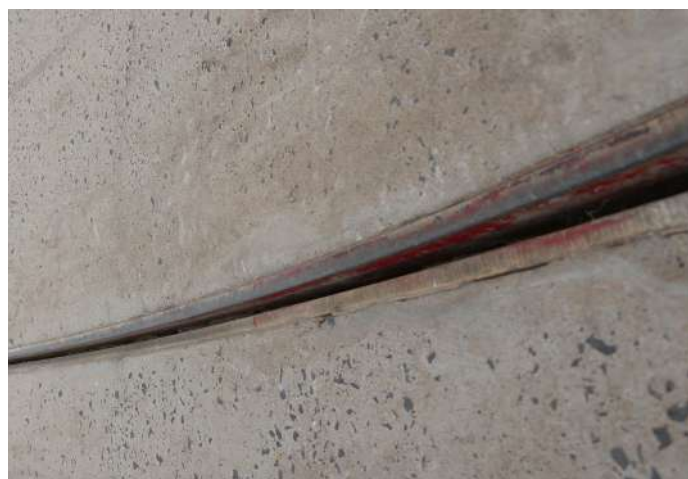
## CONDITION ASSESSMENT - CONCRETE TO SKATE STEEL JOIN

The construction method of a number of the features across the facility has seen a combination of both metal and steel used. Due in part to both the age of the facility as well as quality of construction, there are a number of metal edges and gaps across the facility, largely located in or around faces of transition. Transitions are areas where users are travelling at high speeds, and the edges and gaps in these areas present opportunities for smaller skateboard and scooter wheels to become lodged, subsequently throwing riders from their vehicles.

| GRETA SKATE FACILITY | | | | |
|---|---|---|---|---|
| CONCRETE TO SKATE STEEL JOIN | HAZARD DETERIORATION AGE | HIGH | REMOVE METAL COMPONENTS, REINSTATE SURFACE PROFILE WITH REINSTATEMENT MORTAR, STRIKE OFF LEVEL WITH SURROUNDING CONCRETE SURFACE, STEEL TROWEL FINISH. REPLACE COPING IN LOCATIONS WHERE RUSTED AND DETERIORATED. | 6 MONTHLY |

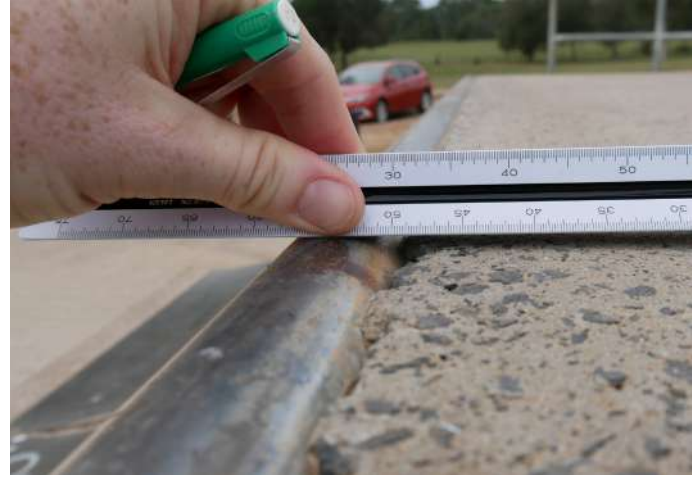
## CONDITION ASSESSMENT - COPING TOLERANCE

The coping offsets around the facility are not in line with modern practices. Typically, coping should sit 10mm above ramp platforms, and sit proud 8mm off ramp transition faces. These standard offsets dimensions are set to encourage coping tricks, and to allow smooth use of the transition ramps. Across most of the facility, the coping sits close to flush with the platform level, while transition offsets vary from 3mm to approximately 5mm. This inconsistency across the facility doesn't promote user confidence in the terrain of the features.

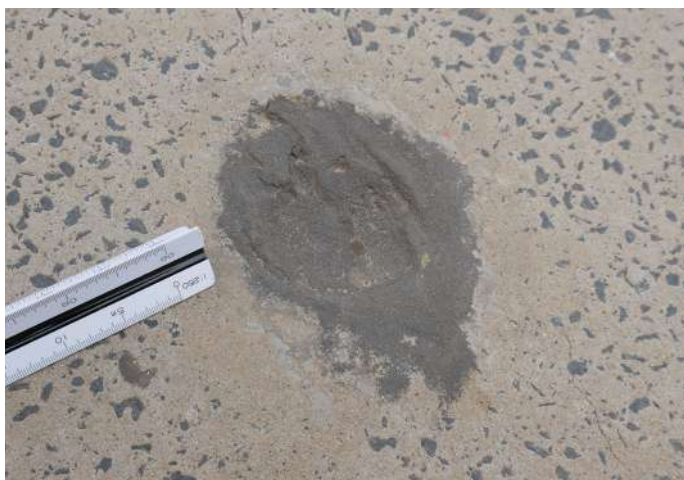
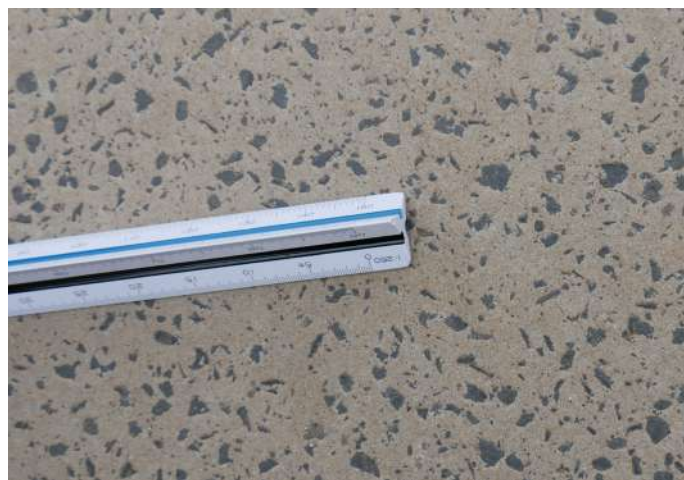
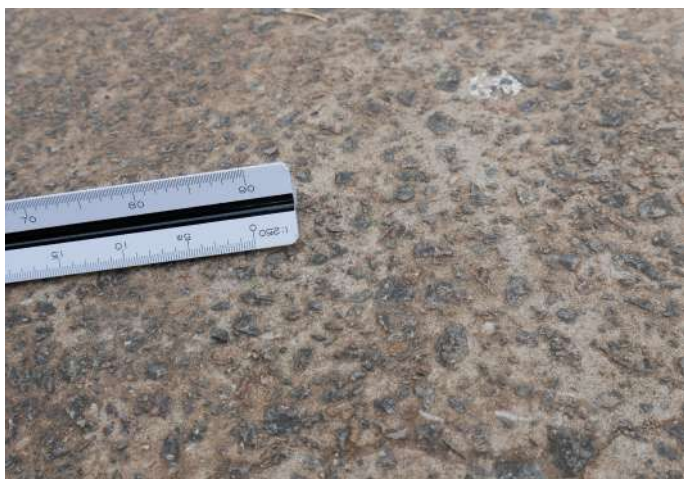
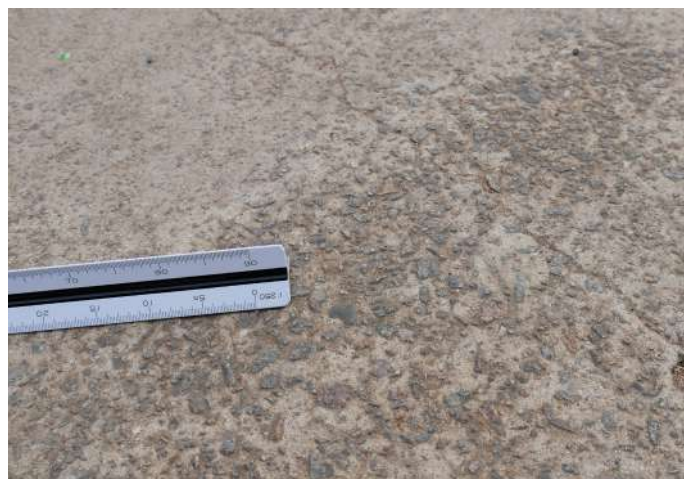
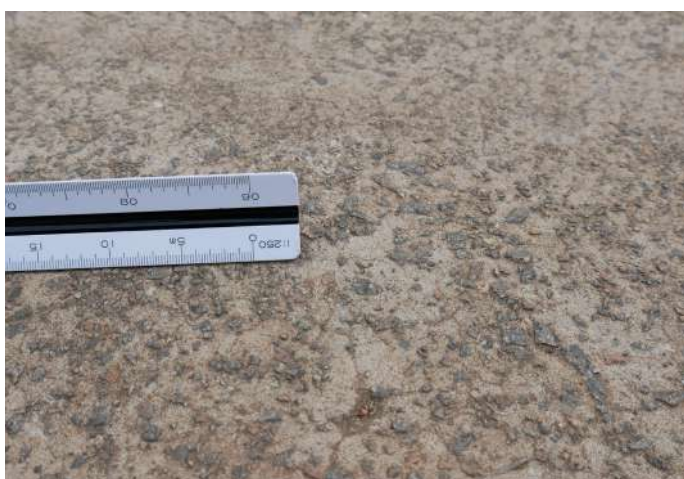
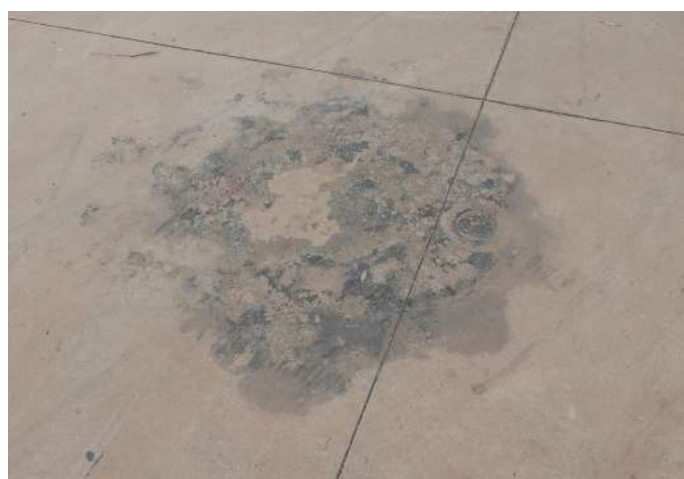
## CONDITION ASSESSMENT - ROUGH SKATE SURFACE AREA

In a number of locations, the skate slab has become extremely weathered and worn, substantially exposing the aggregate in the concrete. Furthermore, there are locations where repairs and patches to the slab have been undertaken, which are in turn degrading. It is imperative that skate surfaces are smooth, as rough areas result in a bumpy and jarring sensation when ridden over, while also presenting an abrasive surface that can cause harm when a user comes into contact. This is a high priority item and should be addressed immediately

| GRETA SKATE FACILITY | | | | |
|---|---|---|---|---|
| ROUGH SKATE SURFACE AREA | HAZARD DETERIORATION AGE | HIGH | GRIND BACK CONCRETE SLABS TO REMOVE ROUGH SURFACE, ENSURE GRINDED AREAS ARE FEATHERED EVENLY TO MEET SURROUNDING SURFACE LEVELS TO ENSURE NO KINKS OR BUMPS IN RIDING SURFACE. | 6 MONTHLY |

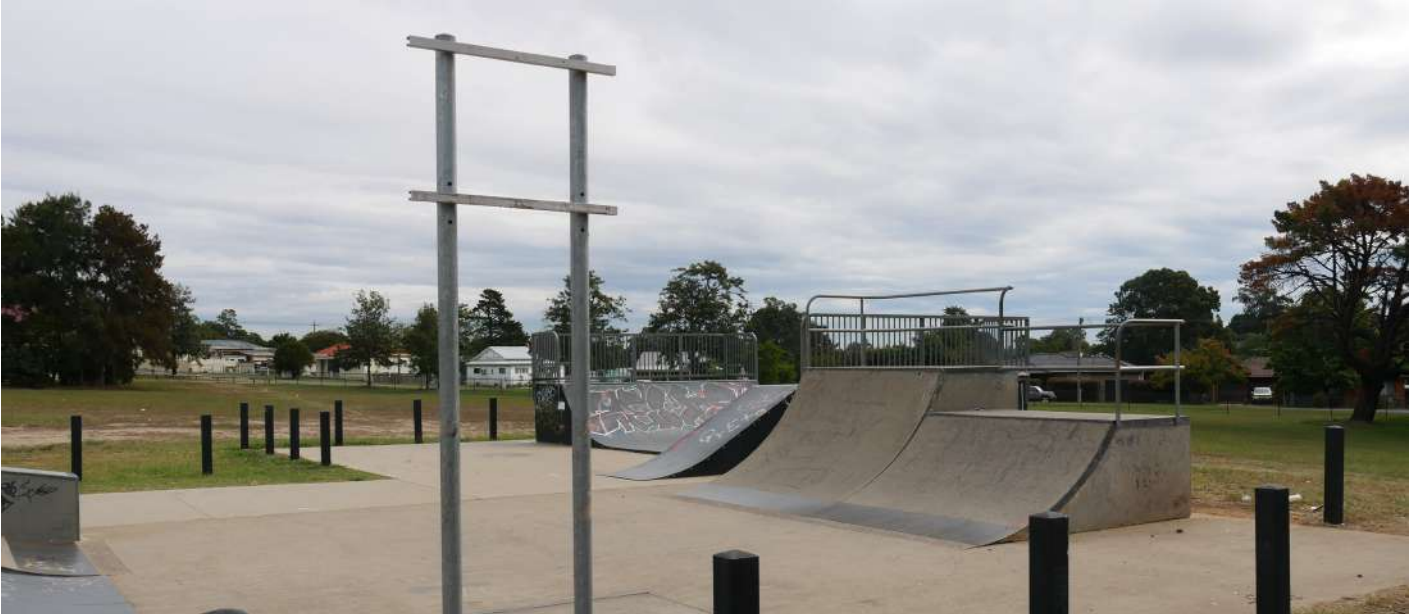
### MISSING SAFETY SIGNAGE

The panel for the safety signage is currently missing. Safety signs contain essential information such as emergency numbers, locations of emergency services, and the address of the facility. It is critical to have this information readily available in the case of an emergency. This should be rectified immediately.

### RISK RATING: LOW

| GRETA SKATE FACILITY | | | | |
|---|---|---|---|---|
| MISSING SAFETY SIGNAGE | HAZARD | LOW | REPLACE SIGN | 6 MONTHLY |

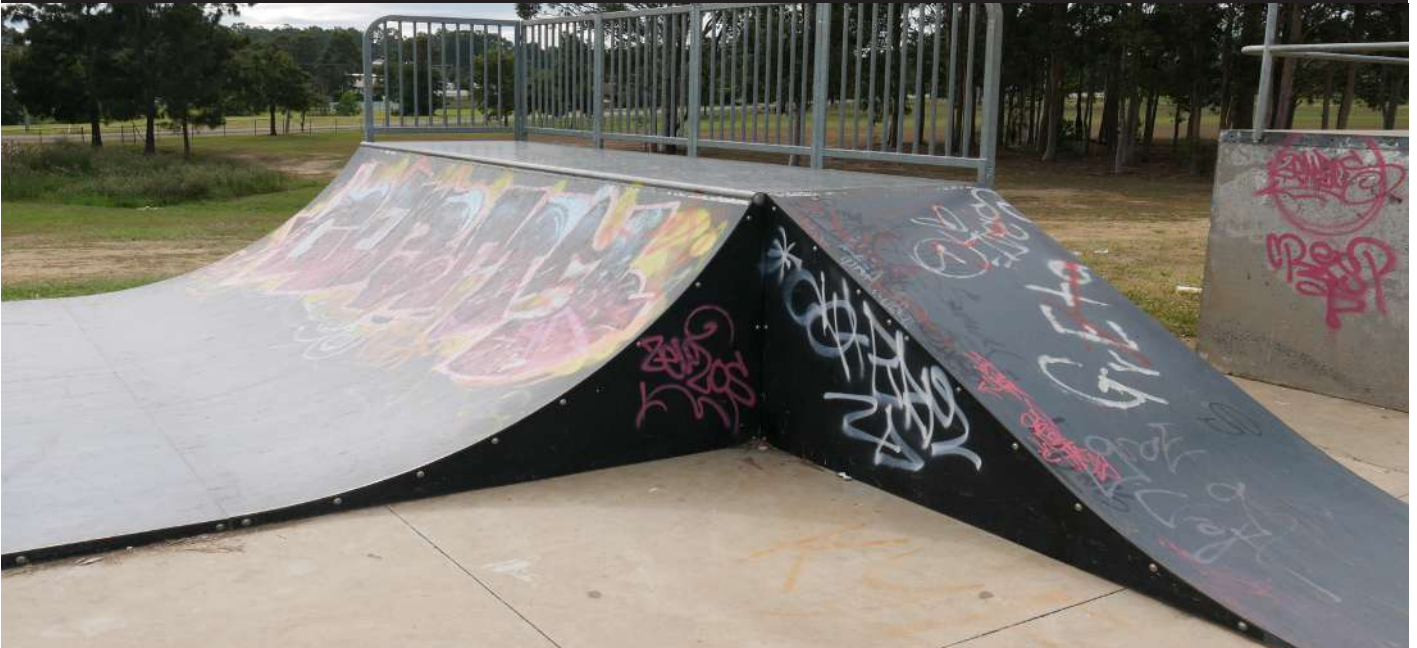
### FALL HEIGHT ISSUE ON MINI RAMP

A section of the ramp platform sits greater than 900mm above the base slab. If a user was to fall in this location they would be prone to sustaining potentially serious injuries. The fall height issue should be rectified immediately.

| GRETA SKATE FACILITY | | | | |
|---|---|---|---|---|
| FALL HEIGHT ISSUE ON RAMP AND QUARTER PIPE | HAZARD | HIGH | MINI RAMP: CONSTRUCT A STEP BELOW THE MINI RAMPTO ACT AS BOTH A STEP TO THE PLATFORM, AND TO PREVENT FALLS. QUARTER PIPE: EXTEND BALUSTRADING TO EDGE OF PLATFORM. | 6 MONTHLY |

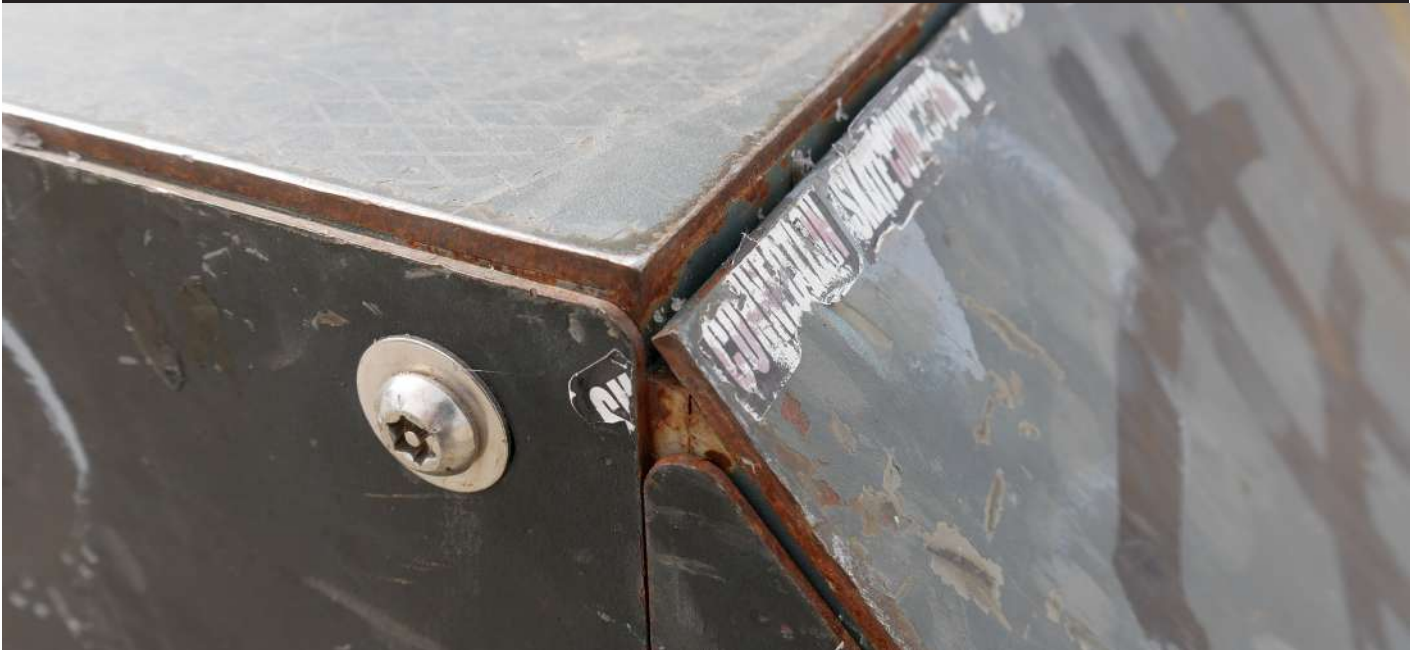
## POORLY CONSTRUCTED FABRICATED FEATURES

The pre fabricated features in the park are poorly made and contain a number of sharp rusted metal edges at the panel joints. These features pose a risk to user safety.

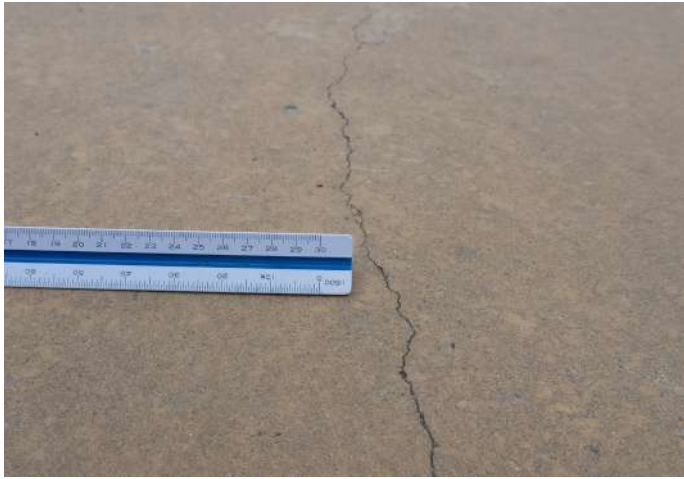
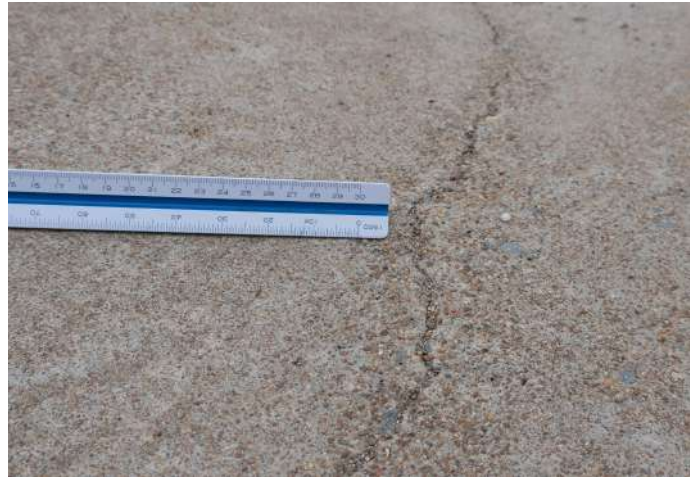
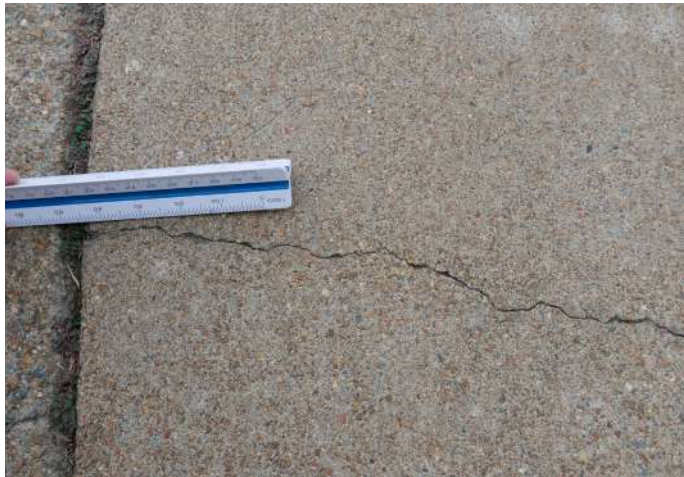
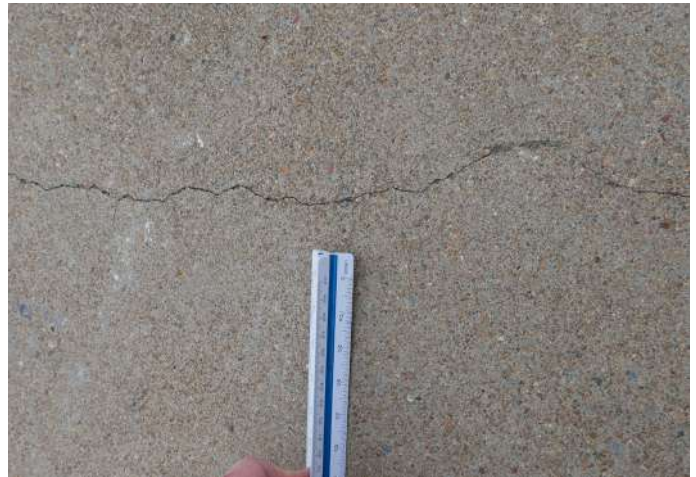
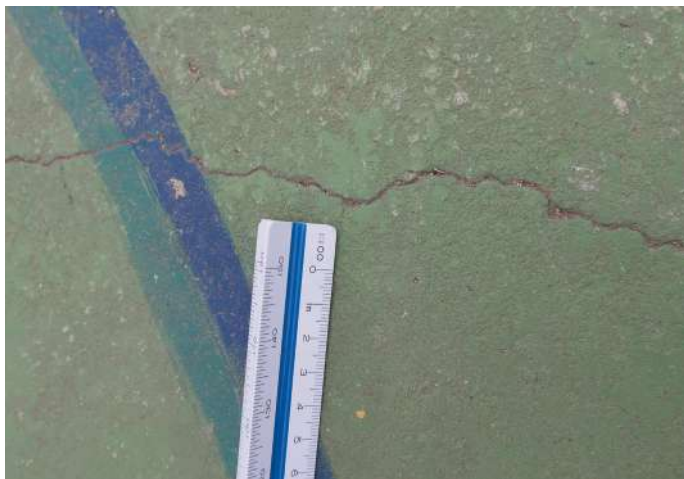
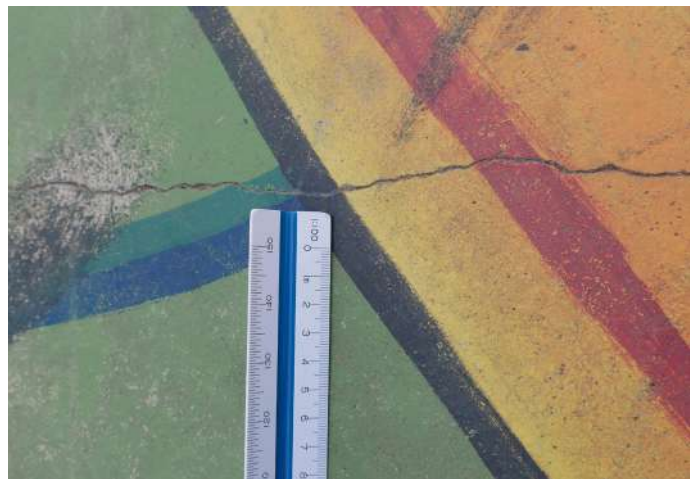
## CONDITION ASSESSMENT - MINOR CRACKING

The concrete slabs are showing signs of minor cracking in a number of locations across the facility. This cracking could be due to earth movement, or general deterioration due to the age of the concrete. While currently minor, if left unaddressed the cracking has the potential to develop further, resulting in major cracking, or leading to an uneven skate surface that is prone to chipping.

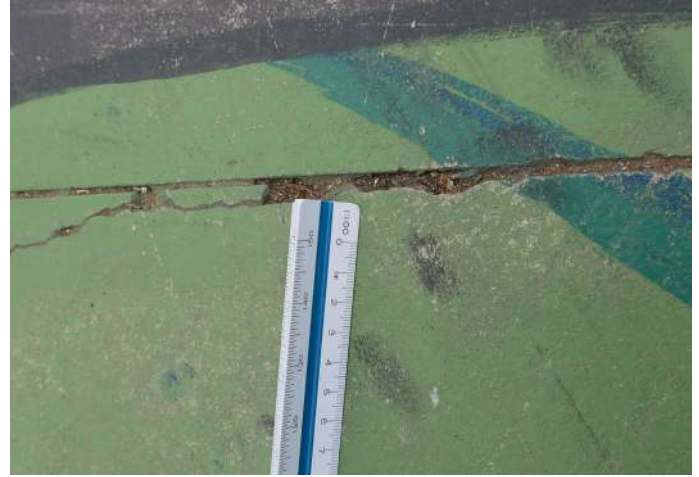
## CONDITION ASSESSMENT - MAJOR CRACKING

There are some incidence of major cracking across the facility. Major cracks present a hazard on the skate area where the smaller wheels of scooters and skateboards can become lodged in the cracks while the user is travelling at speed, consequently throwing the rider off their vehicle. Unexpectedly being thrown while travelling at speed has the potential to result in serious harm to the user.

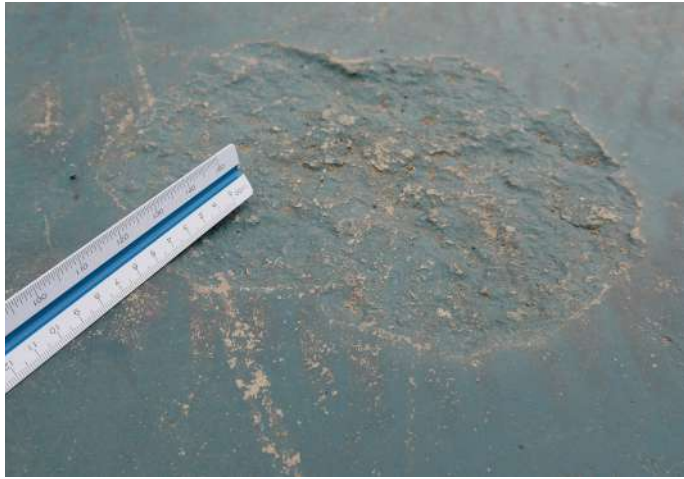
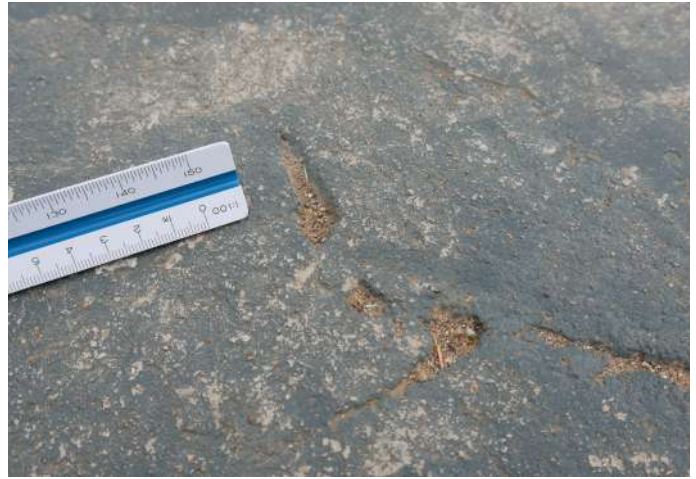
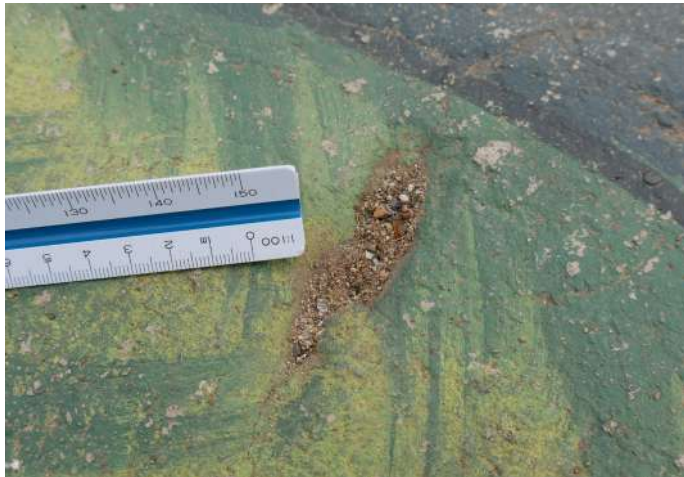
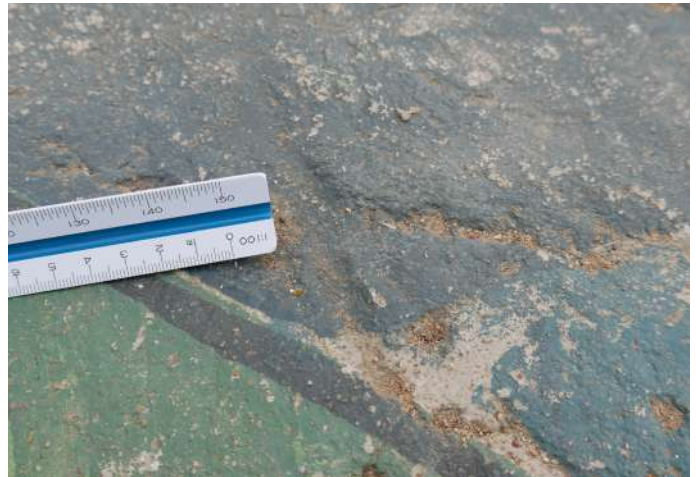
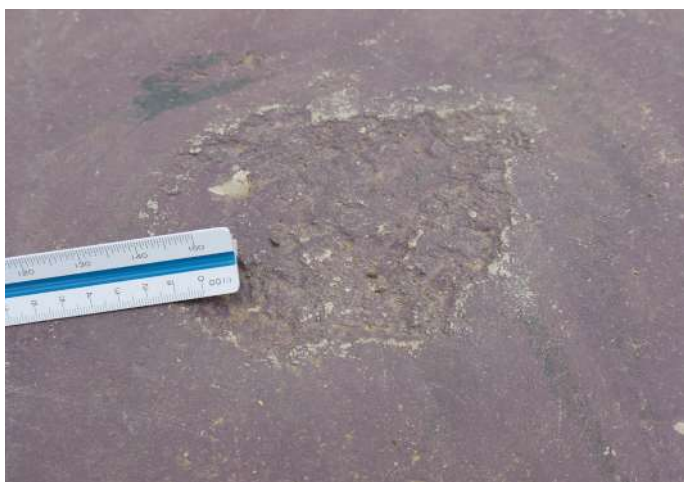
## CONDITION ASSESSMENT - SURFACE CHIPPING

The concrete slabs have a number of areas suffering from surface chipping. Chipping is the result of wear and tear from general use, and is common in parks of this age. Surface chipping presents a hazard on the skate area where the smaller wheels of scooters and skateboards can become lodged while the user is travelling at speed, consequently throwing the rider off their vehicle. Unexpectedly being thrown while travelling at speed has the potential to result in serious harm to the user.

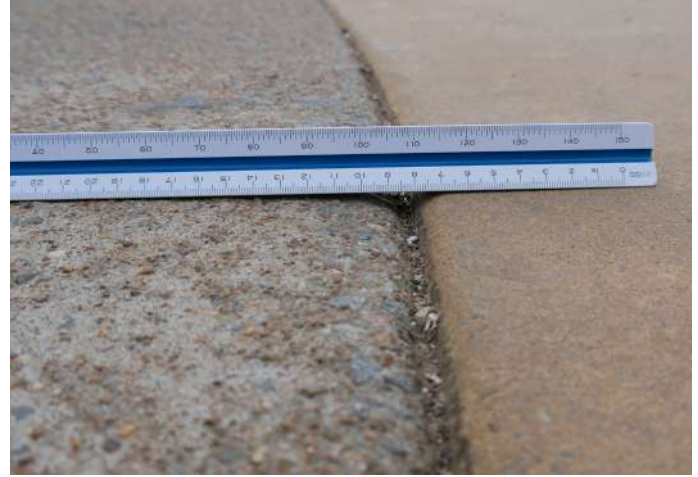
## CONDITION ASSESSMENT - DIFFERENTIAL SETTLEMENT

Differential settlement occurs where a slab has shifted either horizontally or vertically, independent of the adjacent slabs. This results in an edge at the abutment of the two slabs, and presents an opportunity for scooter or skateboard wheels to catch on the edge. Differential settlement in this case has occurred along the connection between the original slab and the new slab, as well as at the base of the features in the southern end of the facility. These locations are where users are travelling at speed, and as such the potential for harm to users is high.

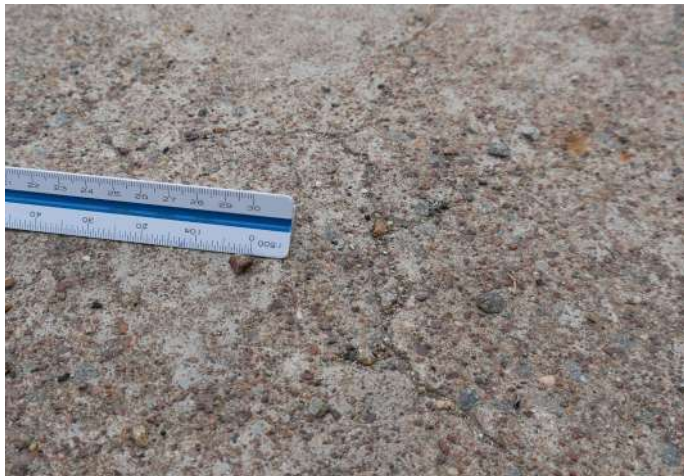
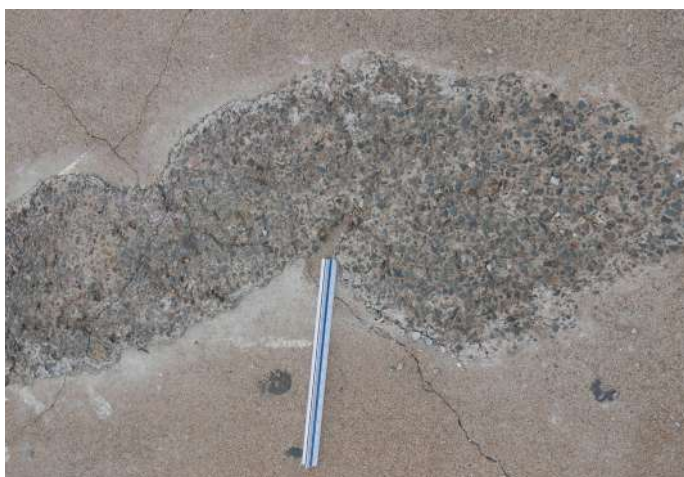
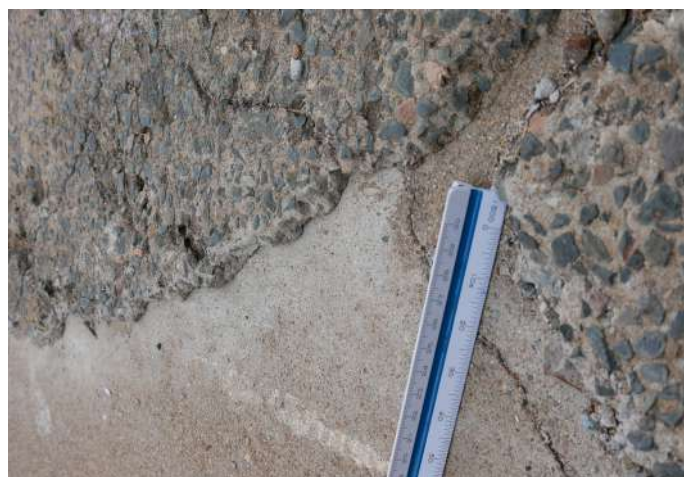
## CONDITION ASSESSMENT - ROUGH SKATE SURFACE AREA

In a number of locations, the snake run slab has become weathered and worn, exposing the aggregate in the concrete. Furthermore, there are instances of large clumps of concrete across the surface of the snake run. It is imperative that skate surfaces are smooth, as rough areas result in a bumpy and jarring sensation when ridden over, while also presenting an abrasive surface that can cause harm when a user comes into contact. Rough surfaces also affect the speed that a rider is able to travel across the surface of the concrete. This is a high priority item and should be addressed immediately

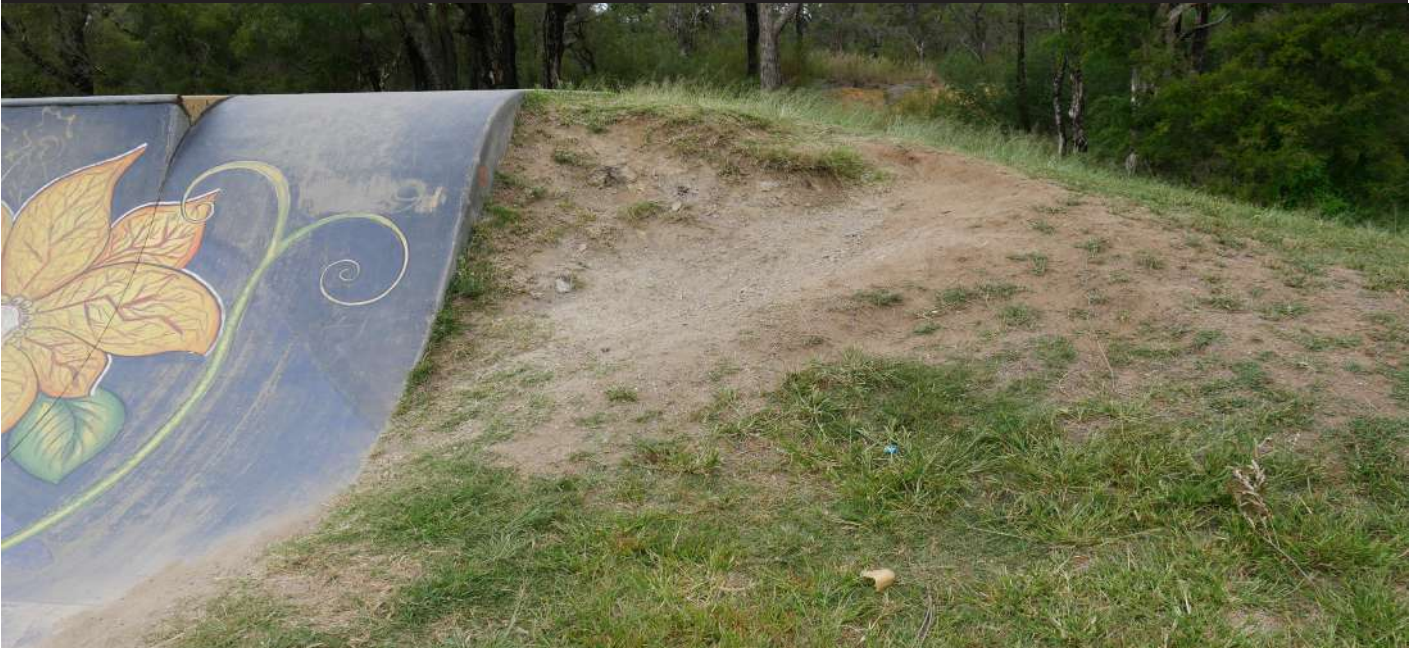
### EROSION OF BATTERS

The battering adjacent to a number of features is becoming heavily eroded, and the resulting dirt is spilling onto the skate surface. Dirt and debris on skate surfaces presents a hazard due to the surface becoming slippery, increasing the likelihood of users sliding out on their boards, scooters, or bikes. It is important to regularly maintain the facility and ensure all surfaces are kept free of debris and dirt.

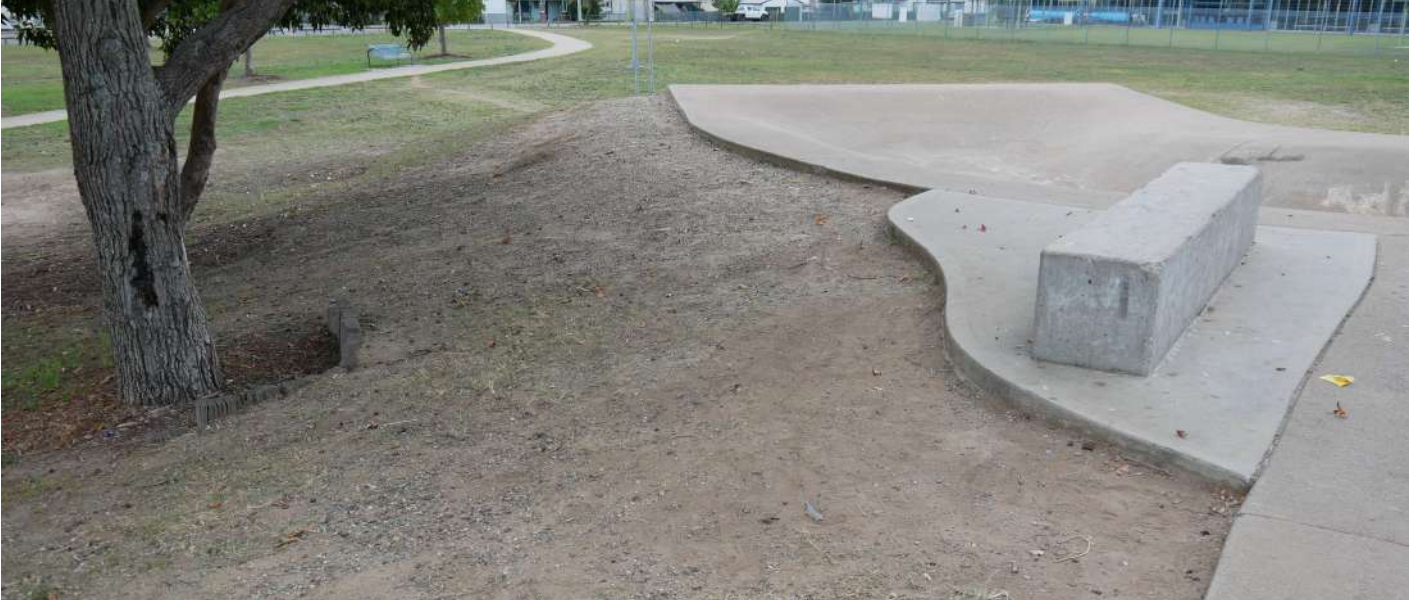
## **EROSION AROUND REFUGE AREA**

Erosion is present on the batters adjacent to the refuge area. The surrounding earth has subsided in this location, creating a tripping hazard for pedestrians travelling up the hill and onto the skate surface. The presence of dirt encourages dirt and debris to become strewn across the skate surface

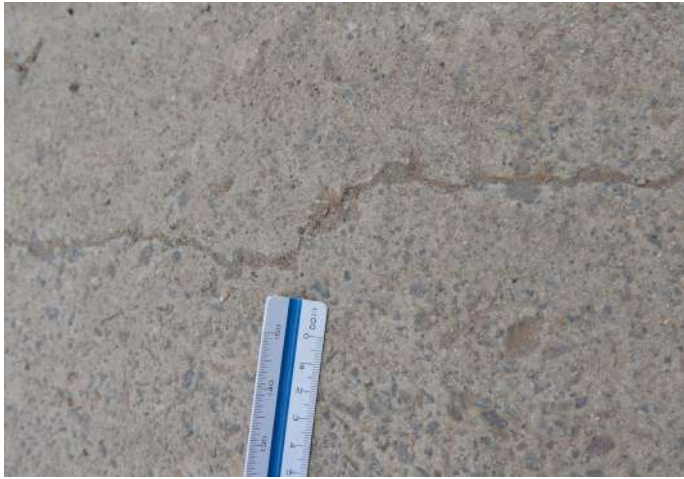
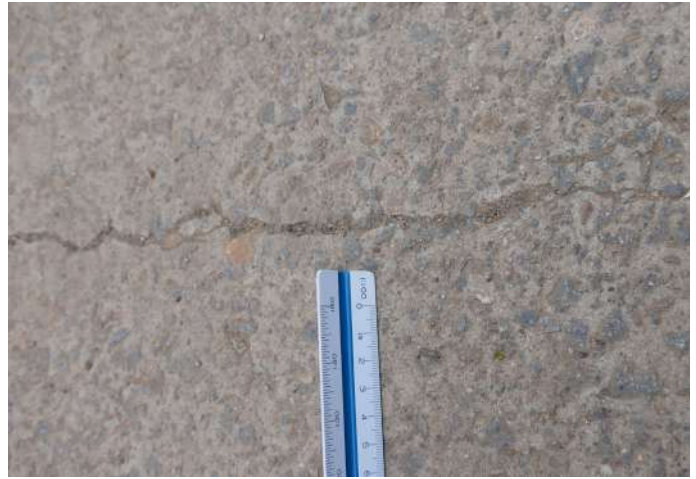
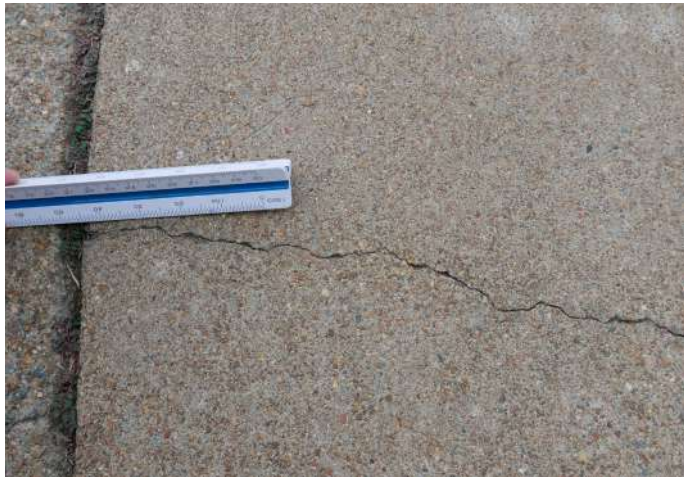
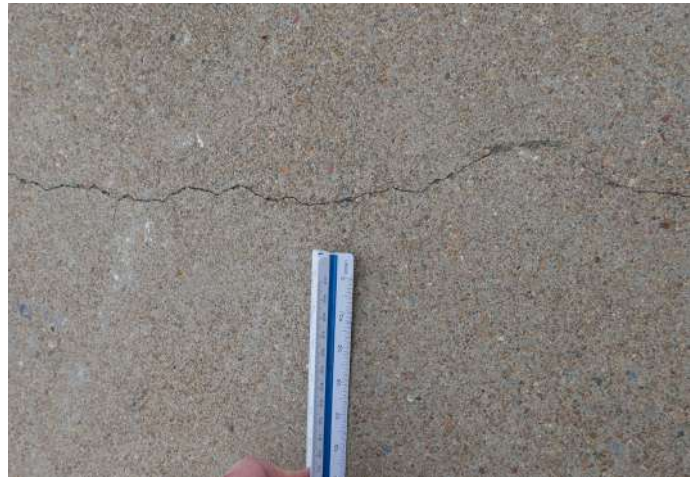
## CONDITION ASSESSMENT - MINOR CRACKING

The concrete slabs are showing signs of minor cracking in a number of locations across the facility. This cracking could be due to earth movement, incorrect construction techniques employed during the initial build, or general deterioration due to the age of the concrete. While currently minor, if left unaddressed the cracking has the potential to develop further, resulting in major cracking, or leading to an uneven skate surface that is prone to chipping.
