# CESSNOCK LGA SKATE PARKS AUDIT REPORT

MAY 2020

CESSNOCK CITY COUNCIL

DOCUMENT: CESSNOCK LGA SKATE PARKS AUDIT REPORT

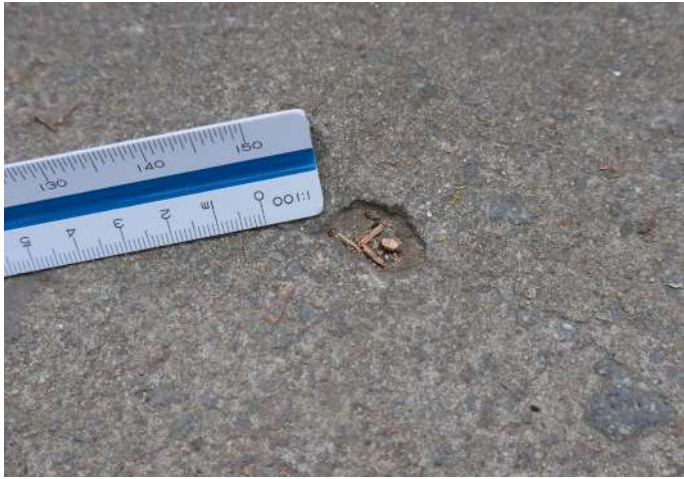
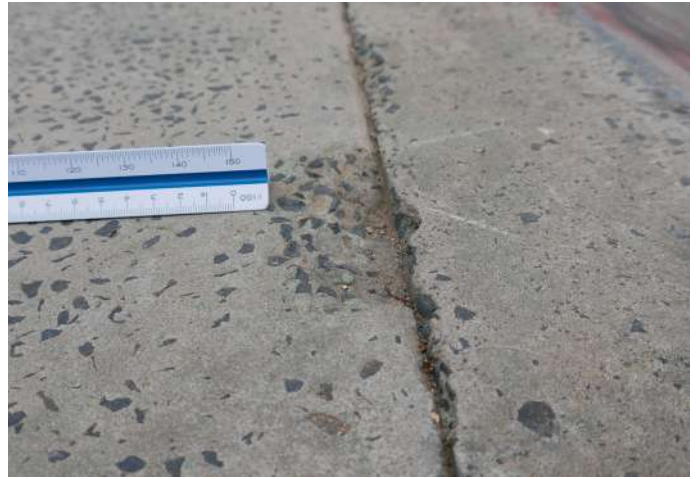
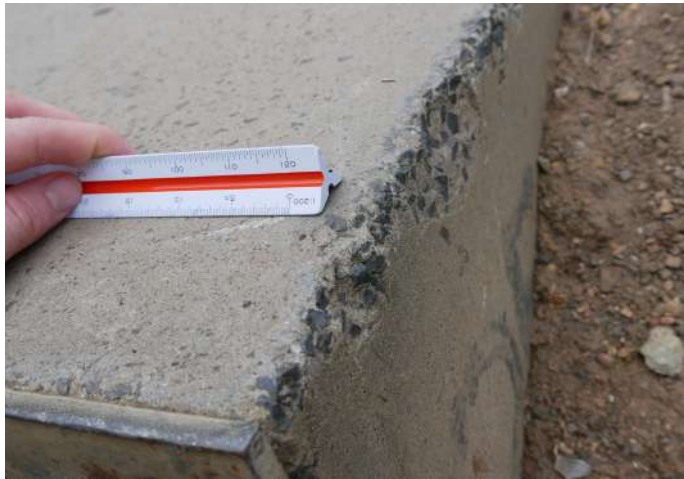
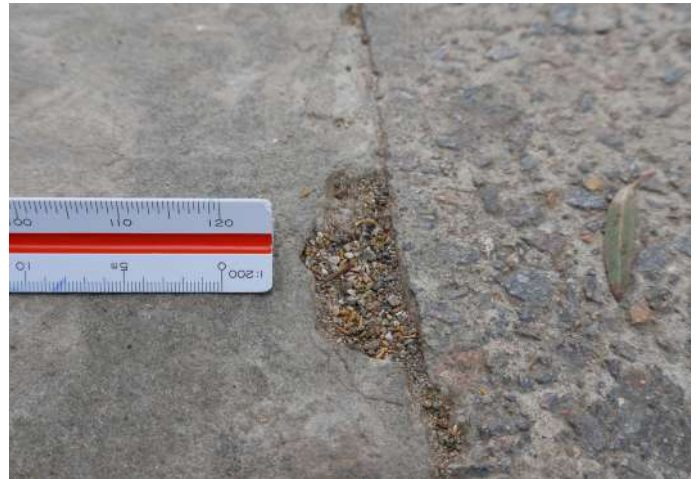
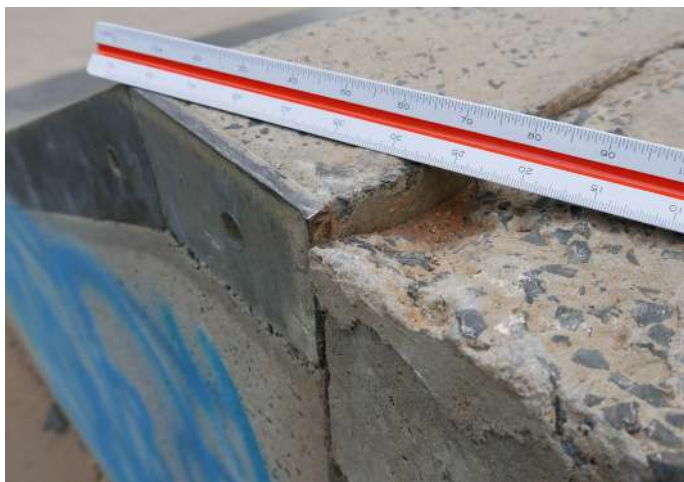
## CONDITION ASSESSMENT - SURFACE CHIPPING

The concrete slabs have a number of areas suffering from surface chipping. Chipping is the result of wear and tear from general use, and is common in parks of this age. Surface chipping presents a hazard on the skate area where the smaller wheels of scooters and skateboards can become lodged while the user is travelling at speed, consequently throwing the rider off their vehicle. Unexpectedly being thrown while travelling at speed has the potential to result in serious harm to the user.

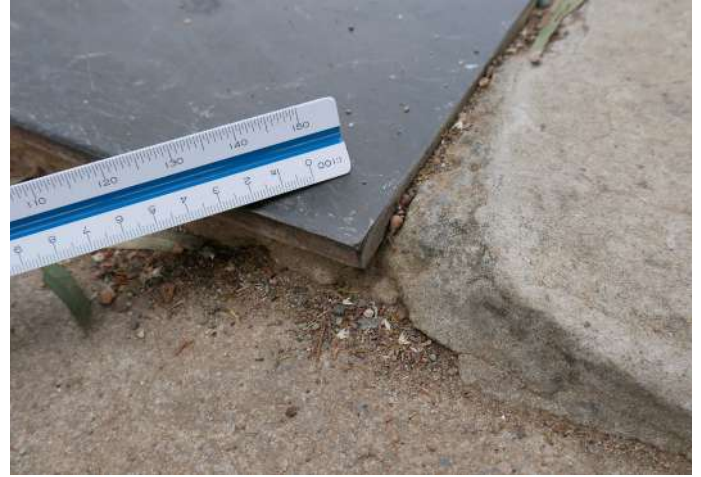
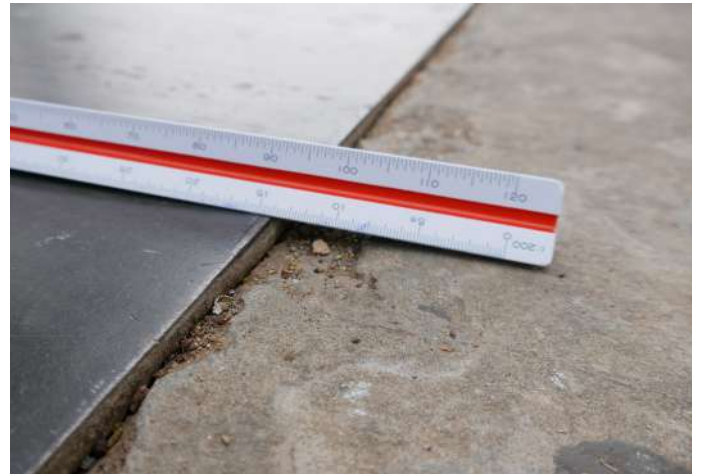
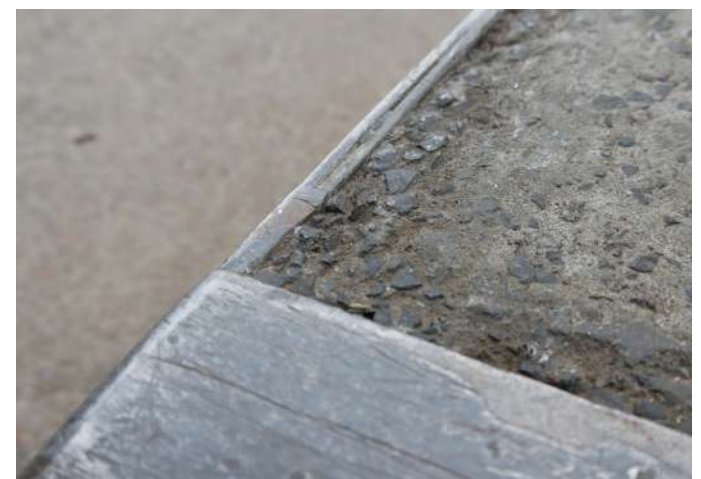
## CONDITION ASSESSMENT - CONCRETE TO SKATE STEEL JOIN

The construction method of a number of the features across the facility has seen a combination of both metal and steel used. Due in part to both the age of the facility as well as quality of construction, there are a number of metal edges and gaps across the facility, largely located in or around faces of transition. Transitions are areas where users are travelling at high speeds, and the edges and gaps in these areas present opportunities for smaller skateboard and scooter wheels to become lodged, subsequently throwing riders from their vehicles.

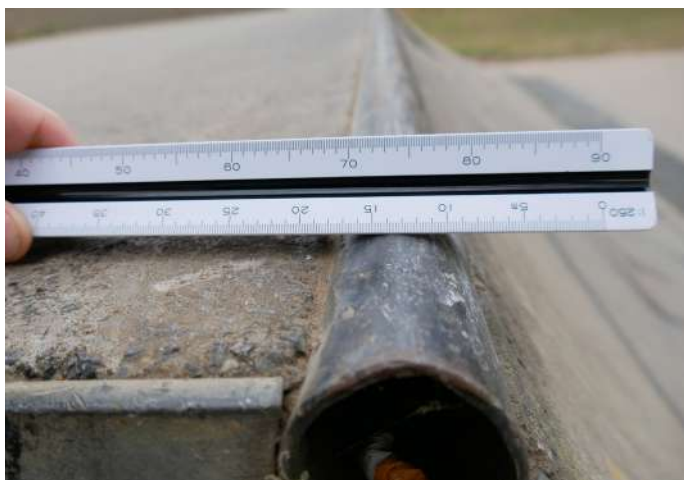
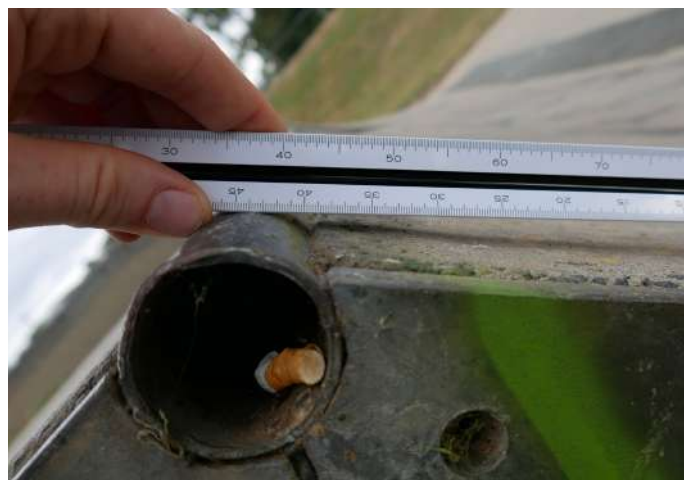
## CONDITION ASSESSMENT - COPING TOLERANCE

The coping offsets around the facility are not in line with modern practices. Typically, coping should sit 10mm above ramp platforms, and sit proud 8mm off ramp transition faces. These standard offsets dimensions are set to encourage coping tricks, and to allow smooth use of the transition ramps. Across most of the facility, the coping sits close to flush with the platform level, while transition offsets vary from 3mm to approximately 5mm. This inconsistency across the facility doesn't promote user confidence in the terrain of the features.

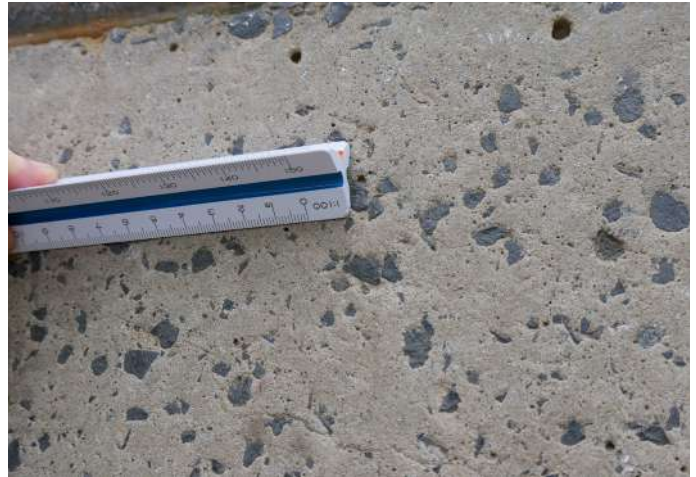
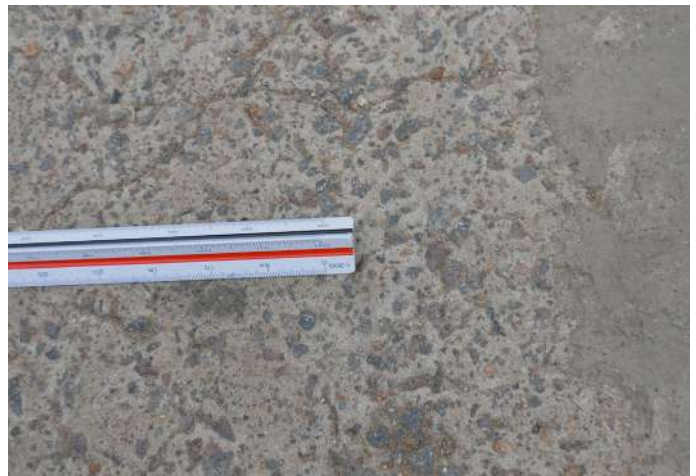
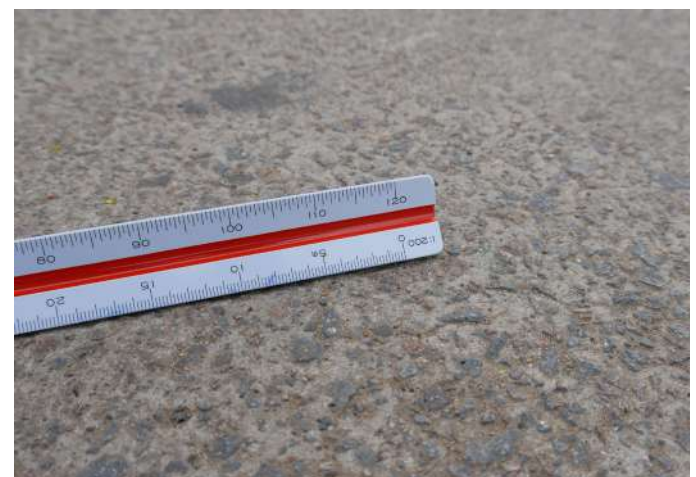
## CONDITION ASSESSMENT - ROUGH SKATE SURFACE AREA

In a number of locations, the skate slab has become weathered and worn, exposing the aggregate in the concrete. Furthermore, there are locations where repairs and patches to the slab have been undertaken, which are in turn degrading. It is imperative that skate surfaces are smooth, as rough areas result in a bumpy and jarring sensation when ridden over, while also presenting an abrasive surface that can cause harm when a user comes into contact. This is a high priority item and should be addressed immediately

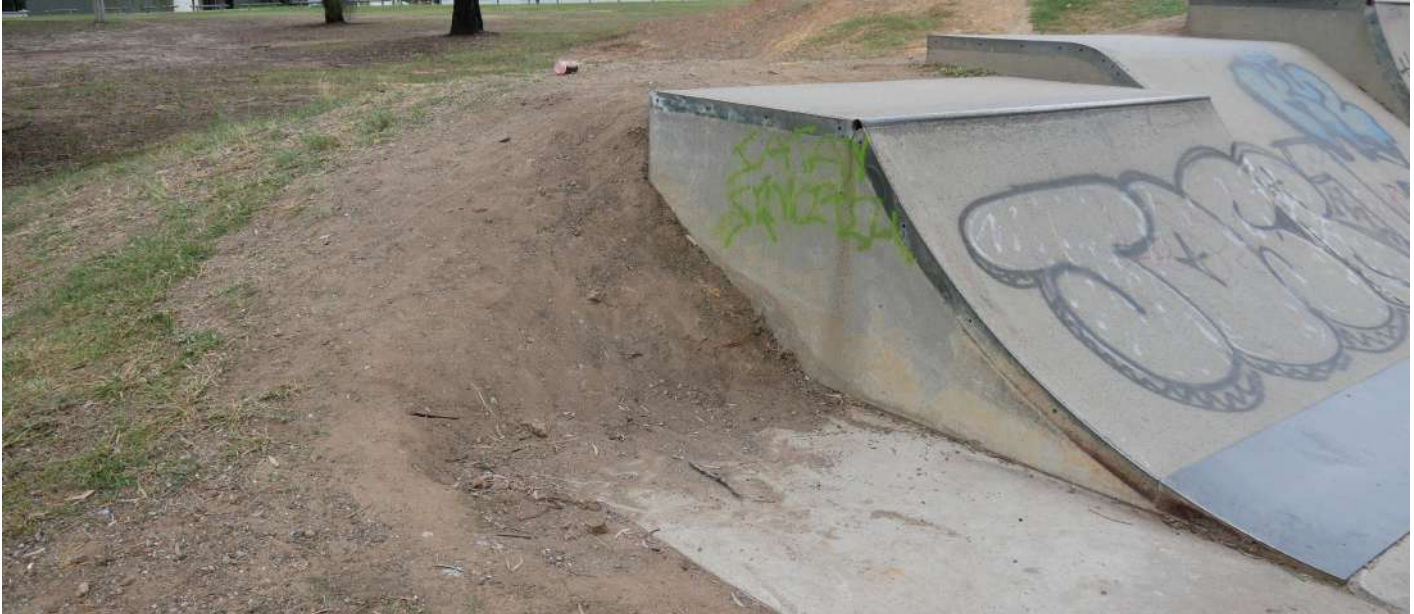
### EROSION OF BATTERS

The battering adjacent to a number of features is becoming heavily eroded, and the resulting dirt is spilling onto the skate surface. Dirt and debris on skate surfaces presents a hazard due to the surface becoming slippery, increasing the likelihood of users sliding out on their boards, scooters, or bikes. It is important to regularly maintain the facility and ensure all surfaces are kept free of debris and dirt.

### RISK RATING: LOW

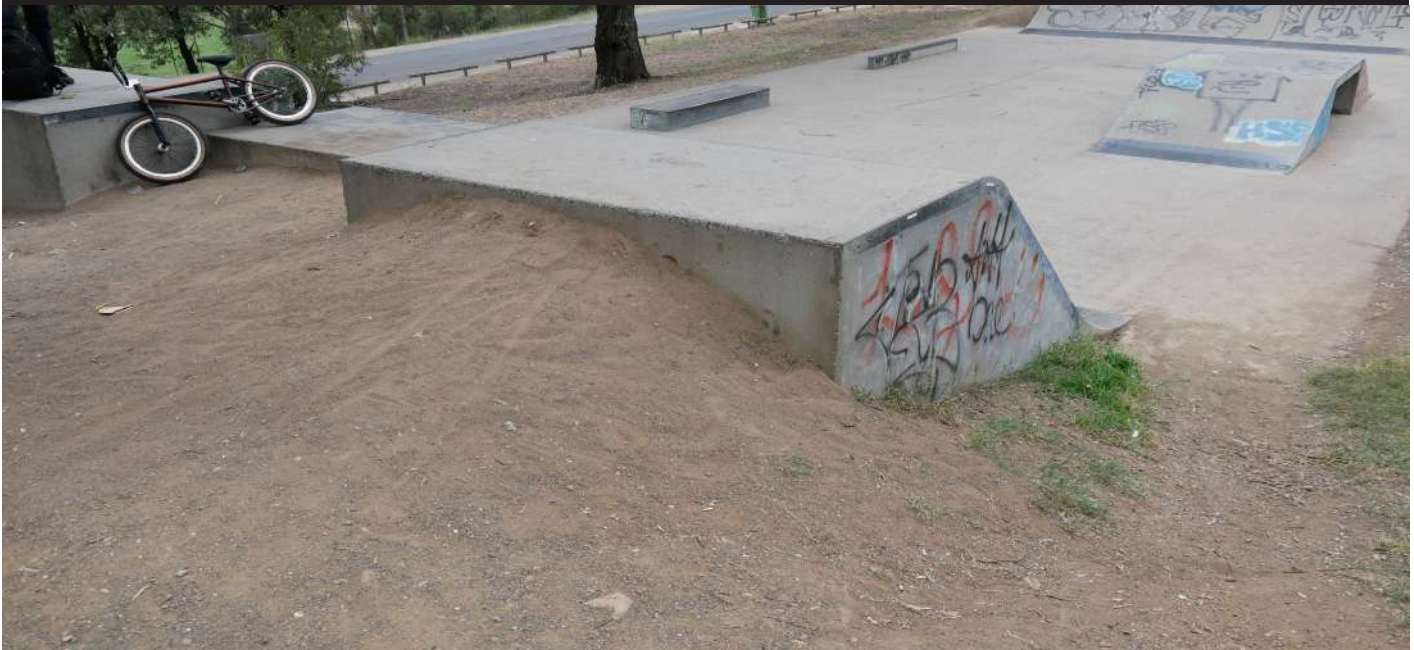
### EROSION OF BATTERS

The battering adjacent to a number of features is becoming heavily eroded, and the resulting dirt is spilling onto the skate surface. Dirt and debris on skate surfaces presents a hazard due to the surface becoming slippery, increasing the likelihood of users sliding out on their boards, scooters, or bikes. It is important to regularly maintain the facility and ensure all surfaces are kept free of debris and dirt.
