Douglas Partners

Preliminary Geotechnical Assessment

Proposed Rezoning
Hydro Aluminium Kurri Kurri
Loxford Portion

Project 81520
March 2015

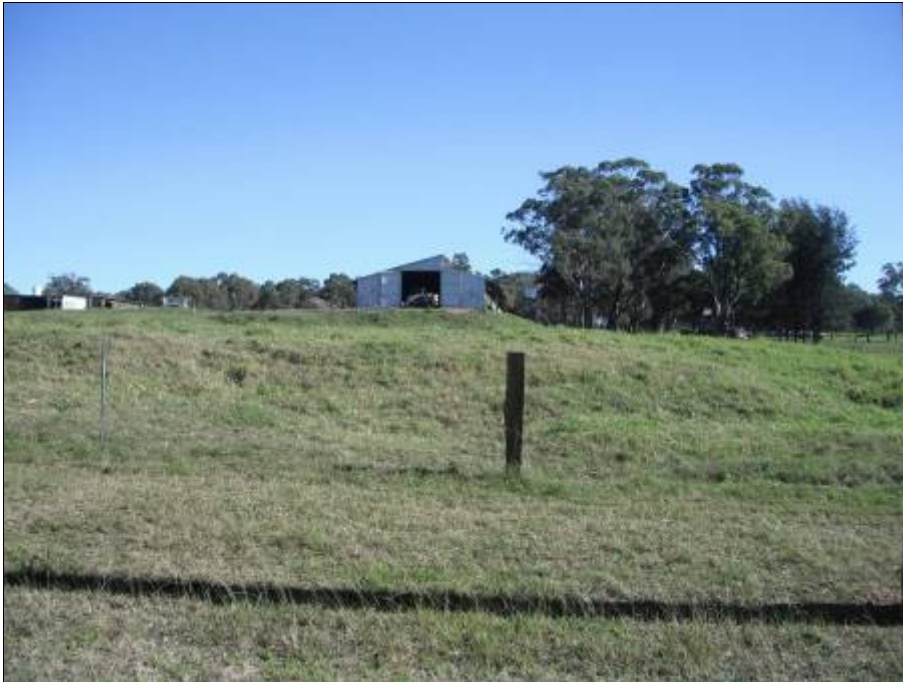
Photo 2: Probable fill platform, looking towards farm sheds / chicken sheds off Bowditch Avenue in Residential Southern part of site

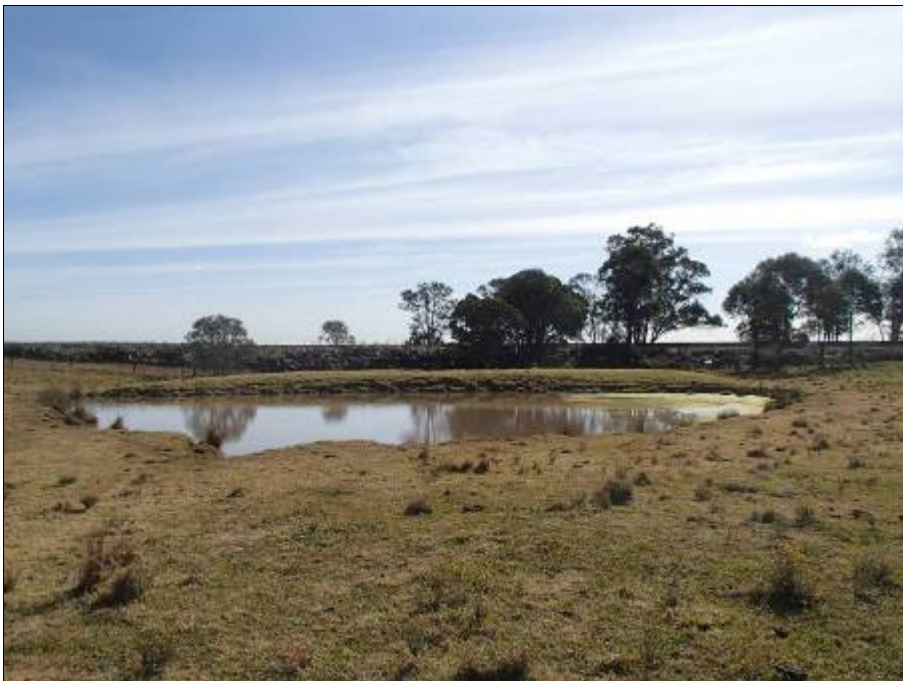
Photo 3: Dam 3, looking north-west from Pit 12 (Residential Central Precinct)

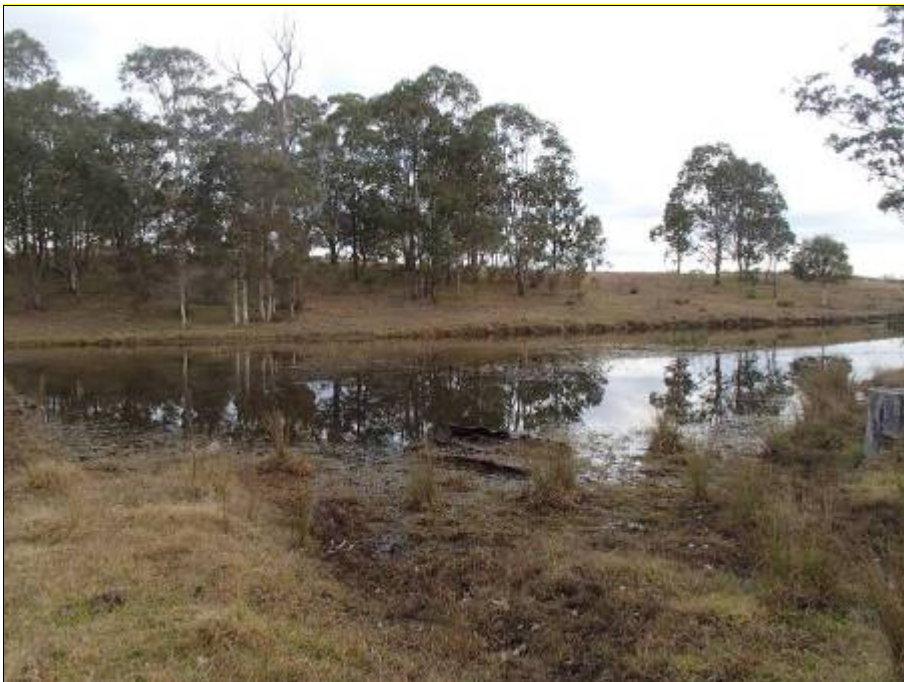
Photo 7: Dam 4 (Residential Central Precinct)

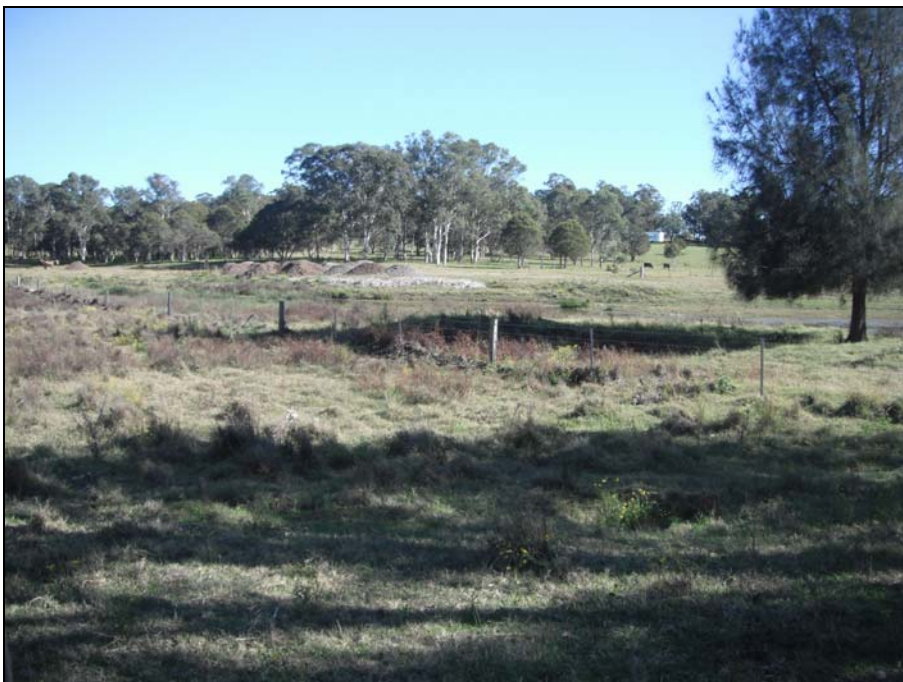
Photo 11: Mounds of filling in vicinity of area between Southern and Central Residential Precincts

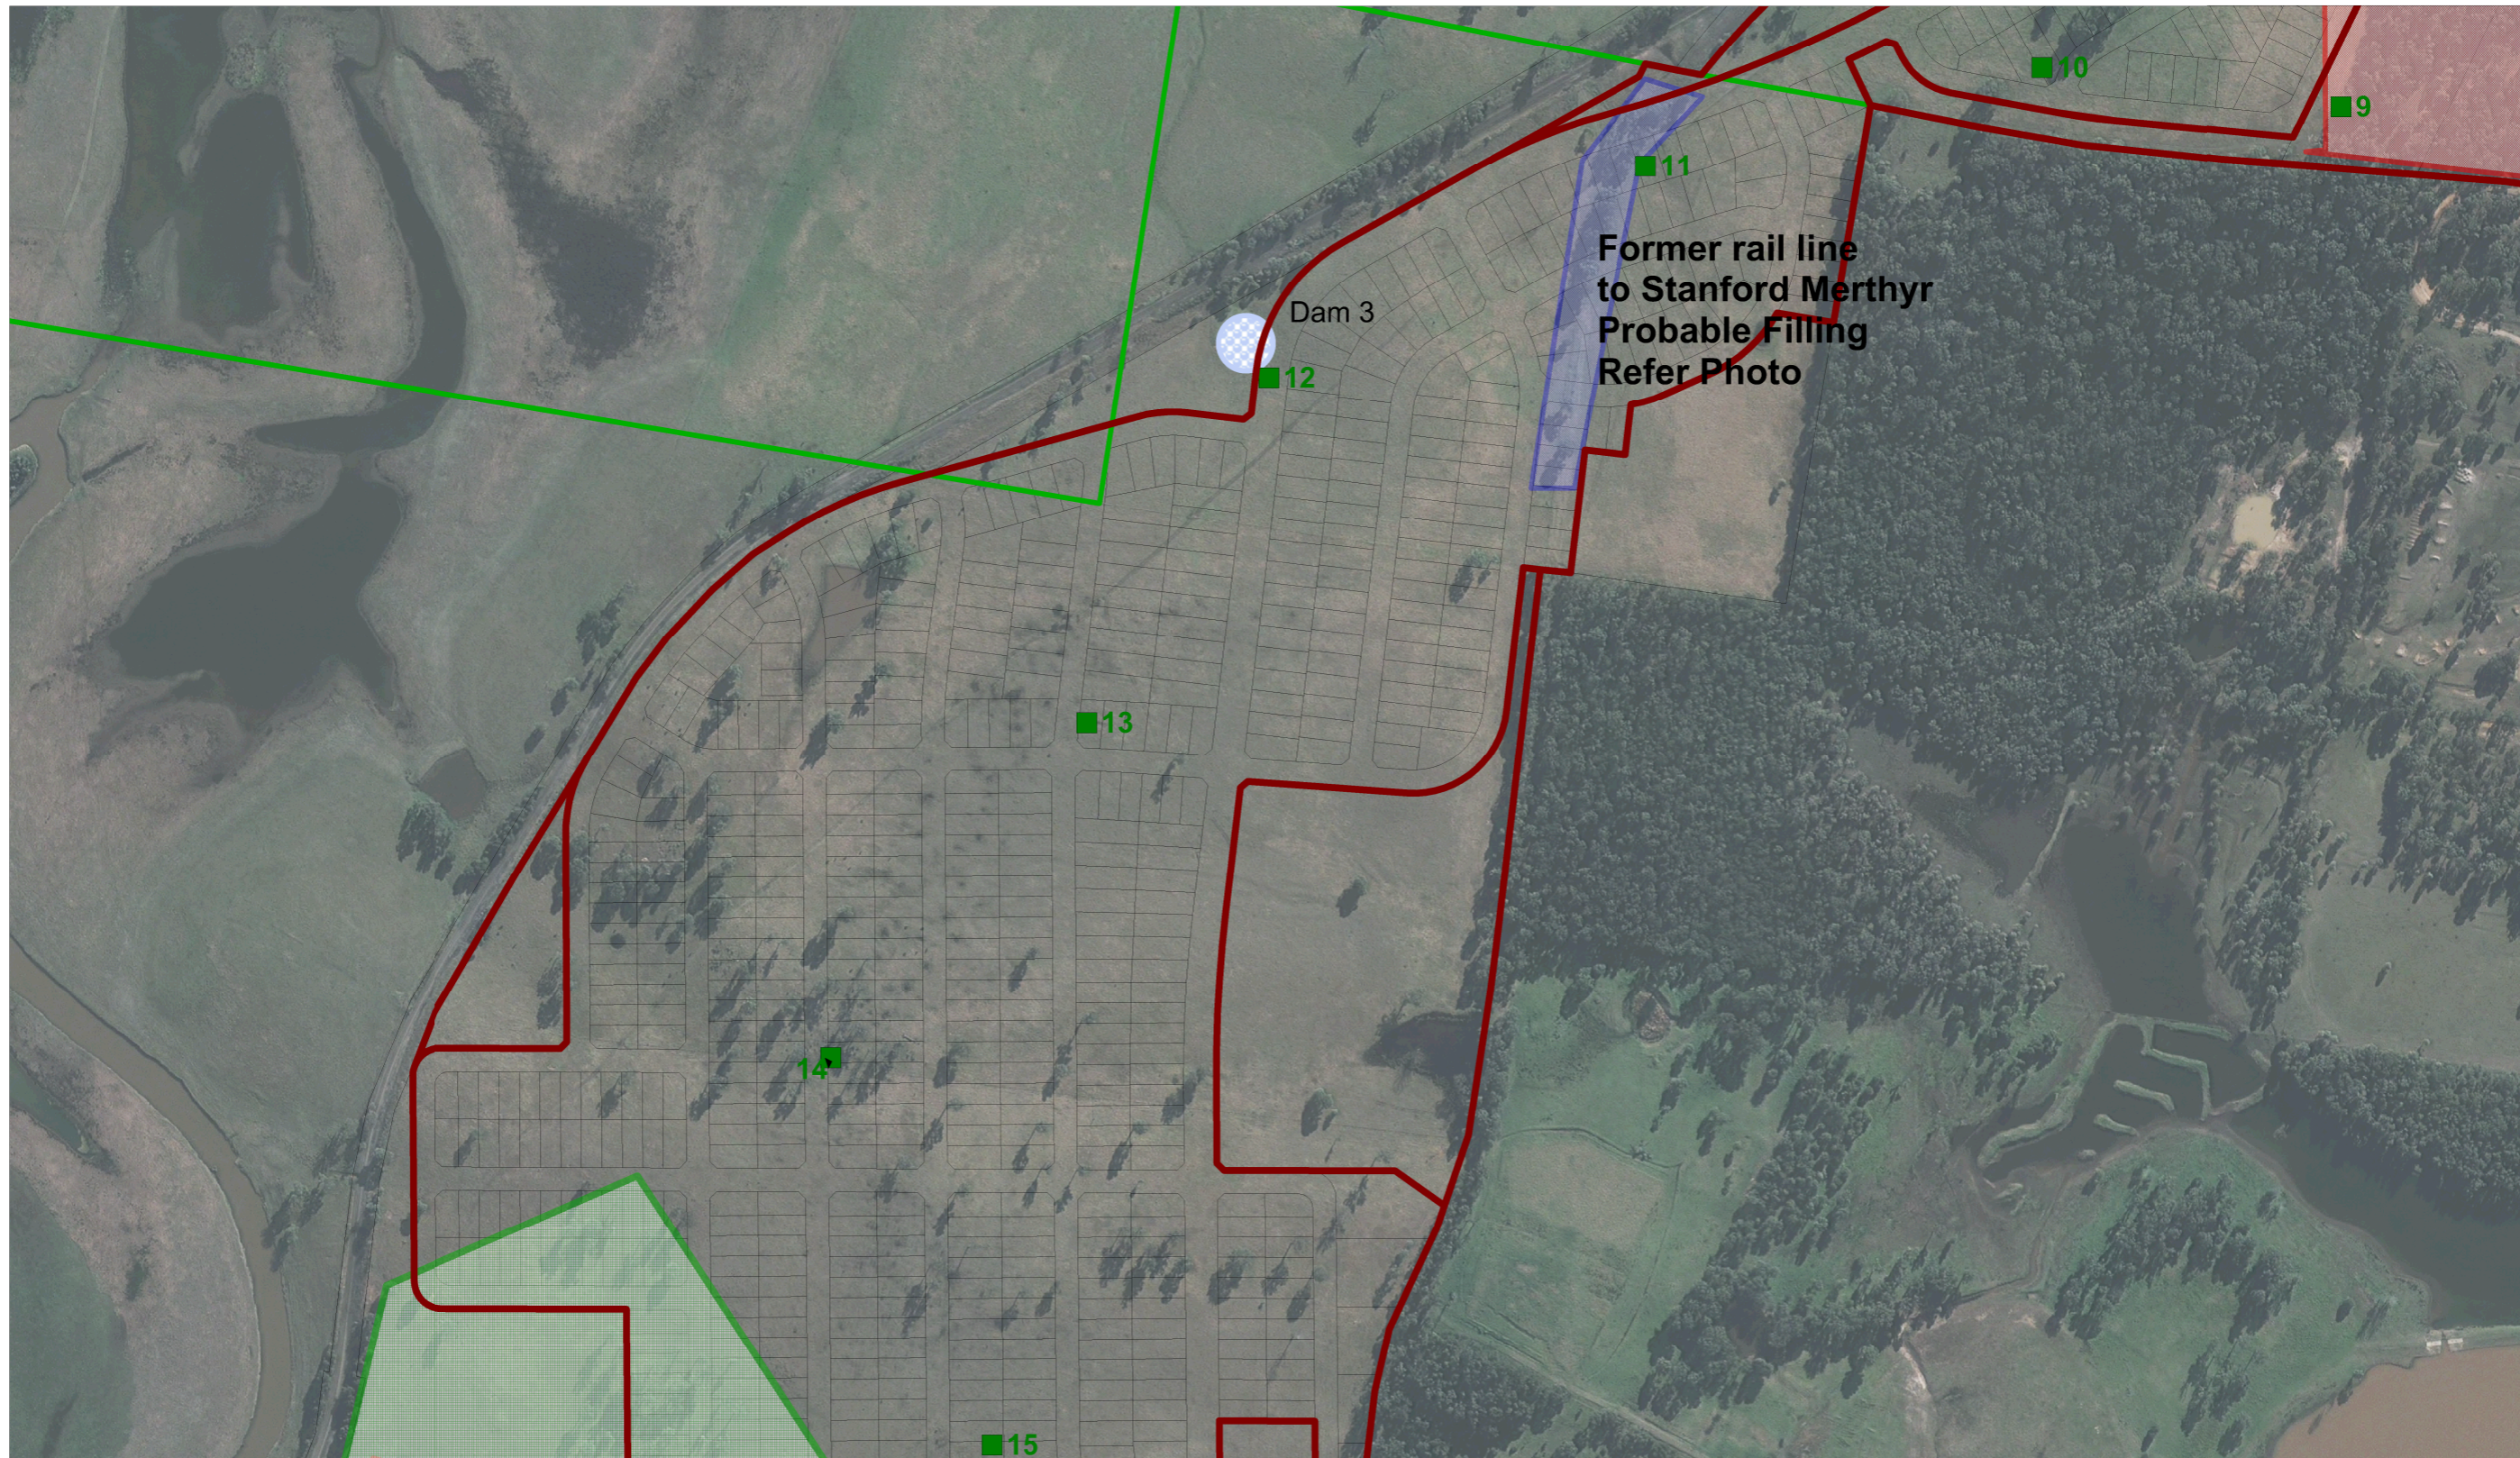
PROJECT No: 81520
 DRAWING No: 3
 REVISION: 0

A significant proportion of the western part of the site will be classified Class P in its current condition due to the presence of filling / disturbed ground. Drawings 3 to 7 in Appendix C, indicate areas of the site where filling may be present based on field observations. These areas can be re-classified if the uncontrolled filling is removed and replaced with engineered filling to the requirements of AS3798 (Ref 4).

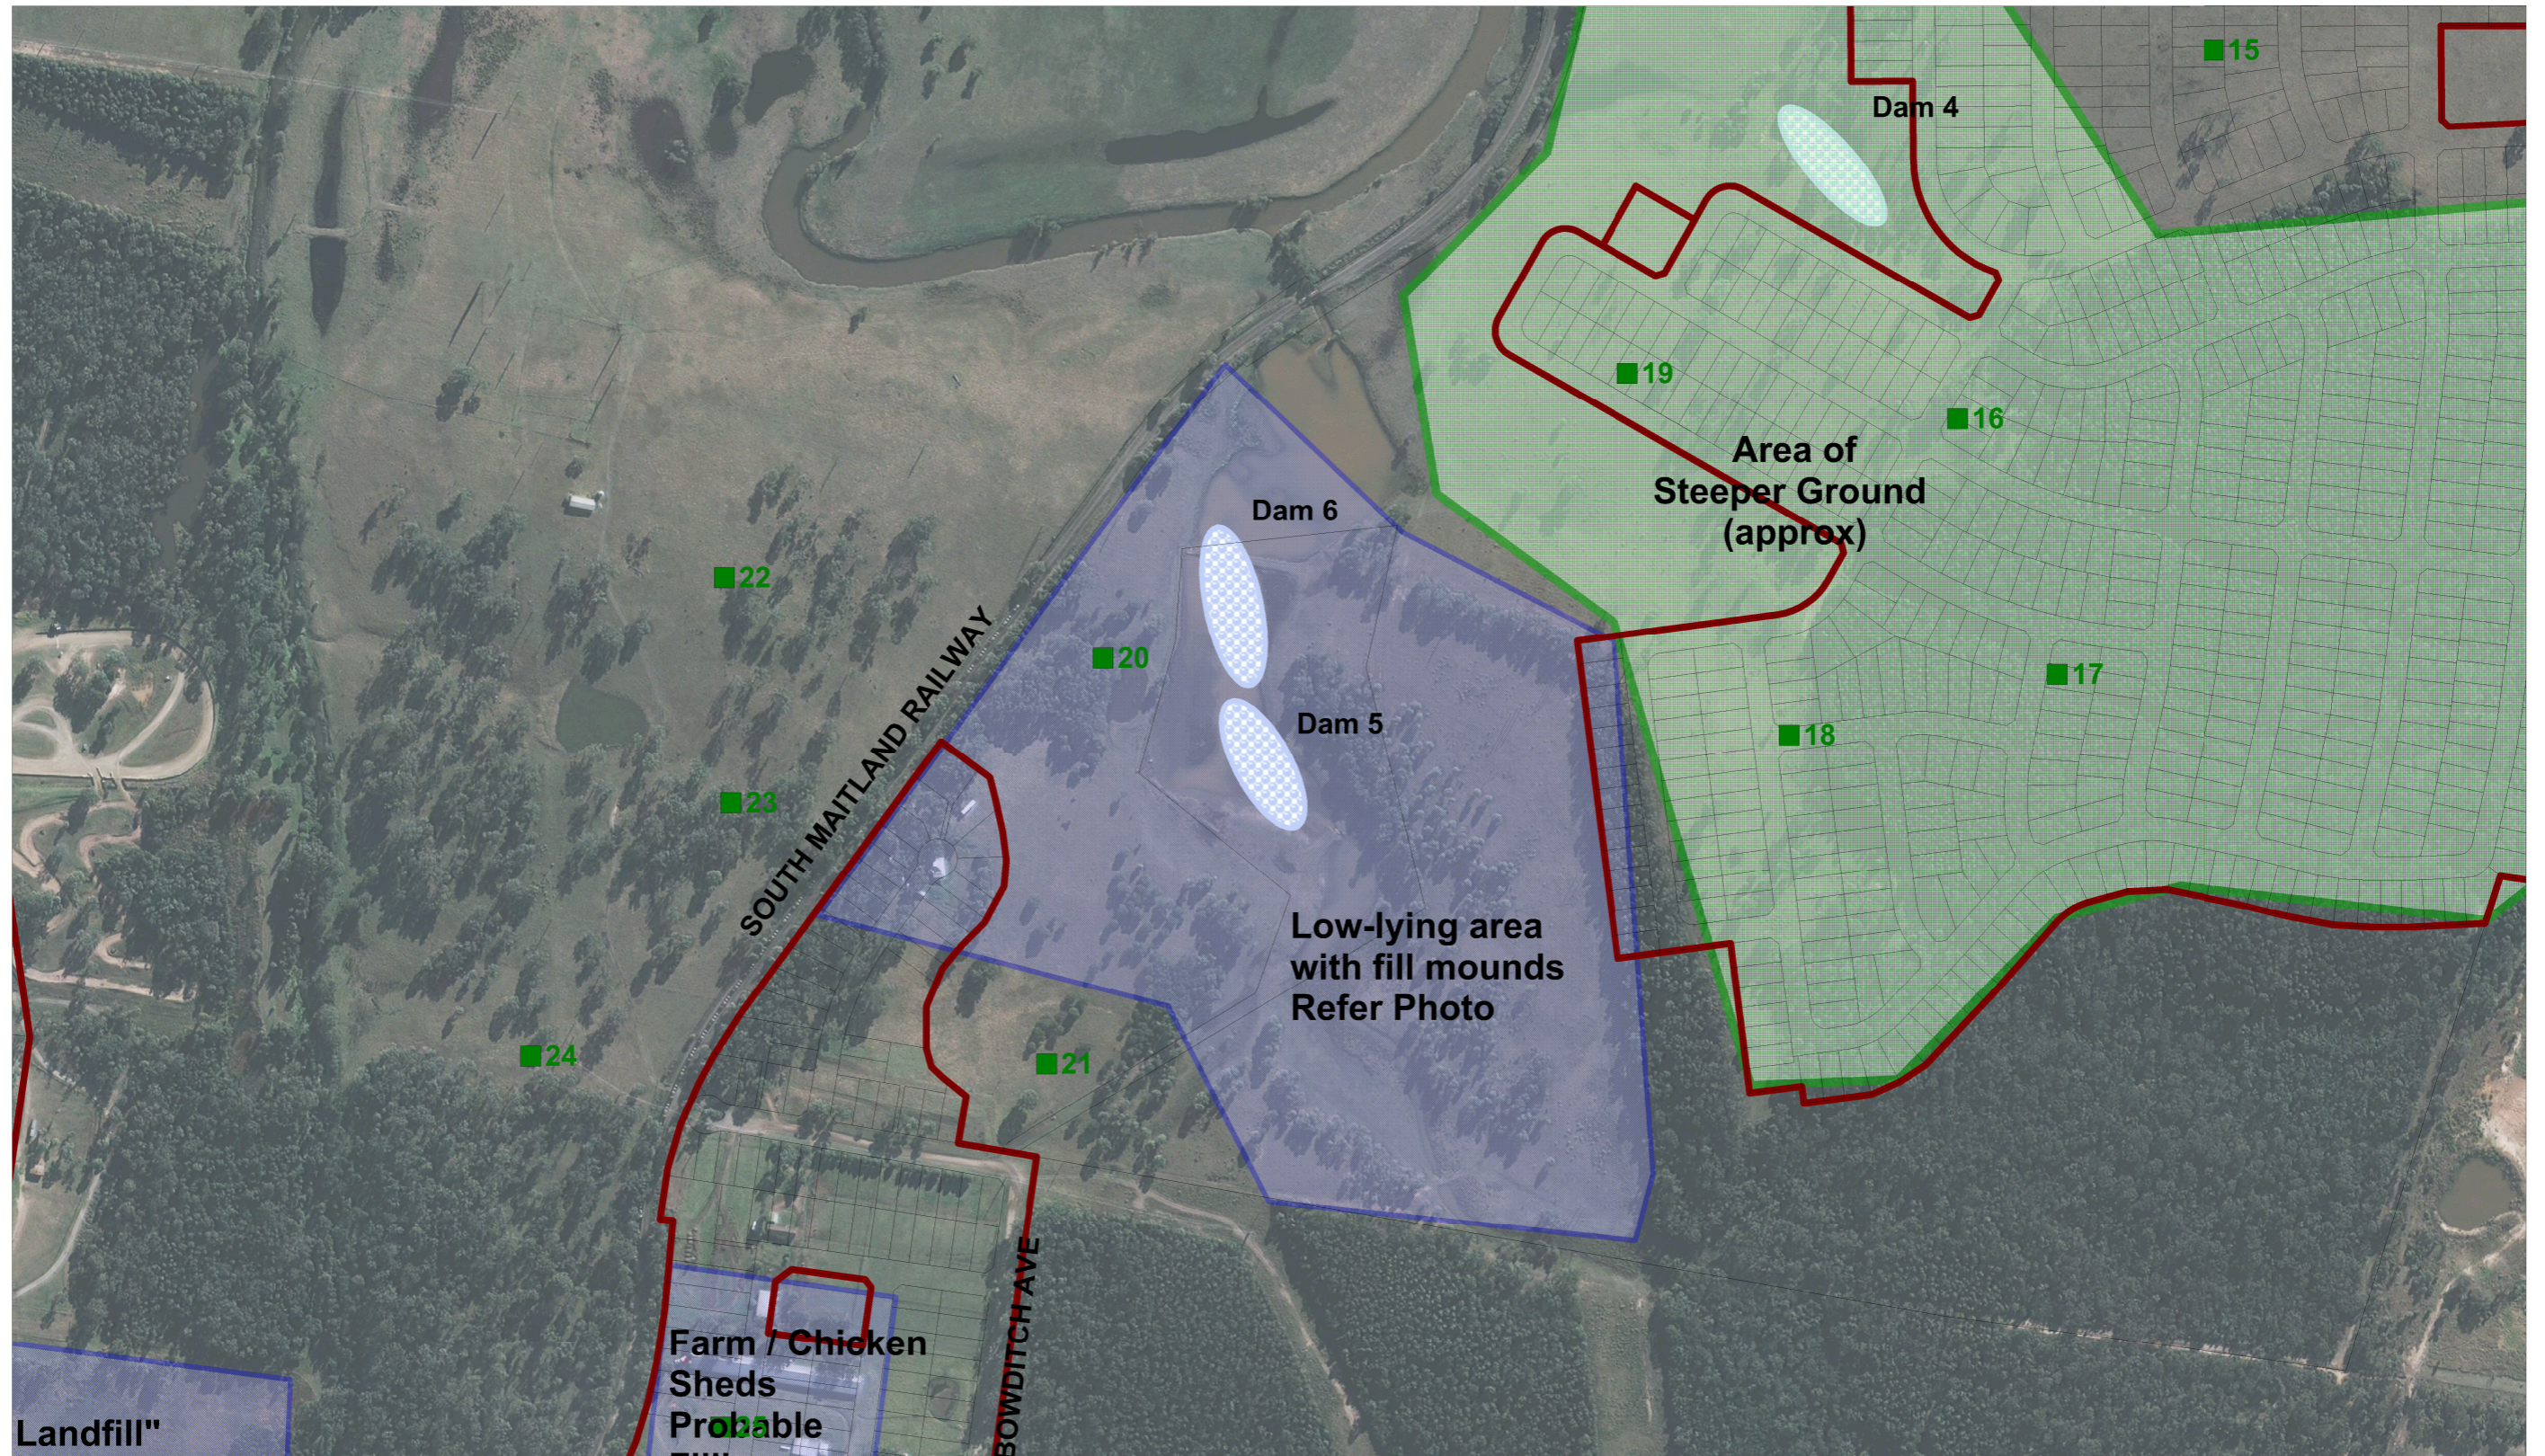
PROJECT No:	81520
DRAWING No:	4
REVISION:	0

The Residential Southern Precinct part of the site generally comprises rural-residential land, which includes a number of rural structures such as chicken and machinery sheds, and also included evidence of previously demolished rural structures (i.e. chicken sheds). This part of the site also included areas where filling is expected to occur, generally through the creation of level building pads for house and/or farm shed construction. In addition, a low lying area was observed between the Residential Southern and Residential Central areas where some fill mounds were observed. This was generally in the vicinity of Dams 5 and 6 (refer Drawing 4).
