CESSNOCK
DEVELOPMENT CONTROL PLAN

E.4: STANFORD MAIN

LANDSCAPE HERITAGE
ASSESSMENT

LANDSCAPE HERITAGE ASSESSMENT
STANFORD MAIN Nº 2 COLLIERY, PAXTON
CONSERVATION MANAGEMENT PLAN
HARDIE HOLDINGS

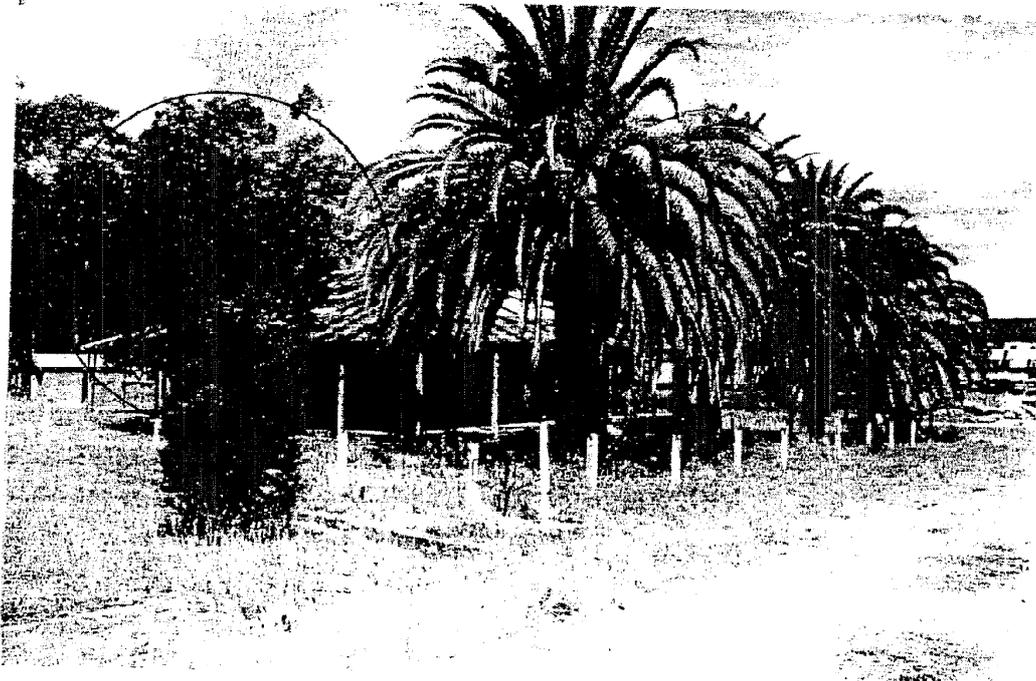
FIGURE 4.3: PLANTINGS ASSOCIATED WITH THE ADMINISTRATION BUILDING
(ie Canary Island Date Palms, Crepe Myrtle)

- **Plantings associated with the Administration Building (Figure 4.3):** It is assumed that considerable care would have been taken in establishing an attractive setting for this building presumably with foundation planting around it. What currently remains, however, are two rows of Canary Island Date Palms (*Phoenix canariensis*) (6 off) to the main elevations (ie north-west and south-west) and a Crepe Myrtle (*Lagerstroemia indica*) on the buildings north-eastern side. All trees appear to be in good condition.

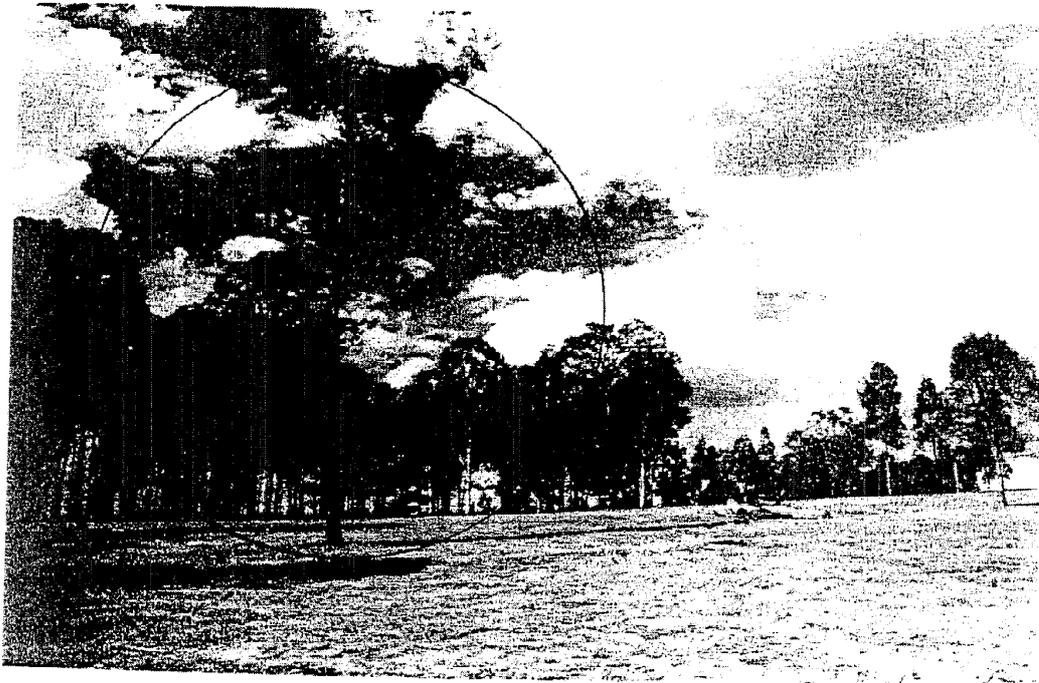
FIGURE 4.6: PLANTING ASSOCIATED WITH FORMER OFFICIALS' COTTAGES (EAST)
(ie Norfolk Island Pine)

- **Planting associated with former Officials' Cottages [South-East] (Figure 4.6):** It is known that the cottages for the Chief Clerk and Mine Engineer were located approximately half way between the Administration Building and the Manager's Residence. Both buildings have been demolished, however, a solitary Norfolk Island Pine (*Araucaria heterophylla*) remains marking the site. This tree is struggling and appears not to be handling the conditions well.

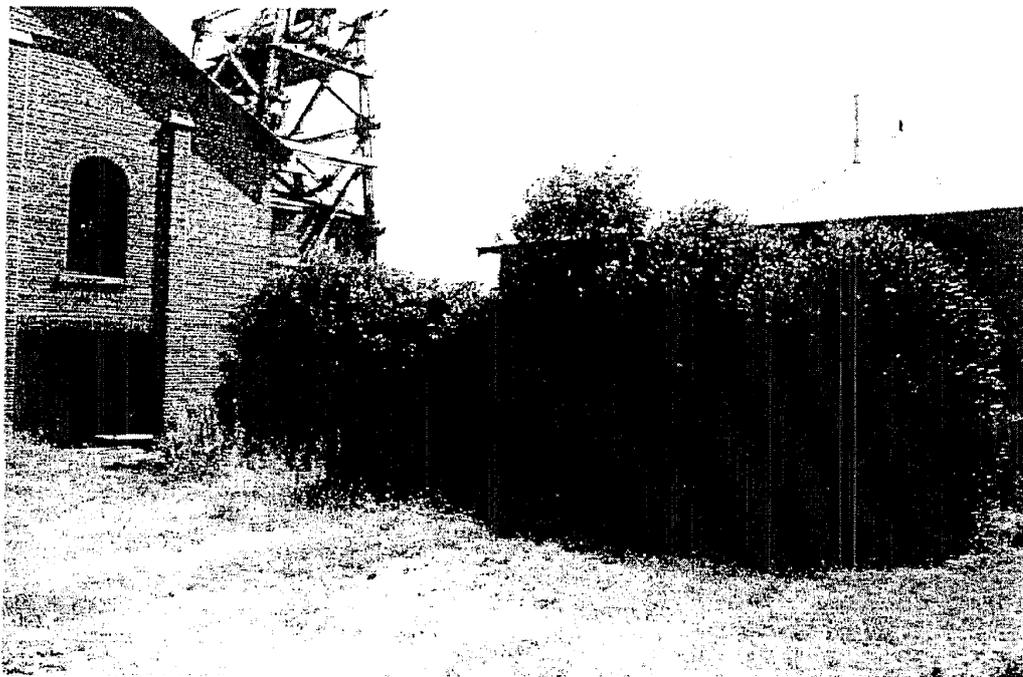
FIGURE 4.8: PLANTINGS ASSOCIATED WITH BATH HOUSE (SOUTH-WEST)
(ie Oleanders)

- **Plantings associated with the Bath House. [South-West]** A row of Crepe Myrtles (4 off) are growing on the south-eastern side of the building. To the south-western side of the building are two rows of Oleanders (*Nerium oleander*). It is assumed that these trees were planted sometime after the construction of the Bath House in 1954. These trees are part of a larger beautification program which eventually did not eventuate. Most trees are in good condition.

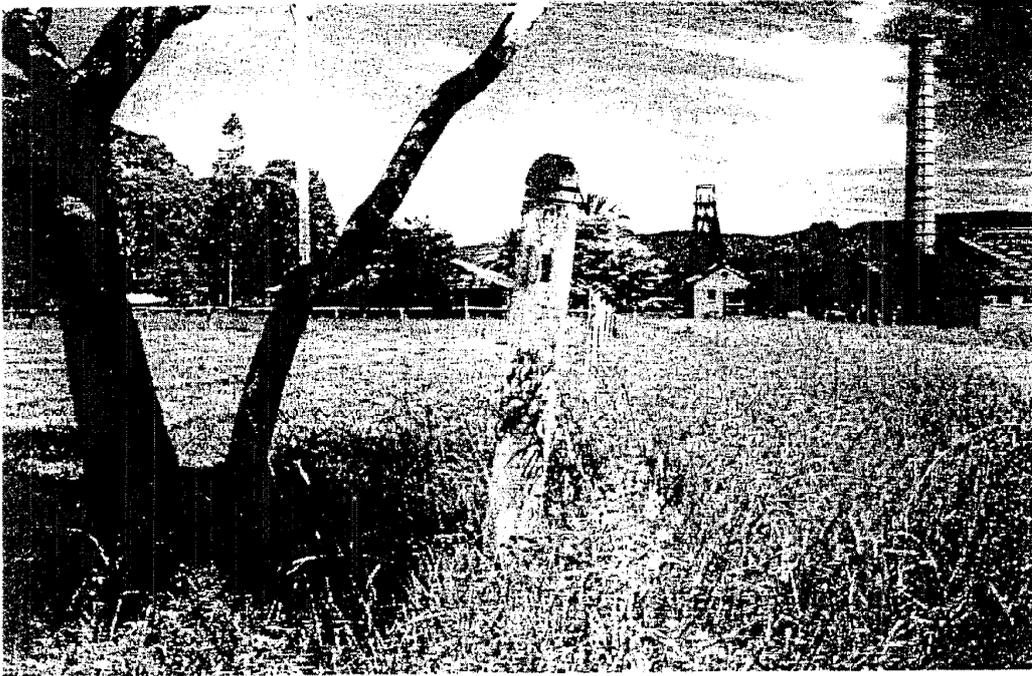
FIGURE 4.12: FENCE POST TO MECHANICAL ENGINEER'S COTTAGE

It is known that a picket fence once existed to the cottages located off the main access to the colliery. This is now evidenced by only two remnant fence posts (Figure 4.12 and front cover). These fence posts are made from sectioned and dressed timber and have rounded heads and two recesses towards the top.

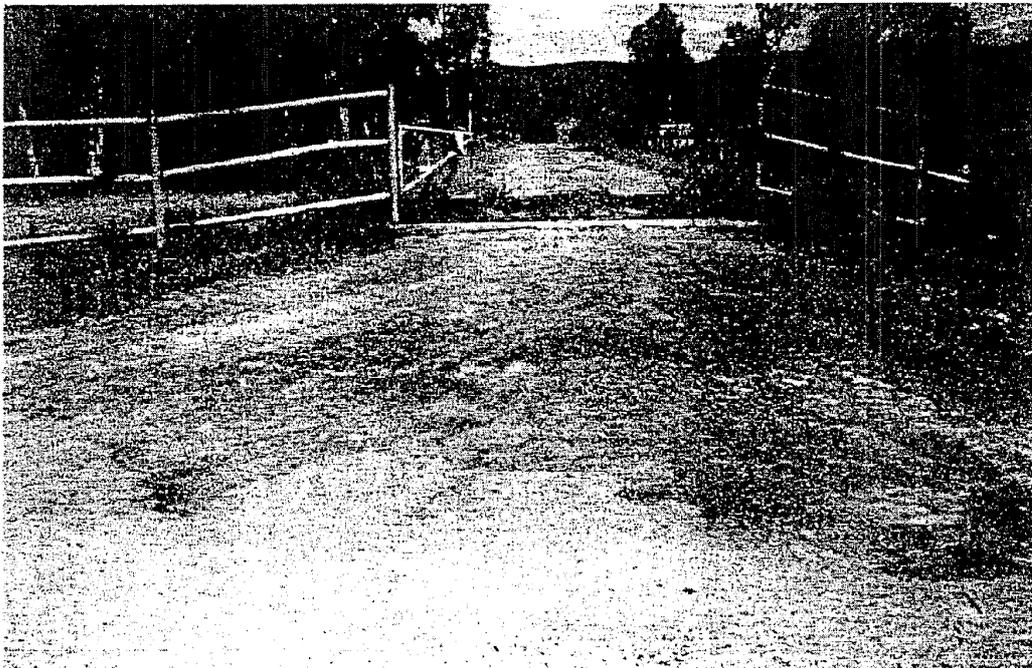
FIGURE 4.13: GATE TO MAIN ENTRY

Three sets of gates occur on site. The main gate is constructed from galvanised tubular steel and incorporates similar fencing on either side (Figure 4.13). Incorporated into the entry is a cattle grid which would suggest that this gate has been installed during the time the site was used for grazing cattle and is therefore of reduced significance. Similarly, a lightweight square steel bar gate has been used for the entrance of the saw mill which would seem to suggest another more recent addition replacing earlier gates (Figure 4.14). The third gate, of which little remains, is the gate located across the main access road just after the car park. This gate is comprised of galvanised steel tube and incorporates steel turnstiles (Figure 4.15). It is assumed that this entrance would have been installed during the mid 1950's to coincide with the construction of the new Bath House.

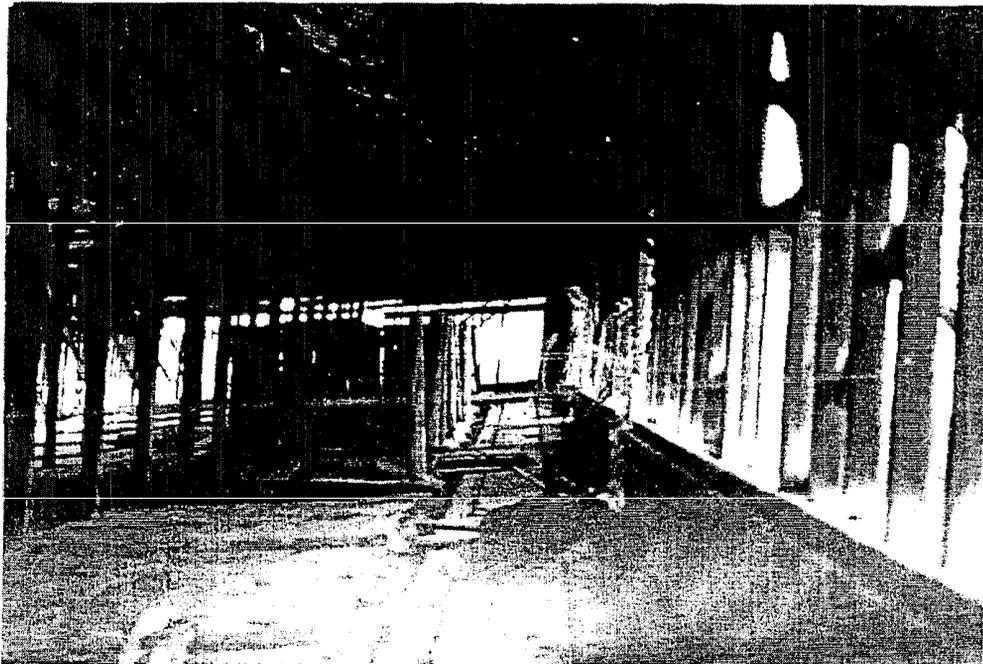
Photograph Two Internal layout of the stables. Note the wires between the external bracing to stabilise the building.

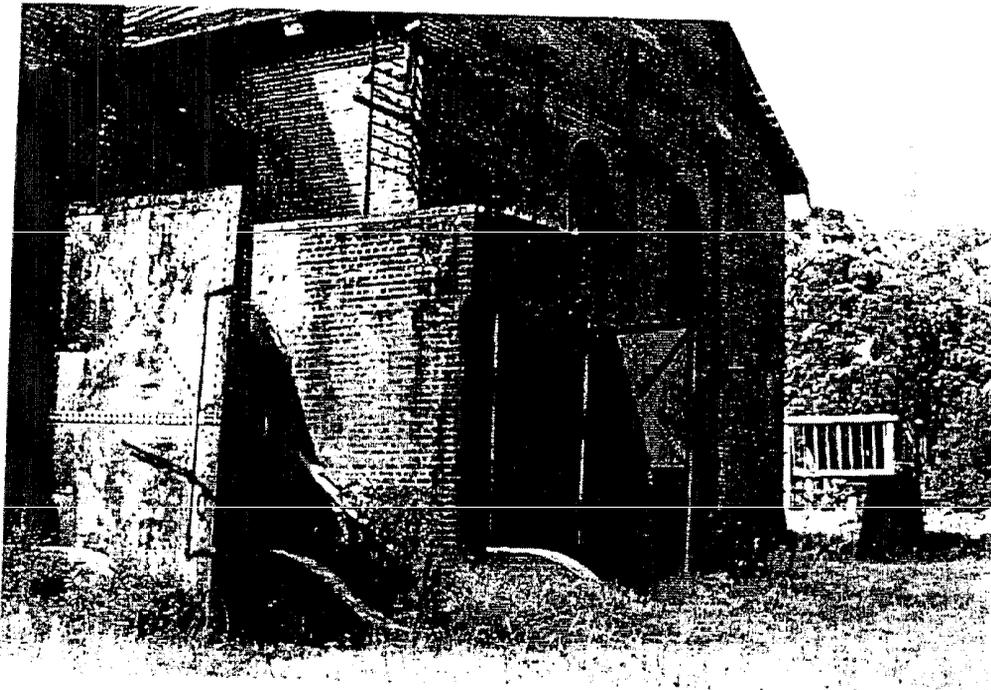
Photograph Twelve The power house and fan evase' from the south-west

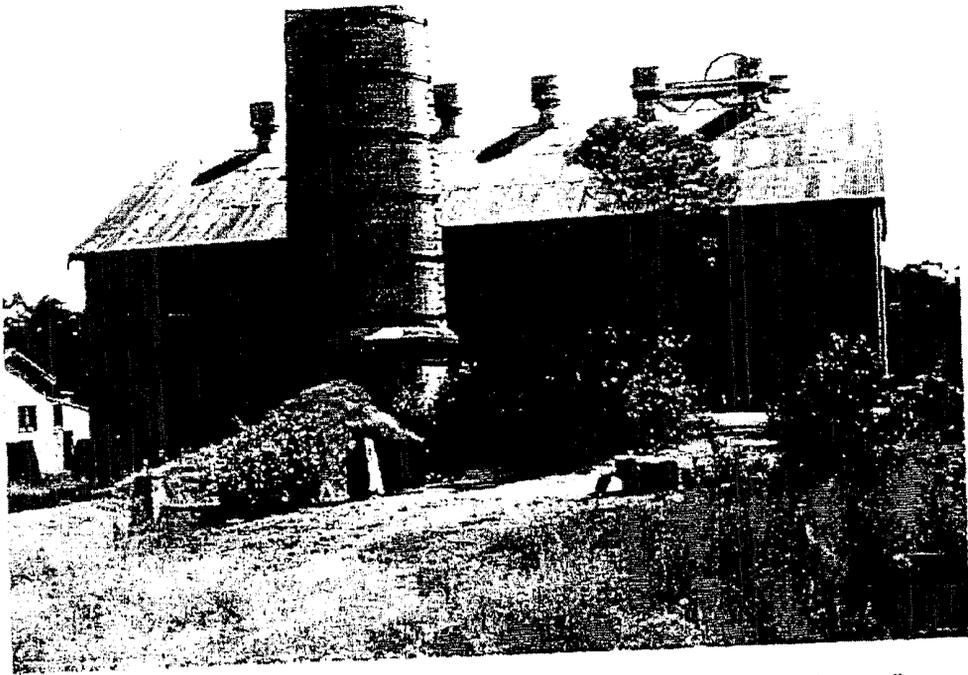
Photograph Fifteen View of the power house, stack and covered boiler house floor from the east.

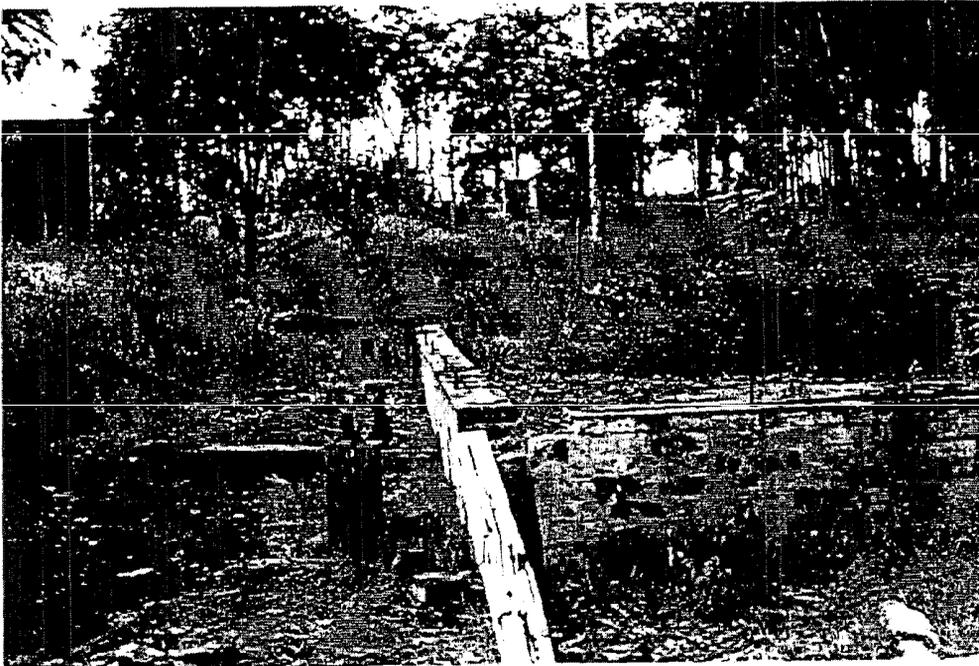
Photograph Twenty The probable laboratory. There are many core samples throughout the ruins. The building is also double earthed suggesting the storage of volatile material. Administration and toilets at rear.

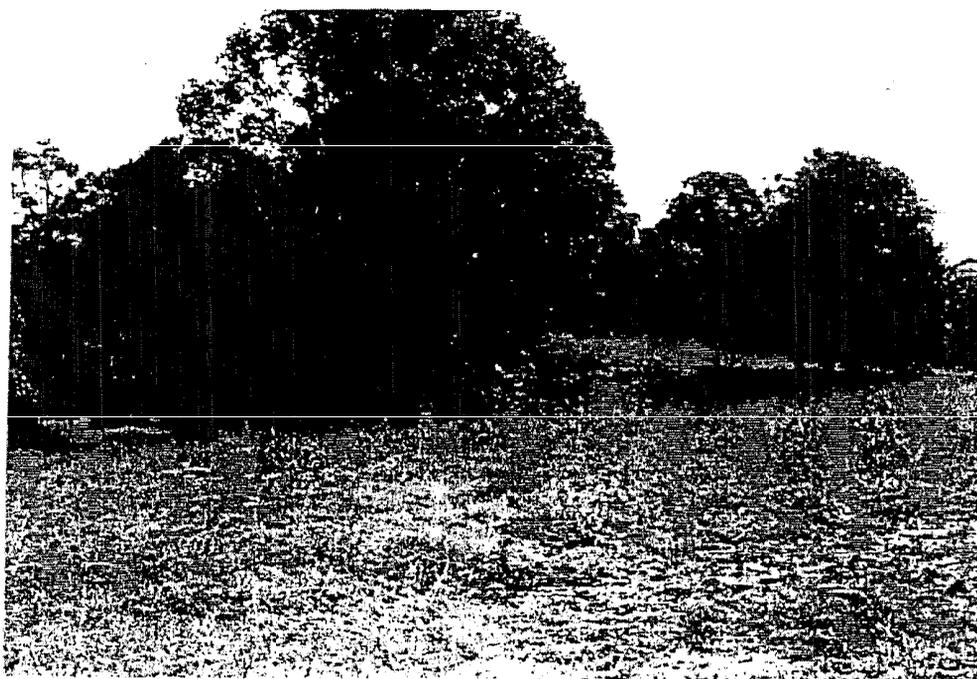
Photograph Twenty one The loading ramp and 'chinaman' at the western end of the sidings. Photo from the east.

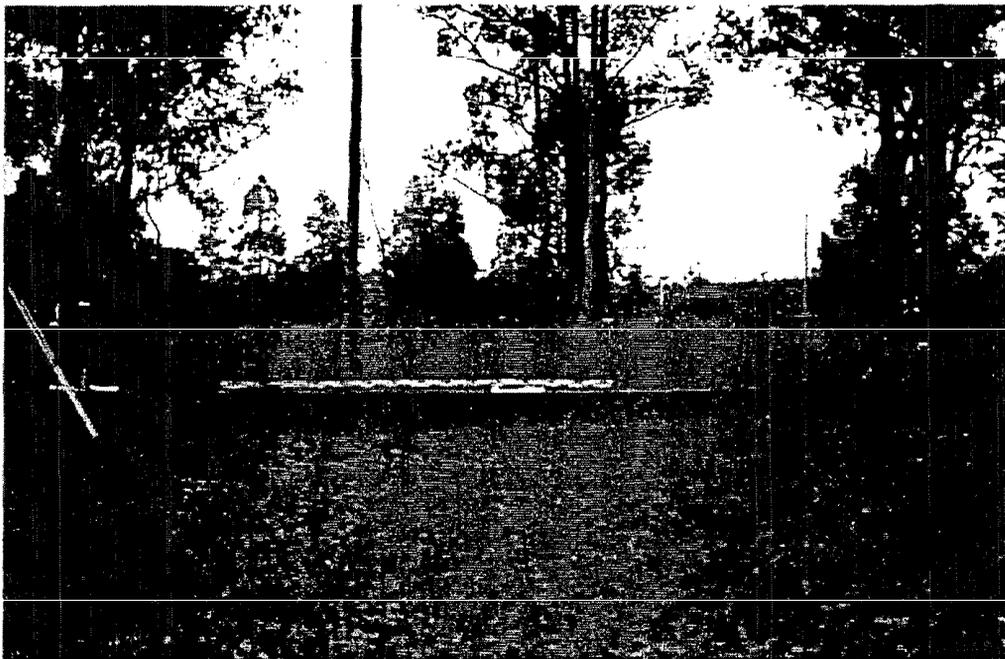
Photograph Twenty four The footings which remain of the brickworks, adjacent to Millfield Road. View from the south-west.
