CESSNOCK LGA PEDESTRIAN ACCESS AND MOBILITY PLAN (PAMP)

FOR
CESSNOCK CITY COUNCIL (CCC)

Project No: P2284

Issue date: 19th April 2016

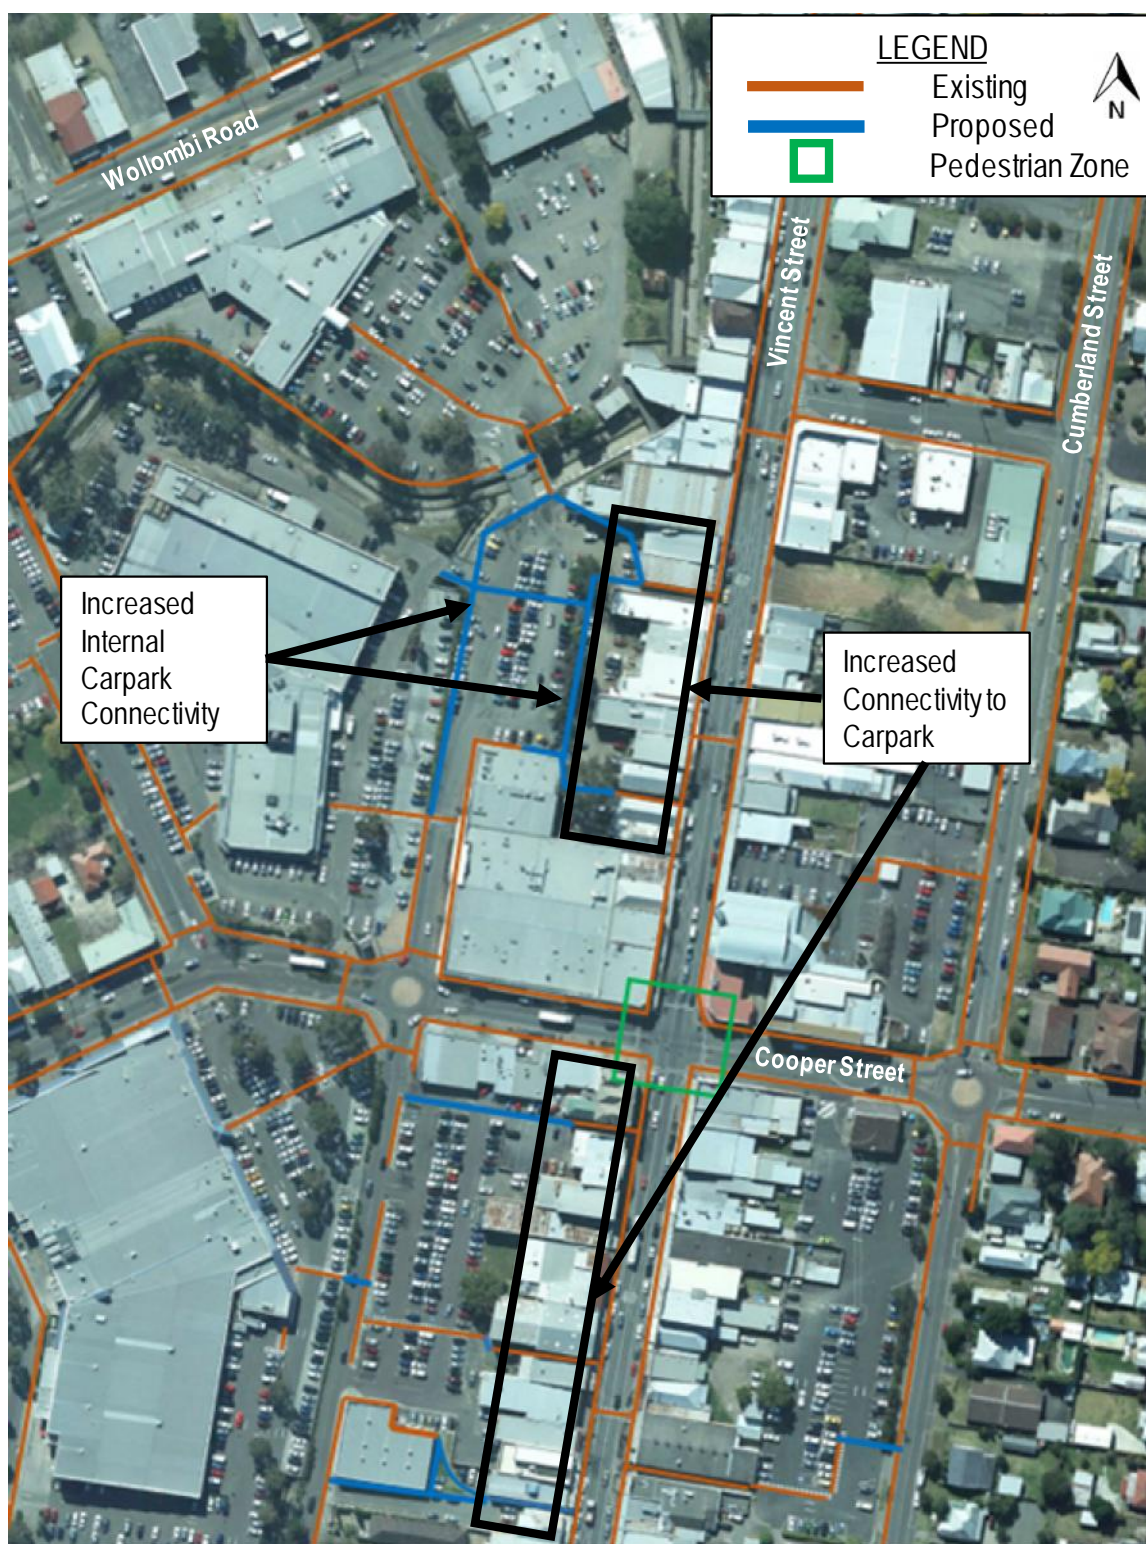
Figure 4.1: Cessnock CBD Routes

Figure 4.1 shows how the side streets and alleyways can be better utilised to increase the permeability in the area. The proposed paths provide links between existing footpaths and aim to increase pedestrian priority and therefore promoting a safe active network. Council will need to work with the private land owners to achieve the desirable pedestrian connectivity illustrated in Figure 4.1. The proposed links are indicative and are subject to change depending on the surrounding land owners.

There are five alleyways along Vincent Street that connect to car parking areas, four of which have existing footpaths but no designated pedestrian paths that connect the carpark area to the alleyways.

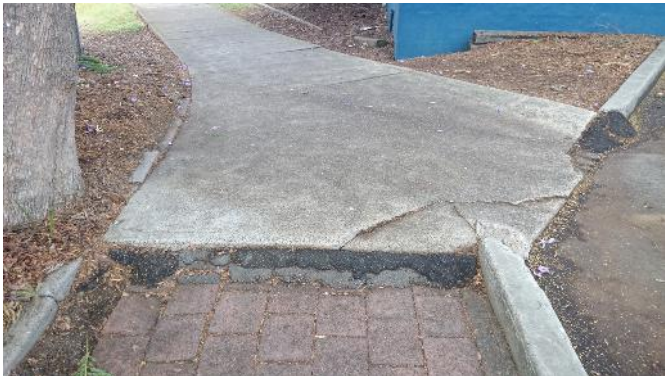
Damaged kerb ramp presenting trip hazard at Central Plaza Shopping Centre Car Park Area, Cessnock

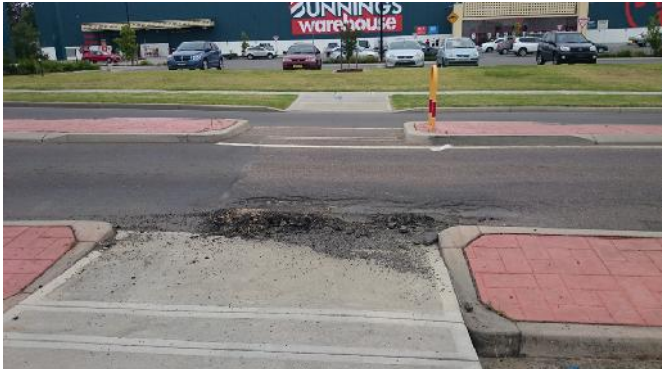
<p>Damaged road surface at the base of kerb ramp. Presents a dangerous trip hazard to pedestrians.</p> <p>Vincent Street, adjacent to Bunnings Warehouse, Cessnock.</p>

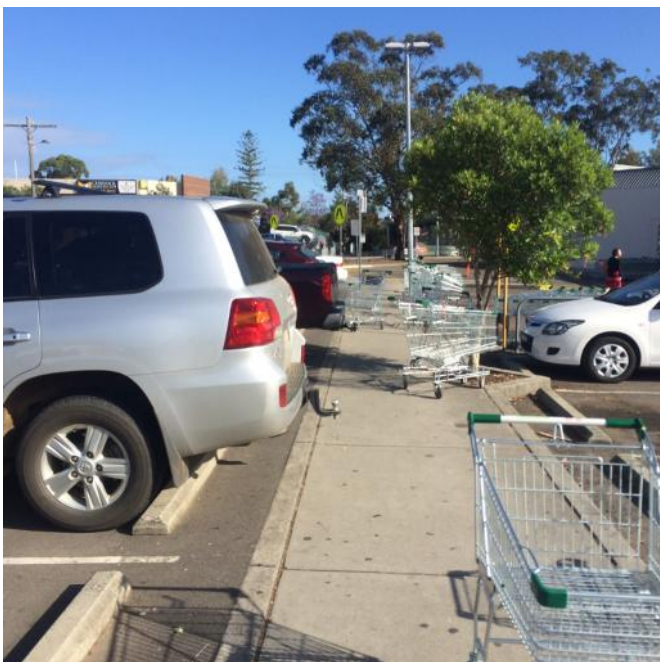
A recurring issue observed was shopping patrons abandoning their trolleys on footpaths. This leaves the existing footpaths congested and difficult to manoeuvre especially for people with disabilities.

<p>Shopping carpark path congested with shopping trolleys</p> <p>Cessnock Plaza Shopping Centre, Cessnock</p>
