Document type
Remedial Action Plan

Date
November 2018

REMEDIAL ACTION PLAN

BUFFER ZONE ASBESTOS KURRI KURRI, NSW

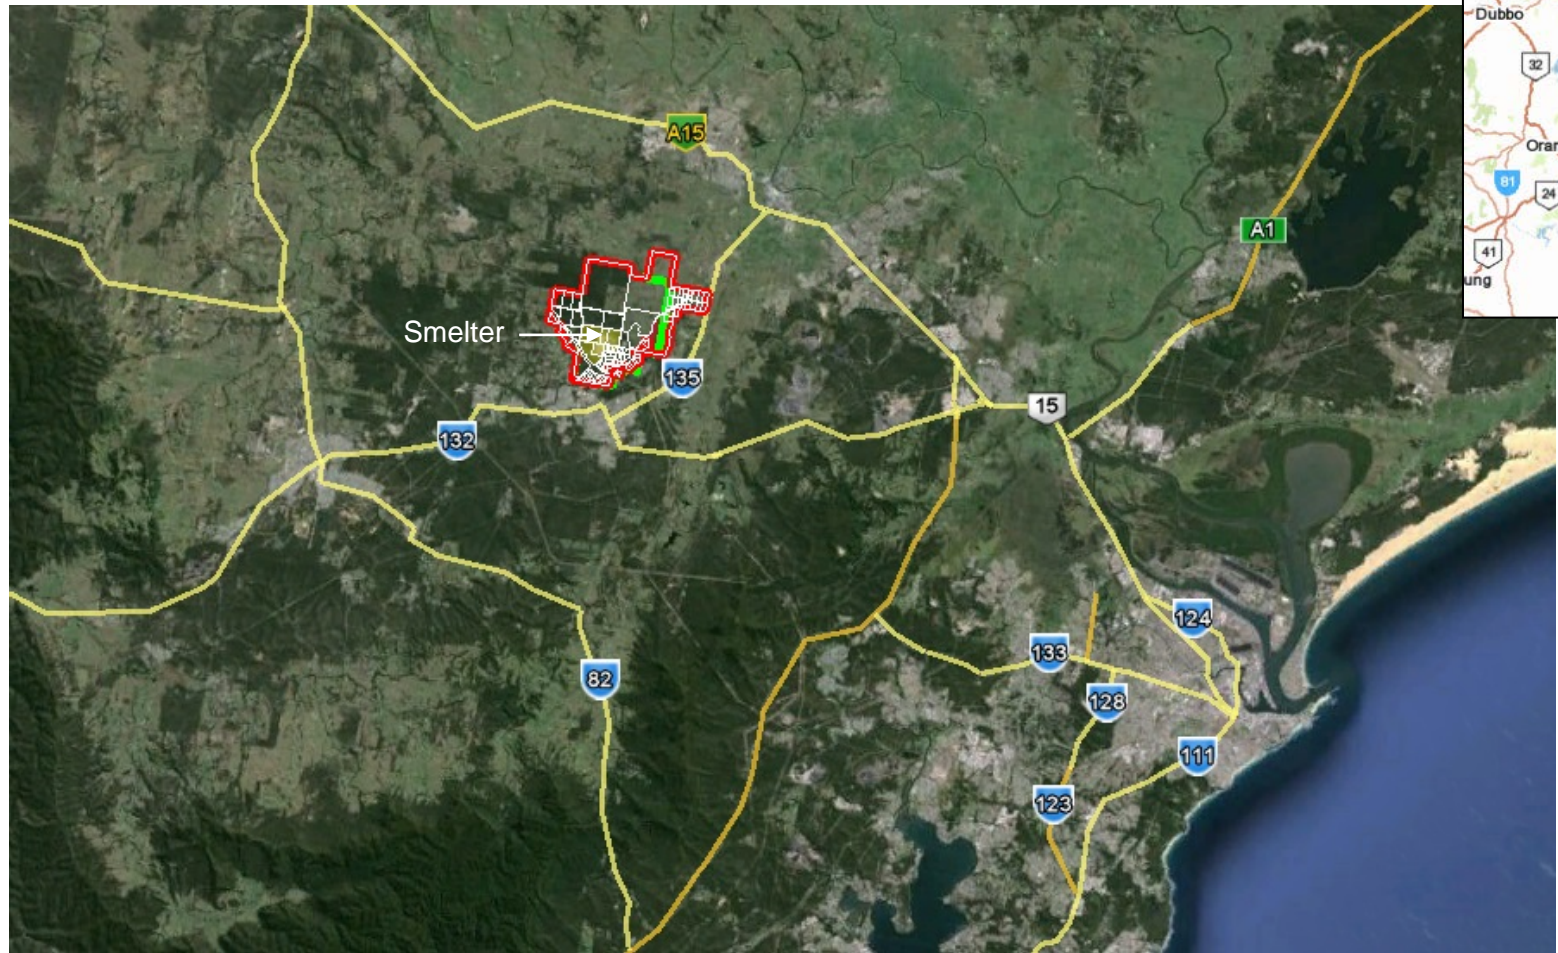
Smelter

- Approximate Location of land owned by Hydro
 - Approximate Location of Buffer Zone
- Approximate Scale 1cm:4.5km

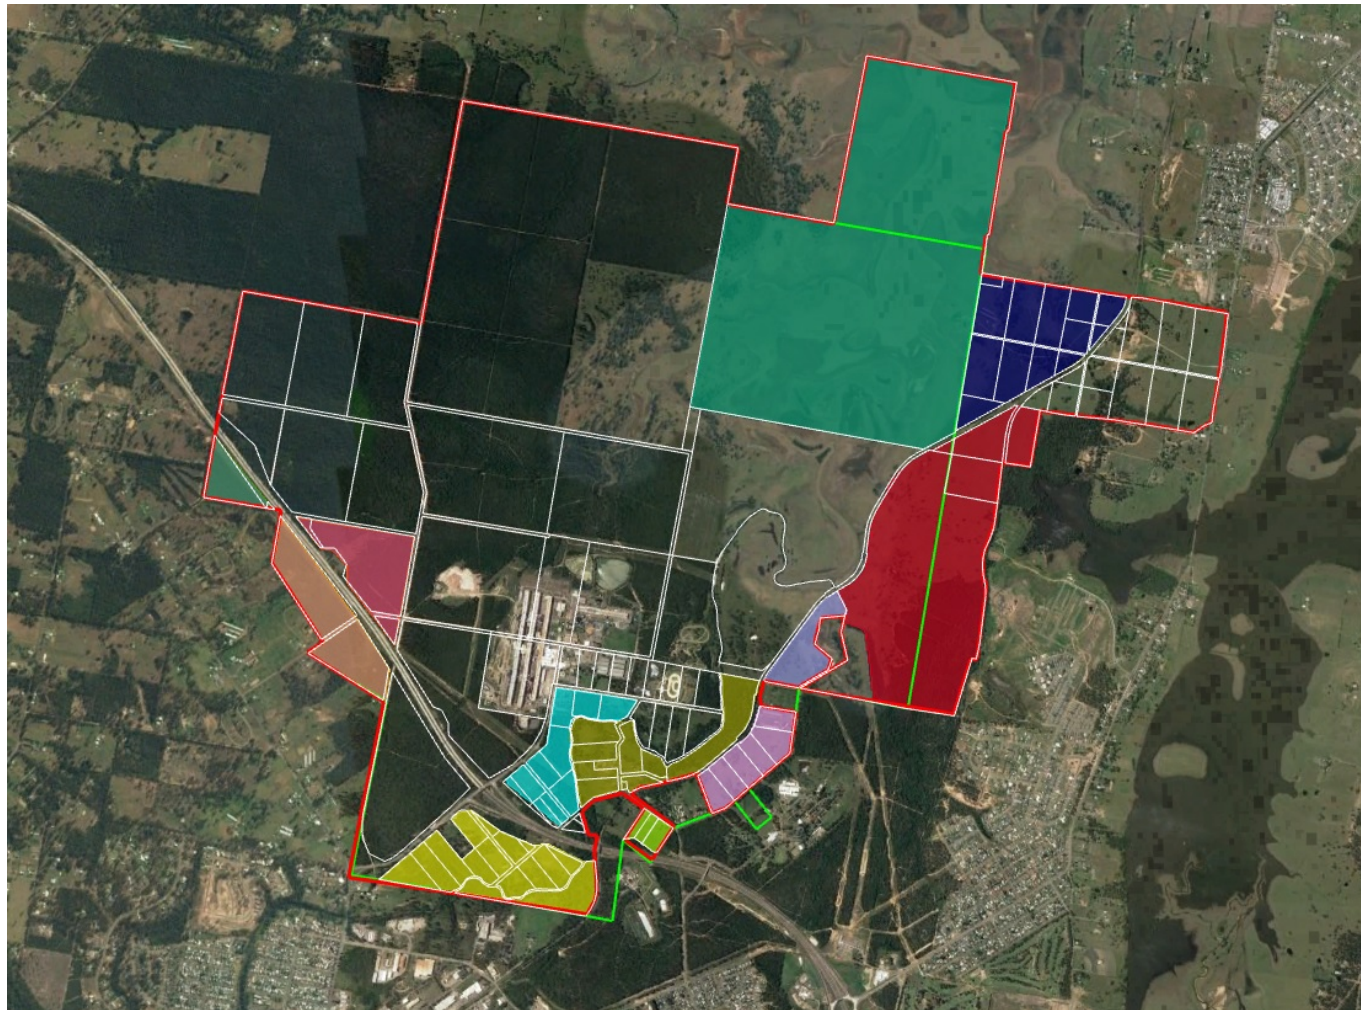
- Location of land owned by Hydro
 - Location of Buffer Zone
 - Smelter Site
 - Parcel 2: Residential
 - Parcel 3: Residential
 - Parcel 4: Industrial and EC
 - Parcel 6: EC
 - Parcel 7: EC
 - Parcel 8: EC
 - Parcel 9: Industrial and EC
 - Parcel 10: Residential and EC
 - Parcel 12: Residential
 - Parcel 13: Residential
 - Parcel 14: Residential
 - Parcel 17: Residential and EC
- EC: Environmental Conservation

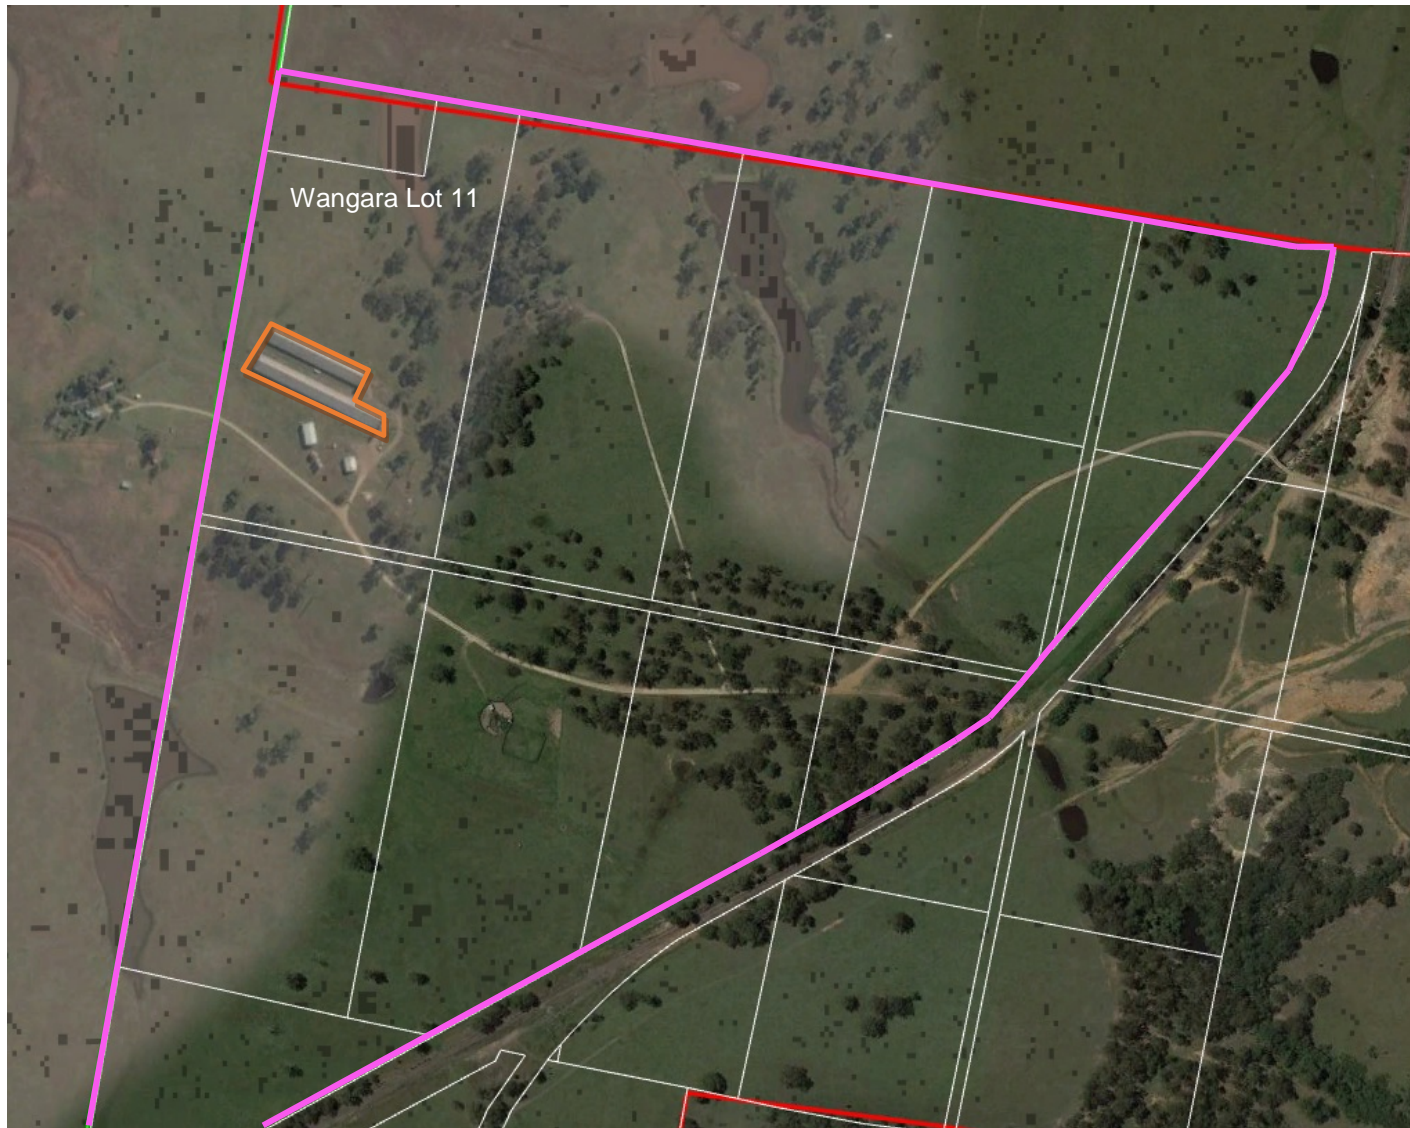
- Parcel 2 Site Boundary
- Poultry Shed Demolition 2017. Validation required.

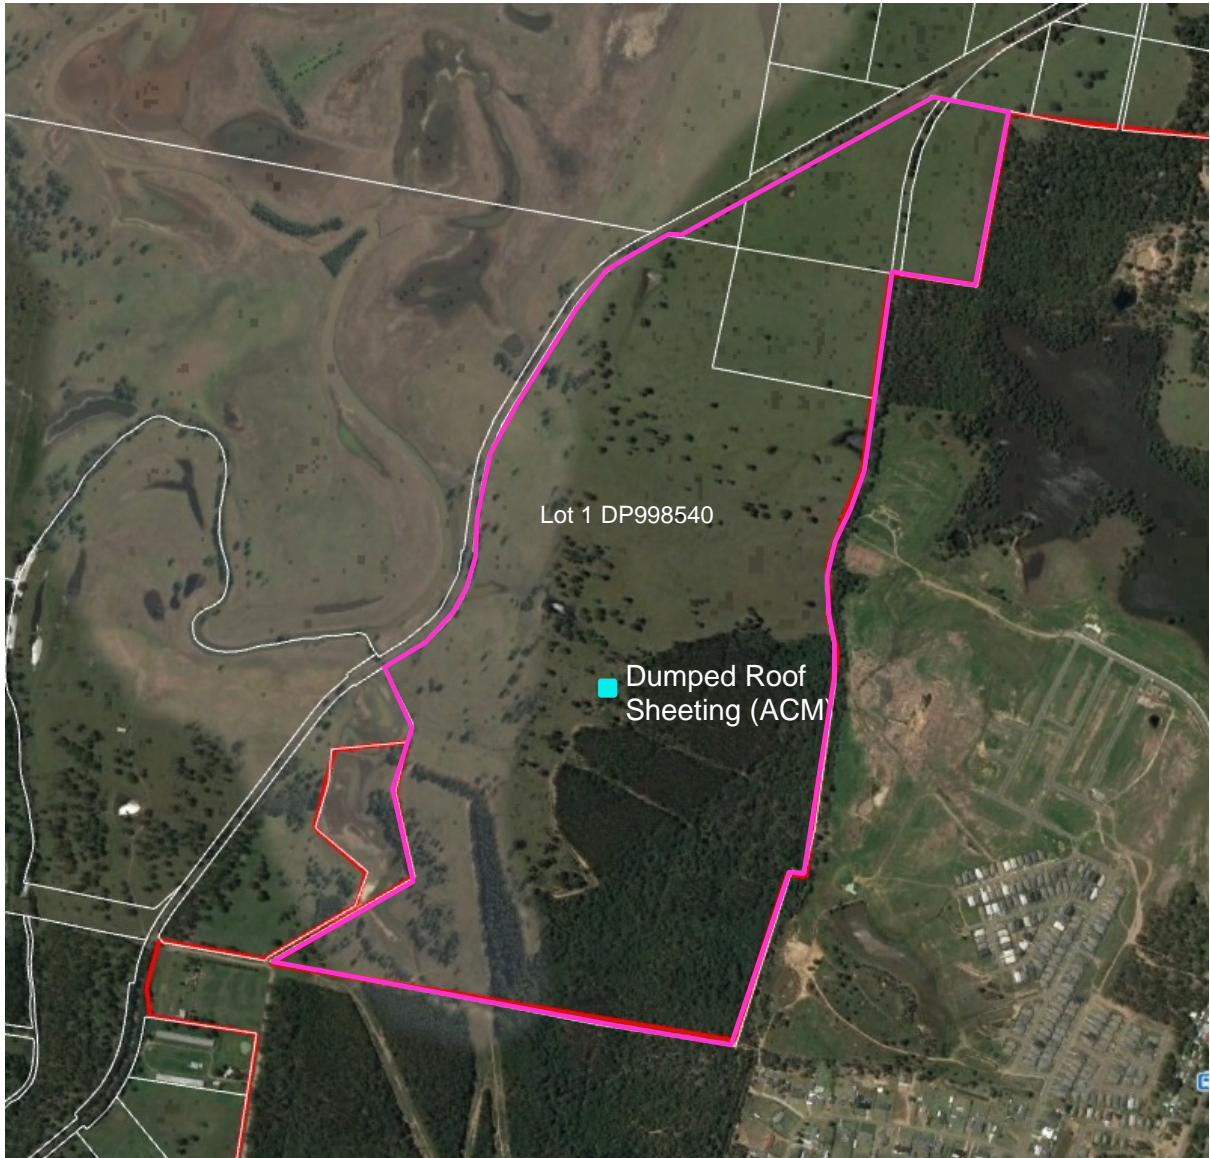
Parcel 3 Layout

- Parcel 3 Site Boundary
- Dumped Roof Sheeting (ACM), collected for disposal in 2015. Validation completed 2015.

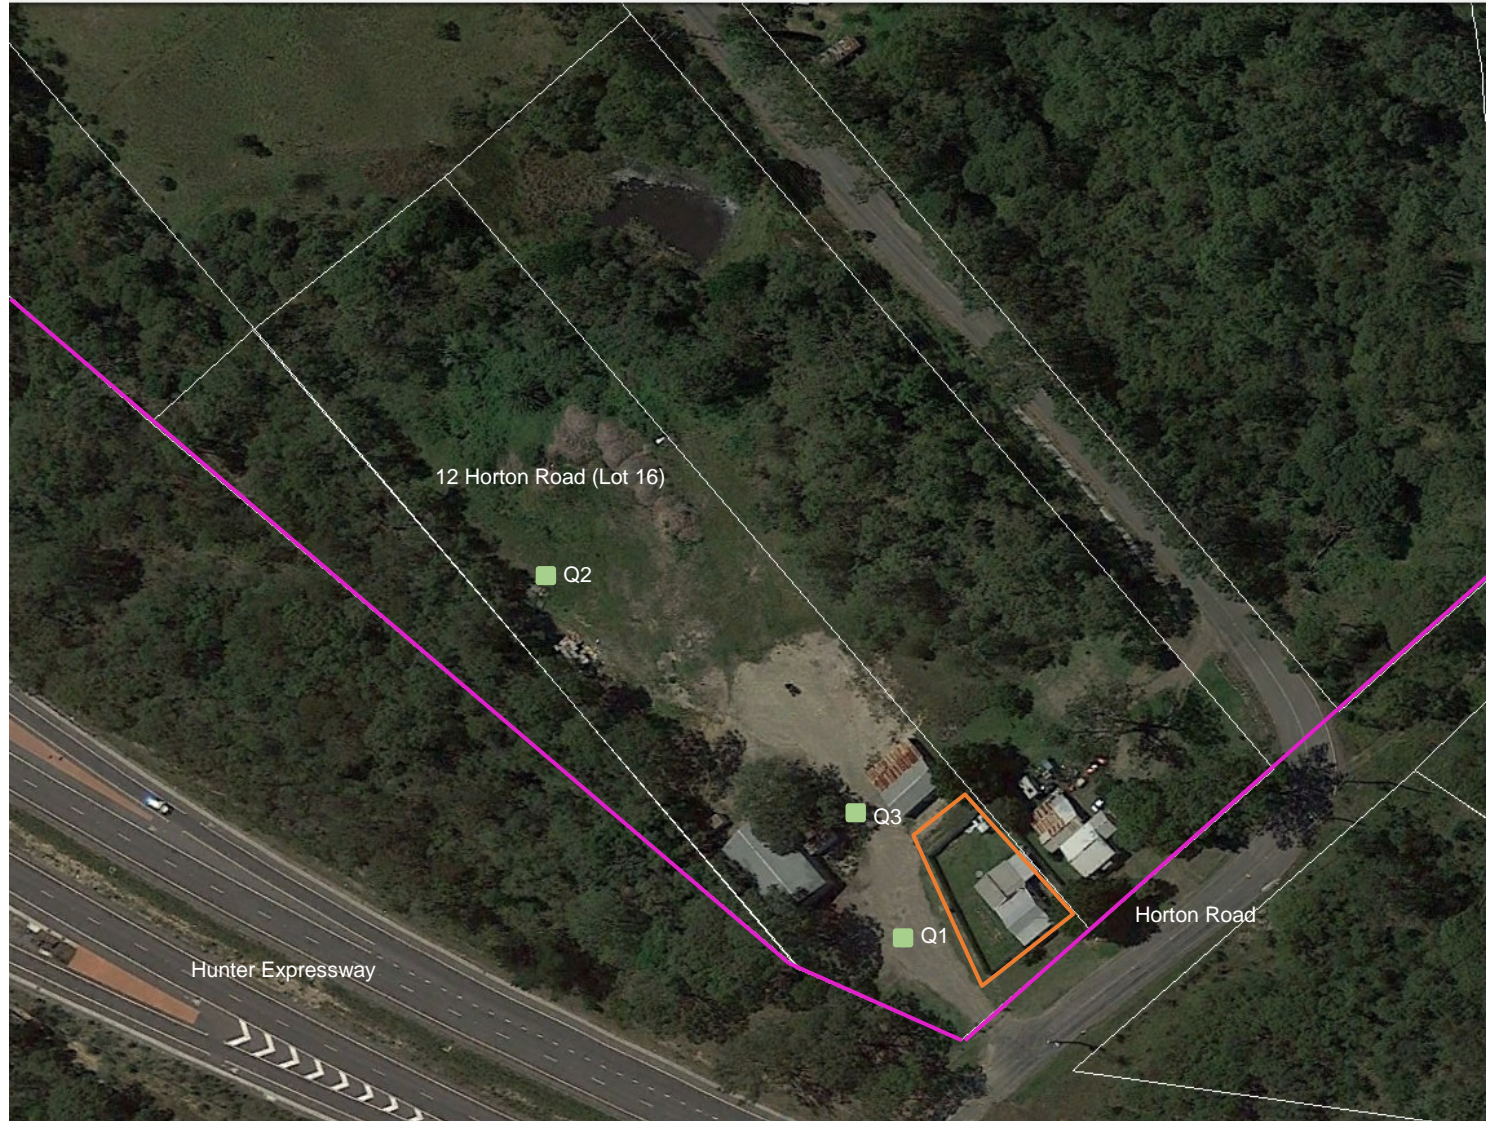
- Parcel 4 Site Boundary
- Asbestos Walkover 10 m by 10 m Quadrant completed 2013 – ACM fragments identified and collected at each location. Removal of surface ACM completed July 2015. Clearance Certificate provided August 2015 by Banksia EOHS.
- House Demolition 2016. Walkover completed Dec 2016 by Hydro/ Ramboll Environ and ACM collected. Validation required.

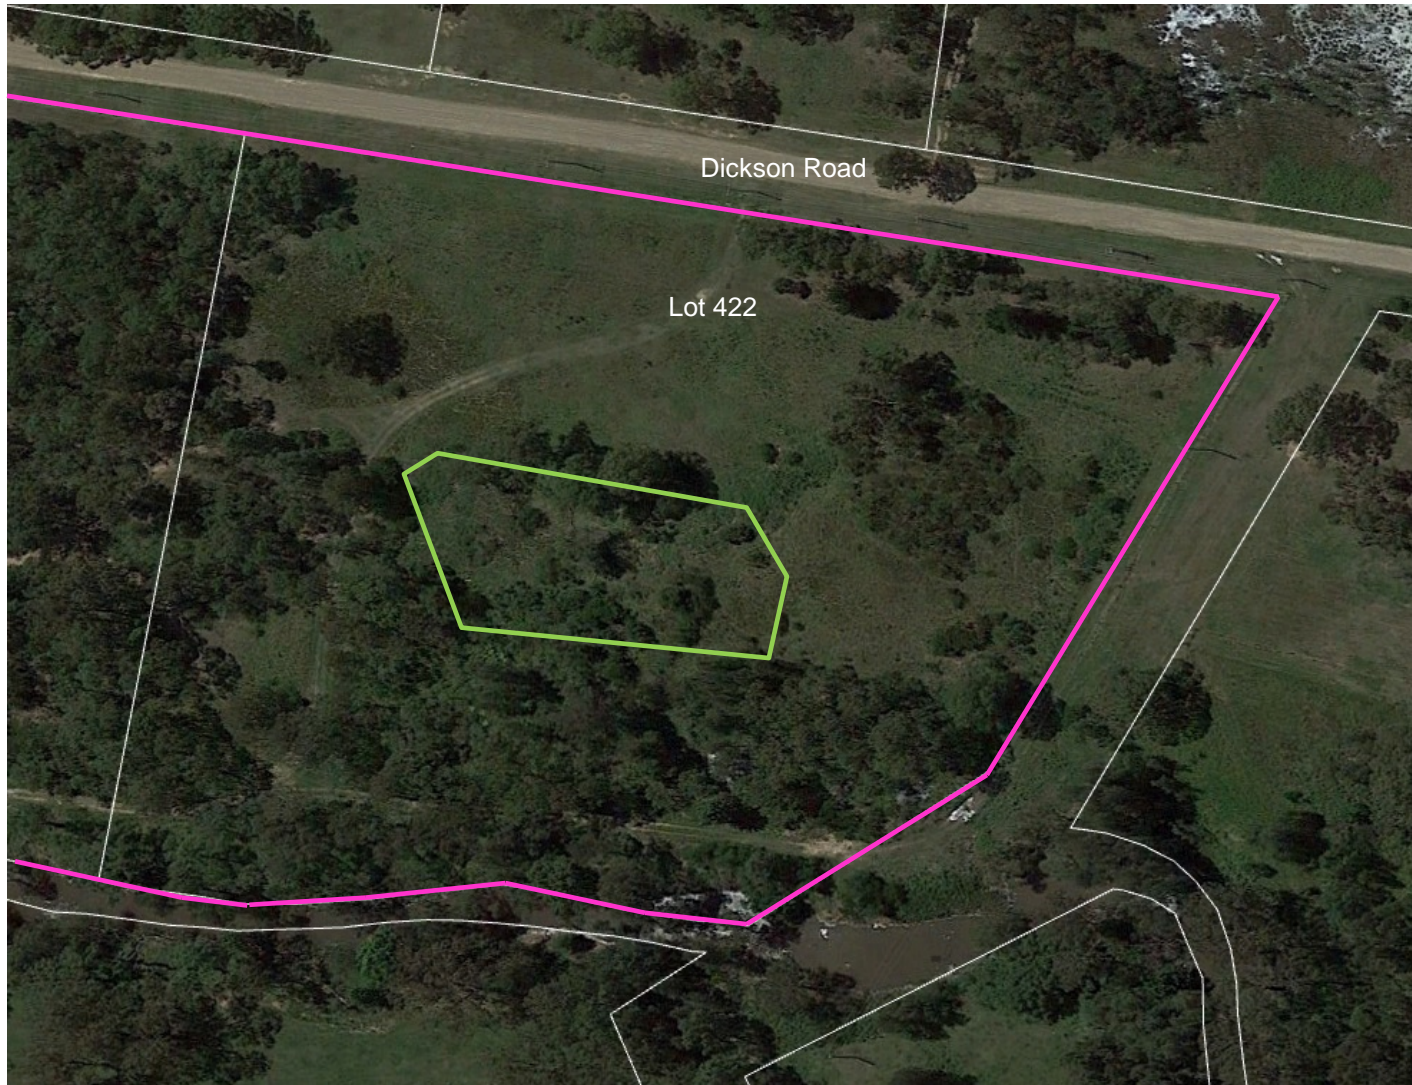
- Parcel 4 Site Boundary
- ACM fragments and other wastes in fill observed in test pits during Phase 2 ESA. Remediation and validation required.

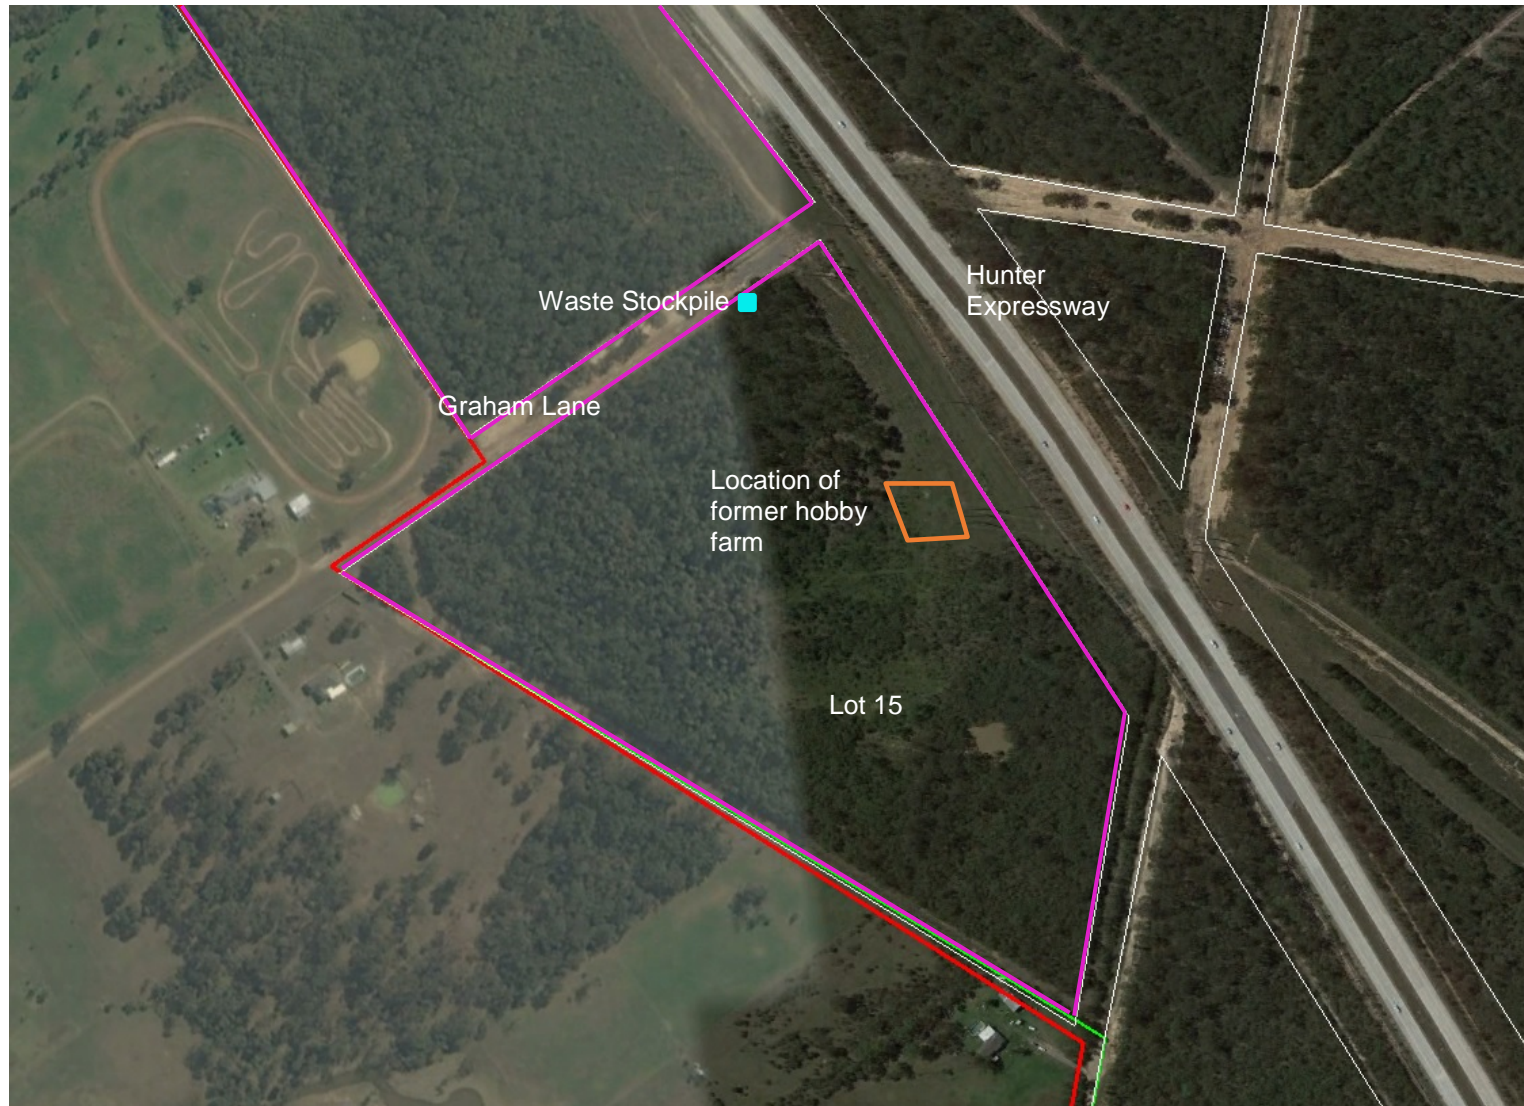
- Site Boundary
- ACM fragments identified in stockpile of waste during Phase 2 ESA. Remediation and validation required.
- ACM fragments identified in stockpiles associated with former buildings during Phase 2 ESA. Remediation and validation required.

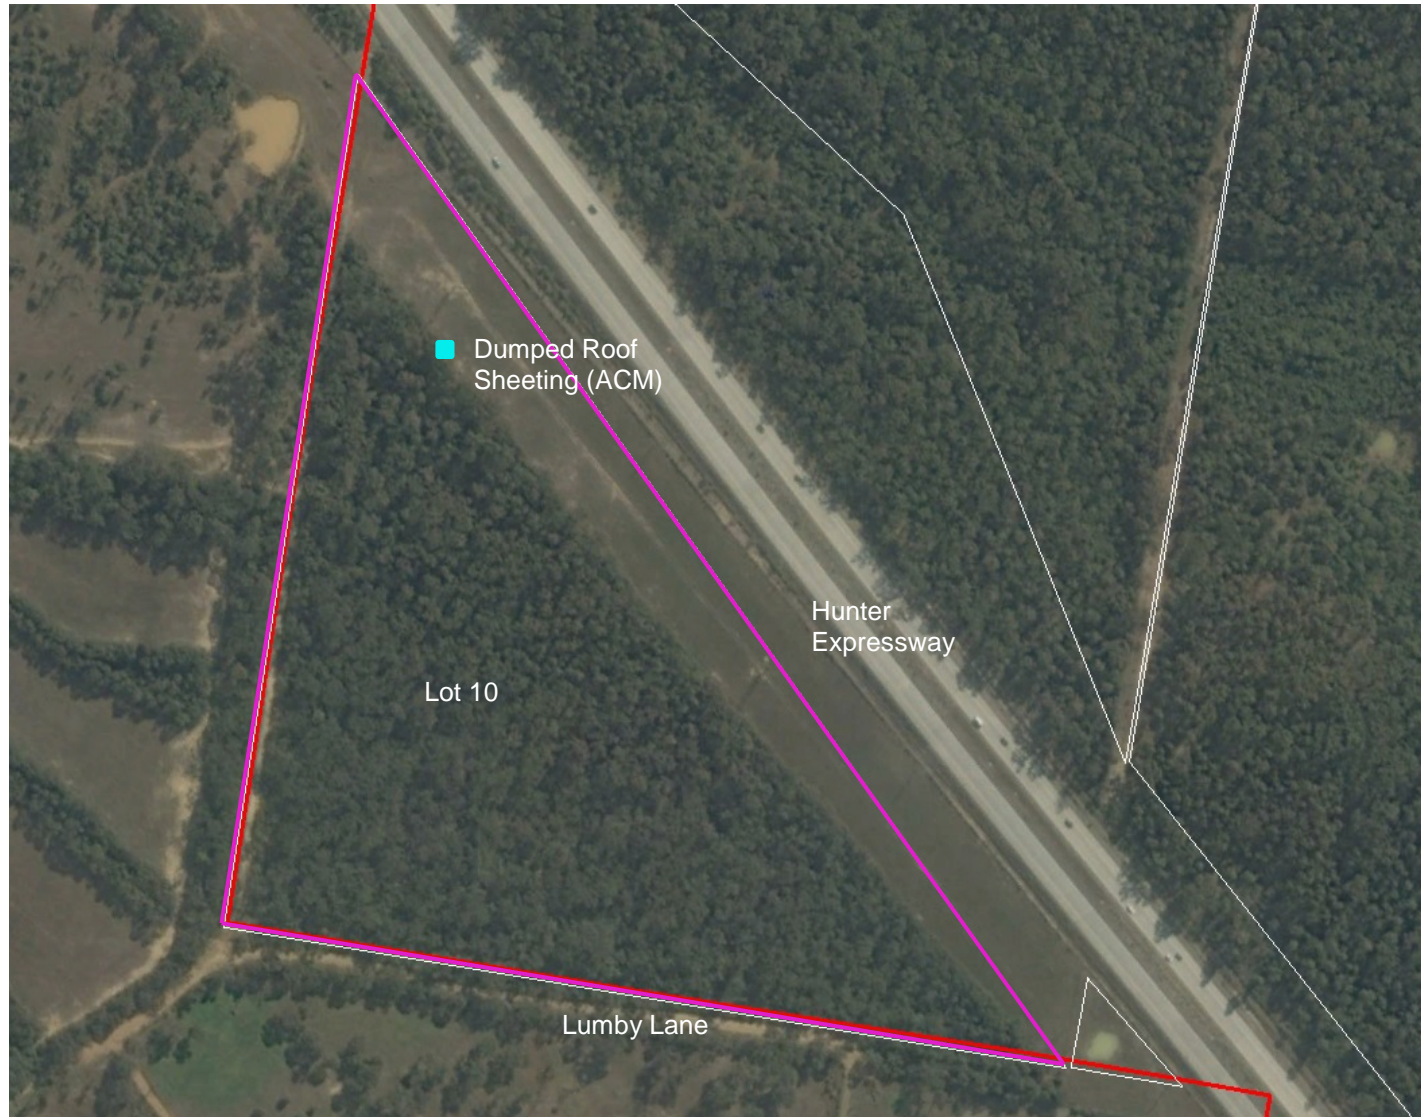
- Parcel 7 Site Boundary
- Dumped Roof Sheeting (ACM) observed during Phase 2 ESA. Remediation and validation required.

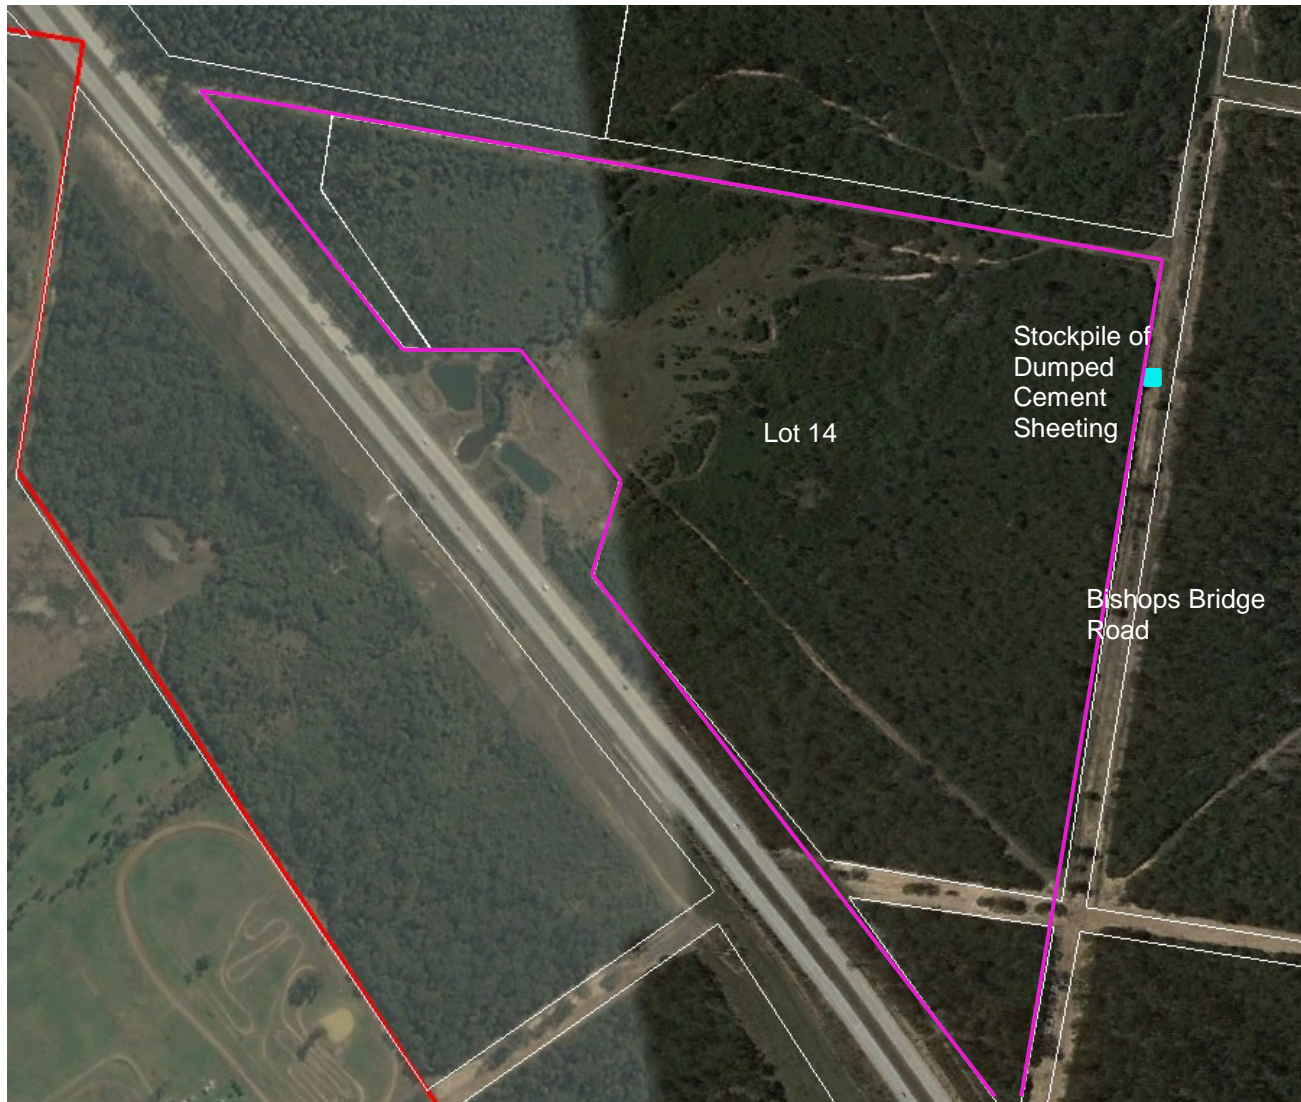
- Site Boundary
- Stockpile of dumped ACM fragments observed during Phase 2 ESA. Stockpile of cement sheeting identified on Bishops Bridge Road (Council land) during November 2017 walkover. No further work required.

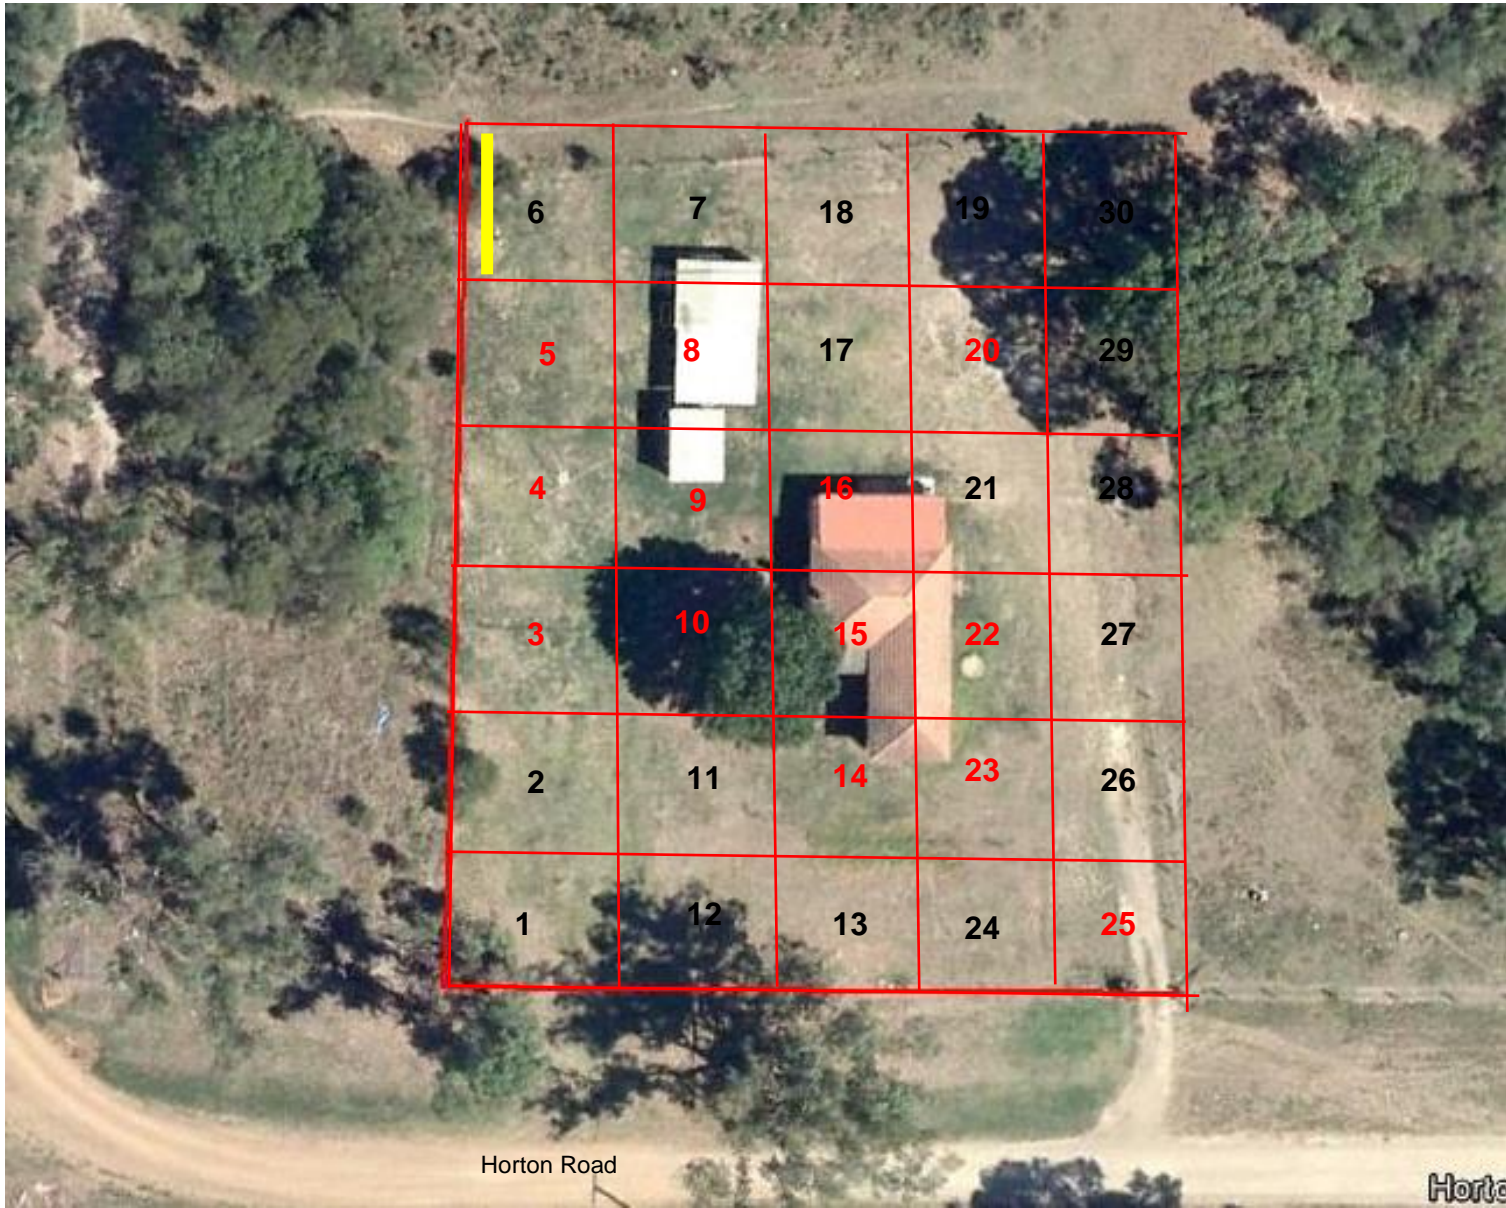
- Walkover Grid
- 8 ACM identified and collected during Phase 2 ESA
- 11 No ACM identified

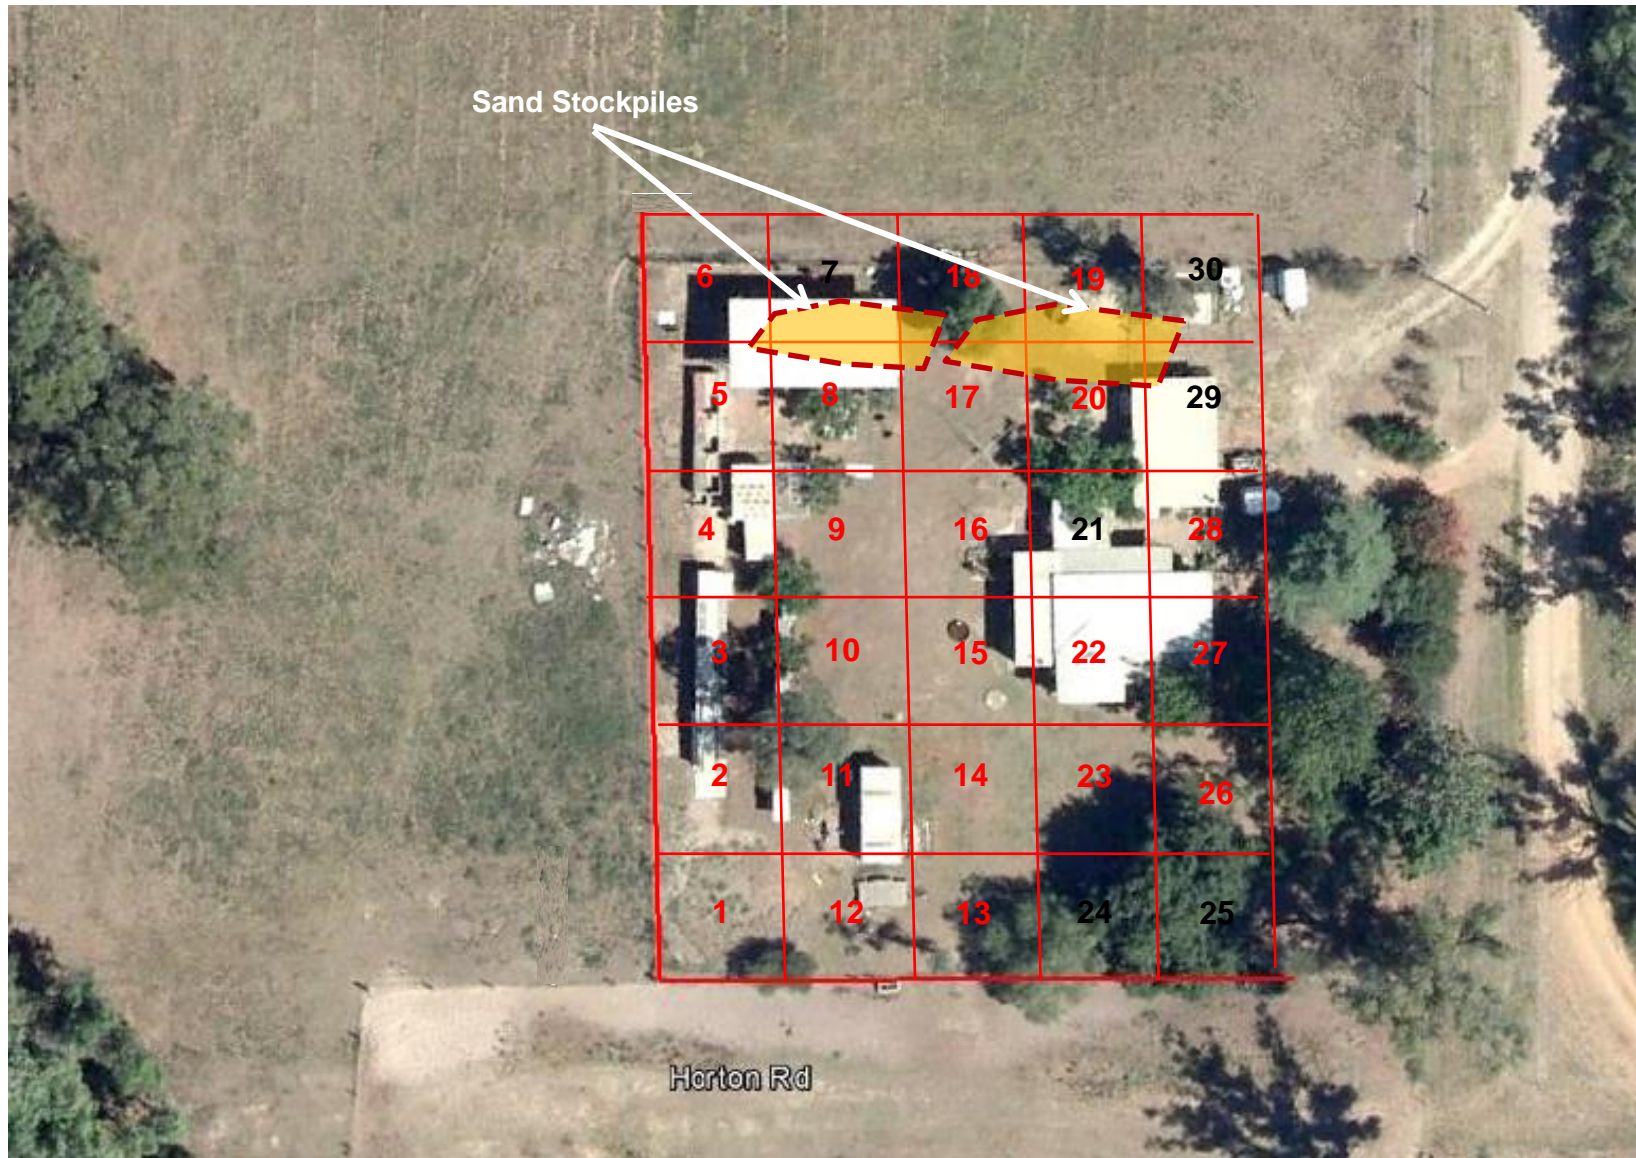
- Walkover Grid
- 8 ACM identified and collected during Phase 2 ESA
- 11 No ACM identified

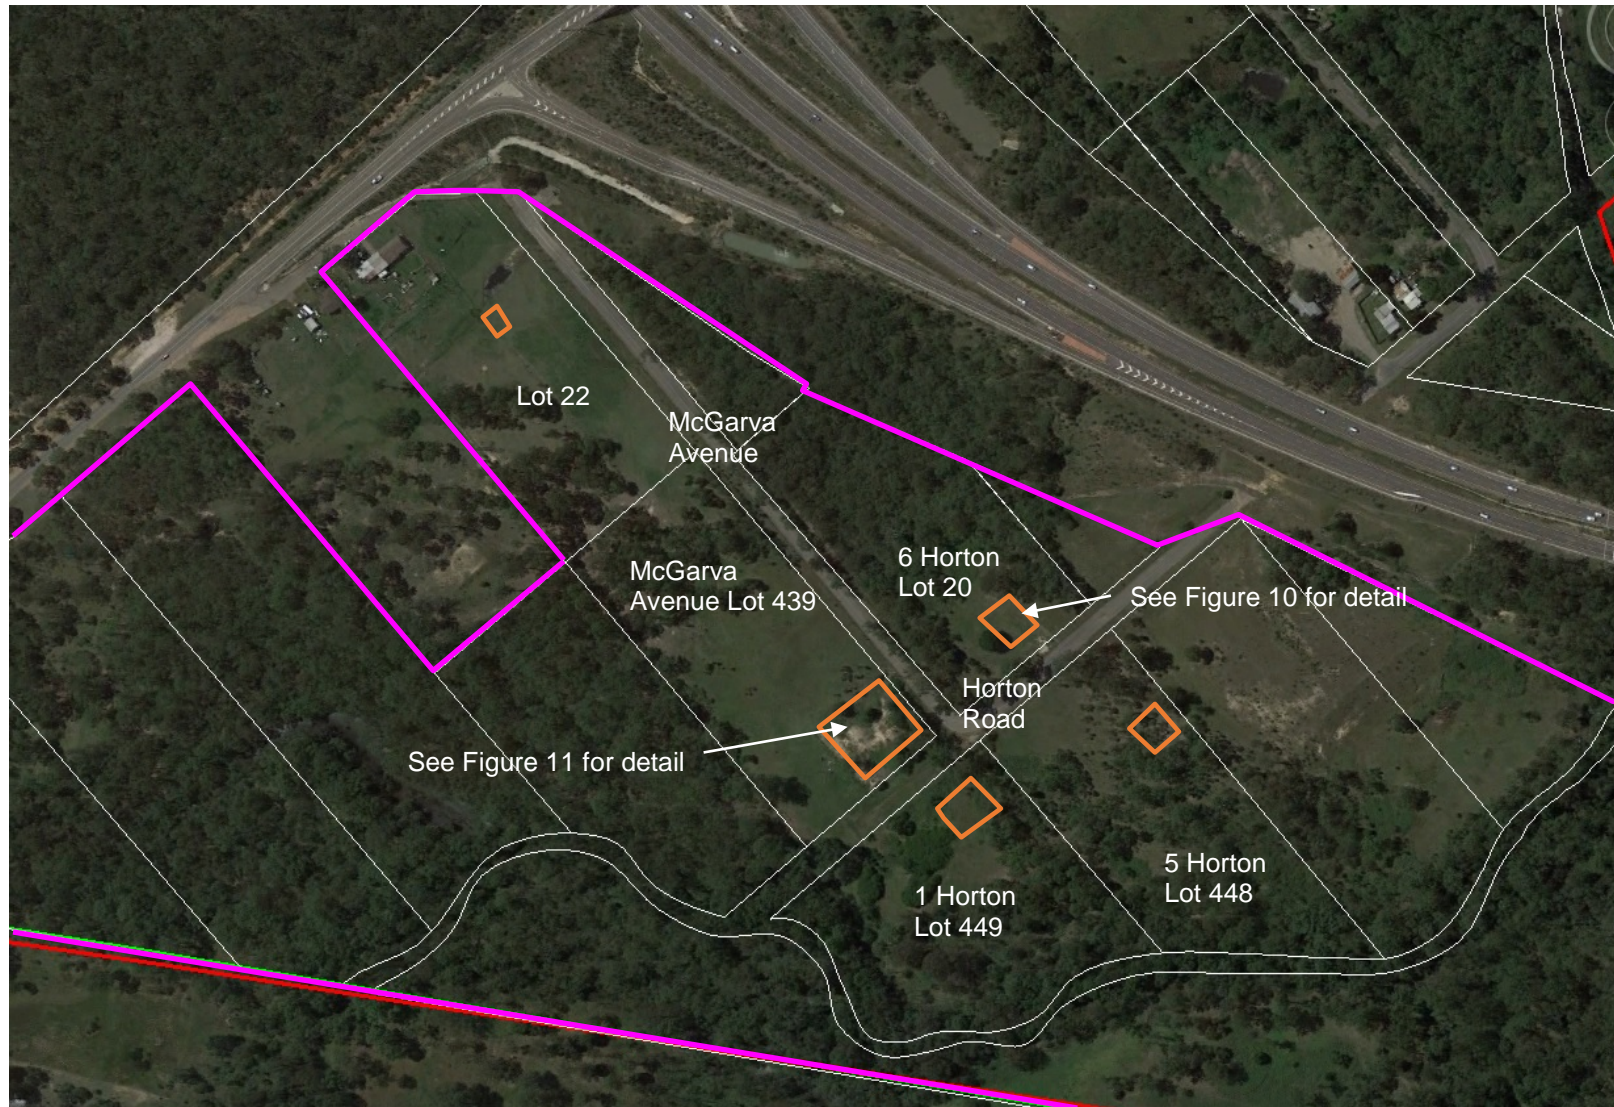
- Site Boundary
- ◇ ACM observed in the footprint of former buildings during Phase 2 ESA. Remediation and validation required.

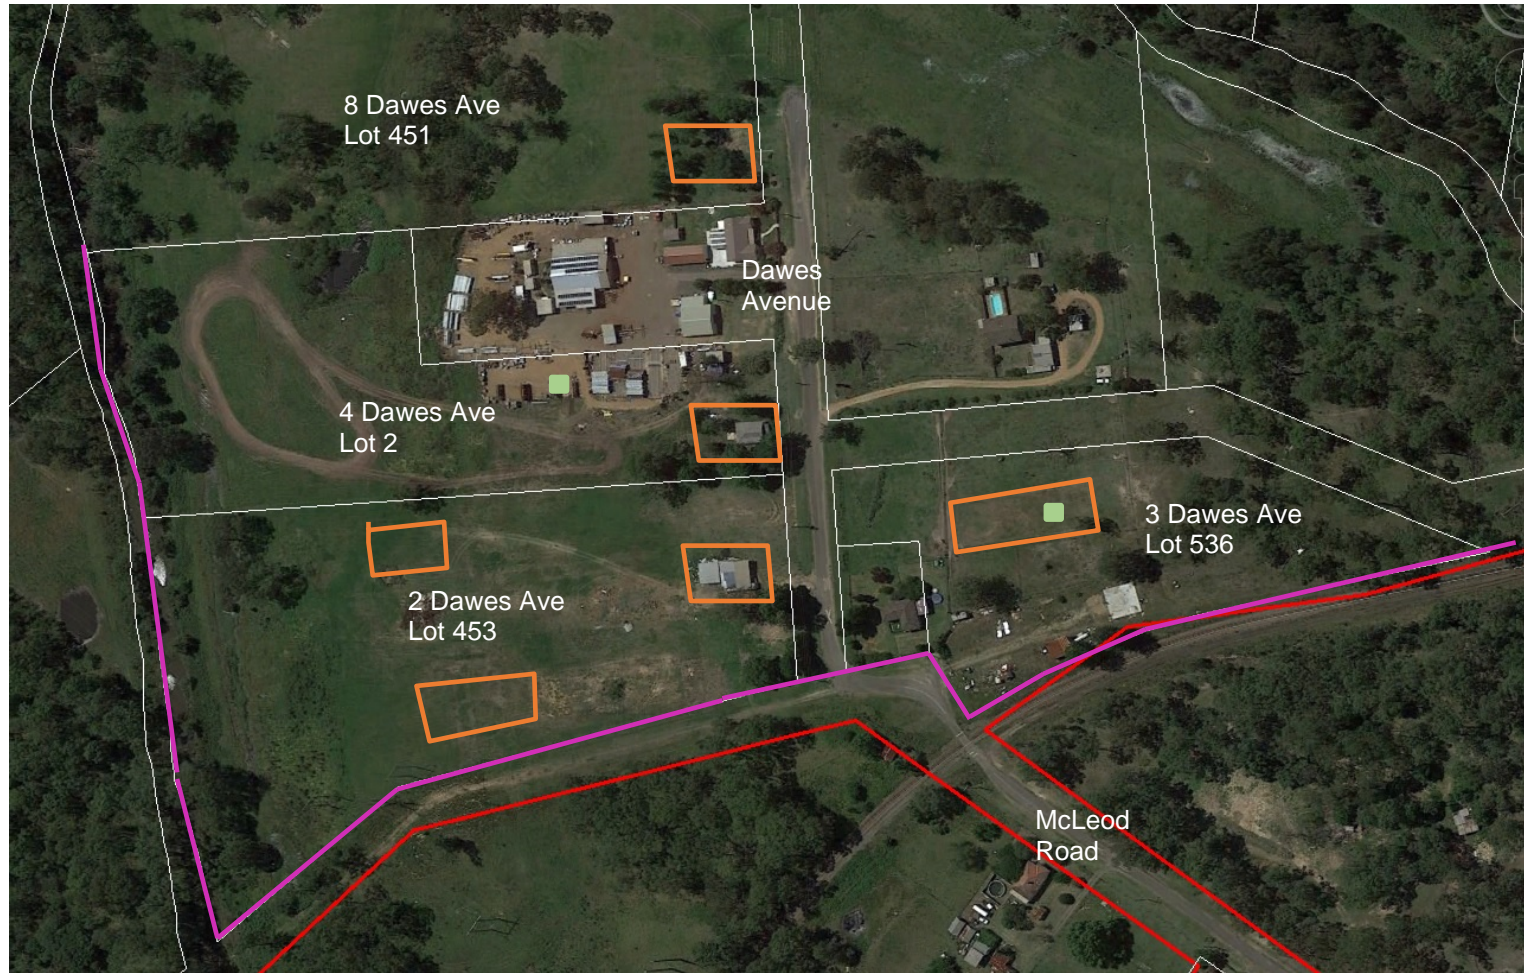
- Parcel 10 Site Boundary
- Asbestos Walkover 10 m by 10 m Quadrant, completed 2013 – ACM fragments identified and collected.
- ACM fragments identified during Phase 2 ESA or following house demolition. Validation required.

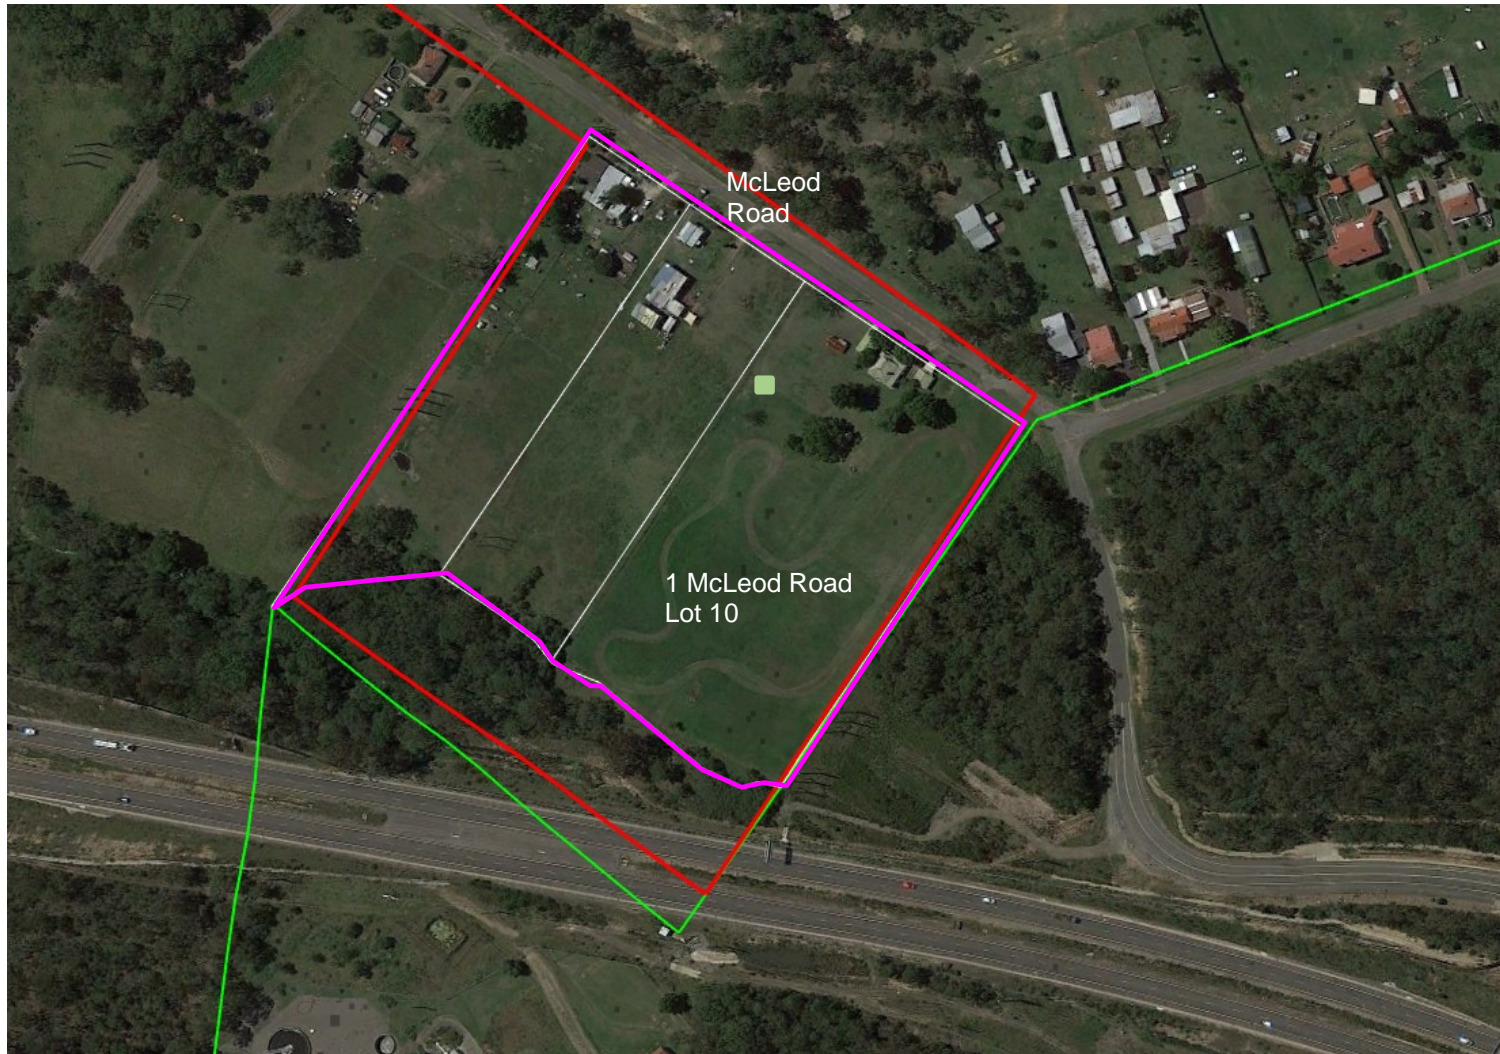
- Parcel 12 Site Boundary
- Three ACM fragments collected on surface during 2013 Phase 2 ESA. Asbestos Walkover 10 m by 10 m Quadrant and test pitting then completed – no further ACM identified. Asbestos Clearance Certificate provided August 2015 by Banksia EOHS.
