Document type
Remedial Action Plan

Date
November 2018

REMEDIAL ACTION PLAN

BUFFER ZONE ASBESTOS KURRI KURRI, NSW

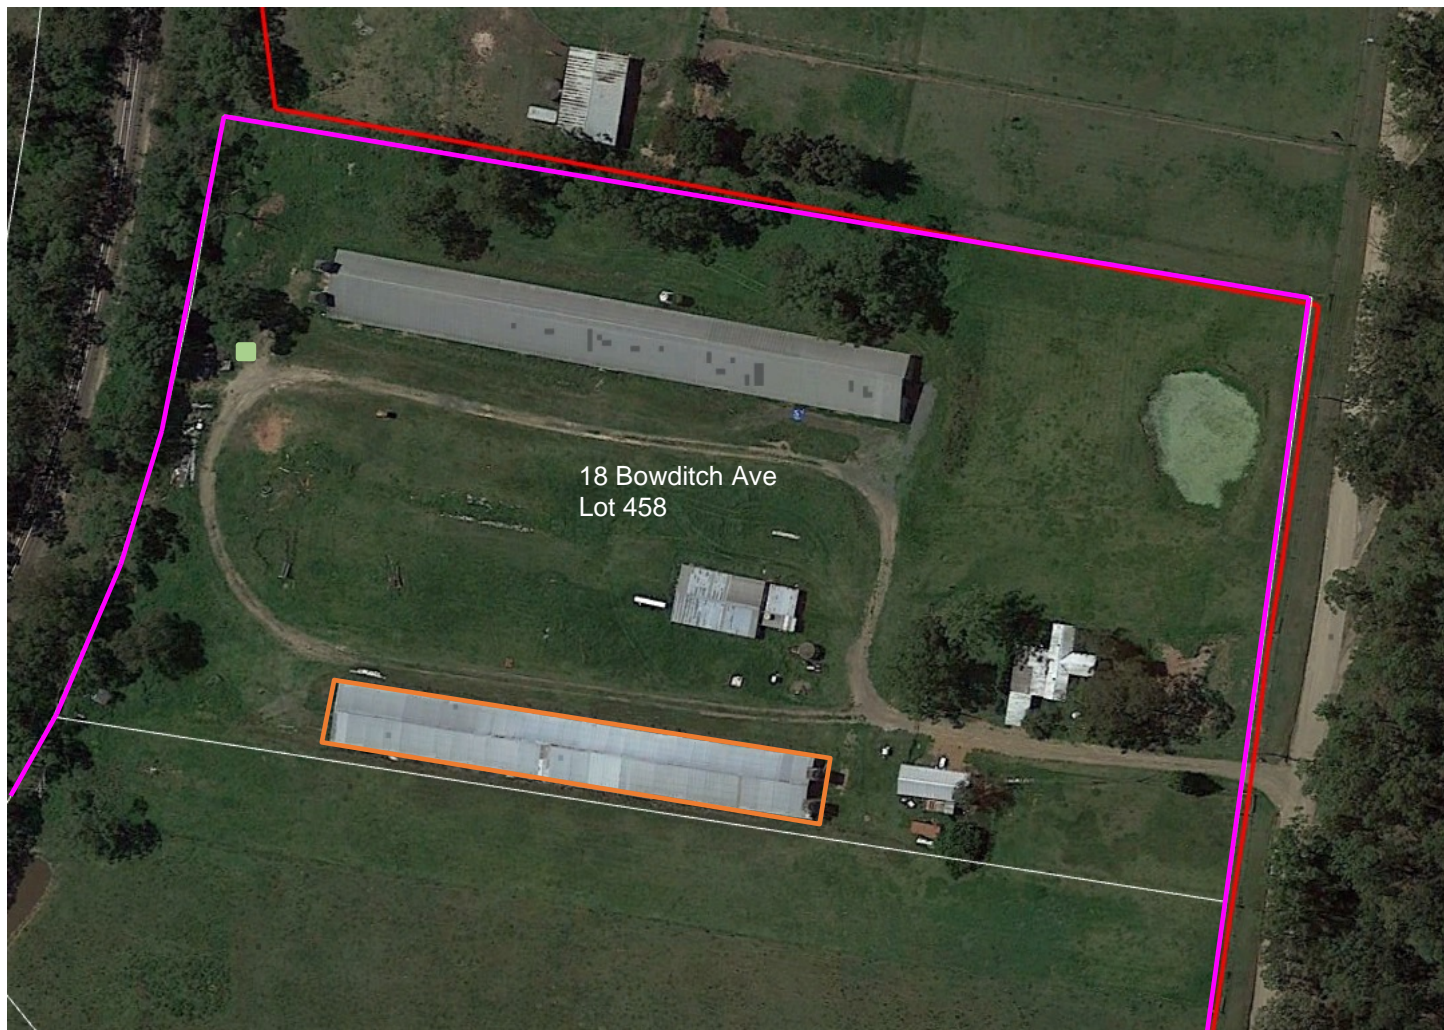
- Parcel 13 Site Boundary
- Chicken shed demolition 2016. Walkover completed Dec 2016 by Hydro/Ramboll Environ and ACM collected. Validation required.
- ACM fragment observed in fill during Phase 2 ESA – could be marked in wrong location. Validation works in 2015 did not identify further ACM fragments.

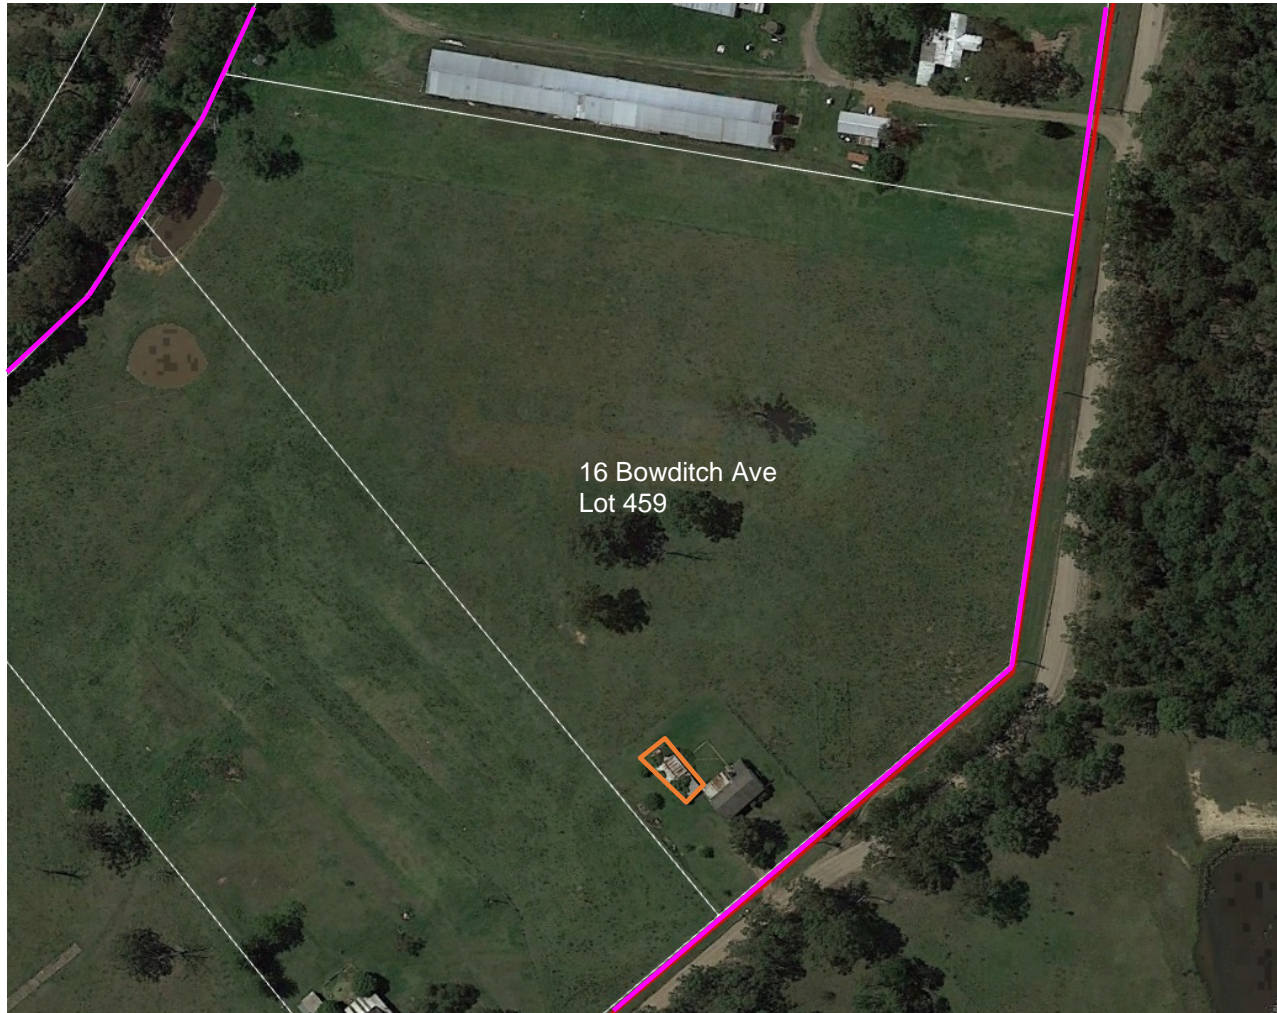
16 Bowditch Ave
Lot 459

- Parcel 13 Site Boundary
- ACM fragments identified in shed footprint in Phase 2 ESA. Removal of ACM fragments completed in 2015. Validation required.

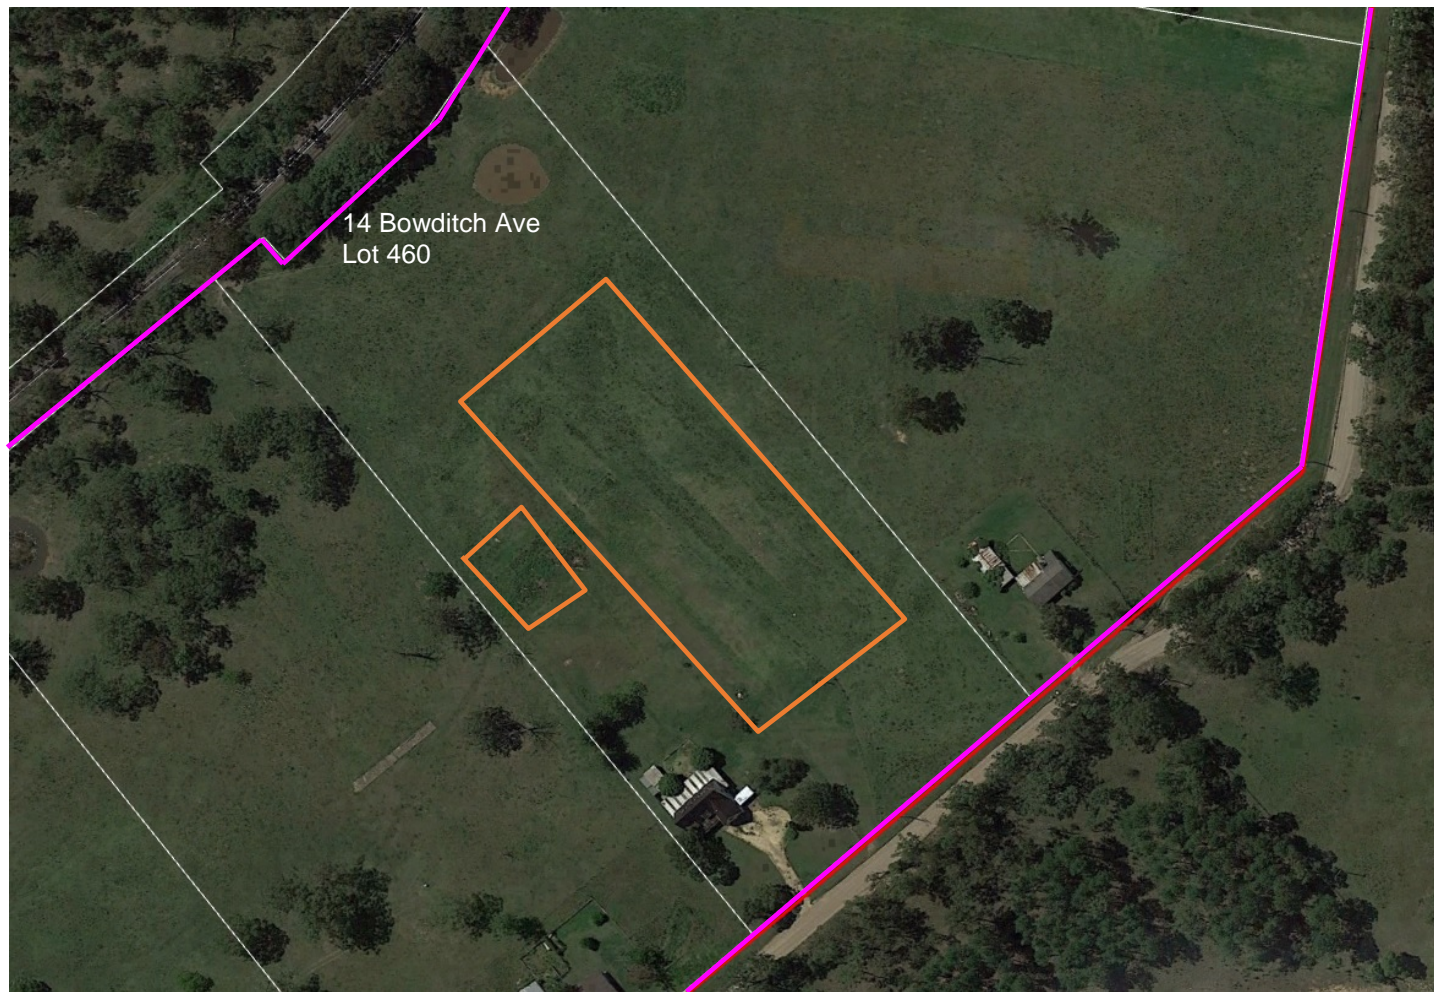
14 Bowditch Ave
Lot 460

ACM fragments observed at building footprint during Phase 2 ESA. Remediation completed 2015. Validation required.
-

No ACM fragments observed on footprint for former poultry sheds, however validation required.

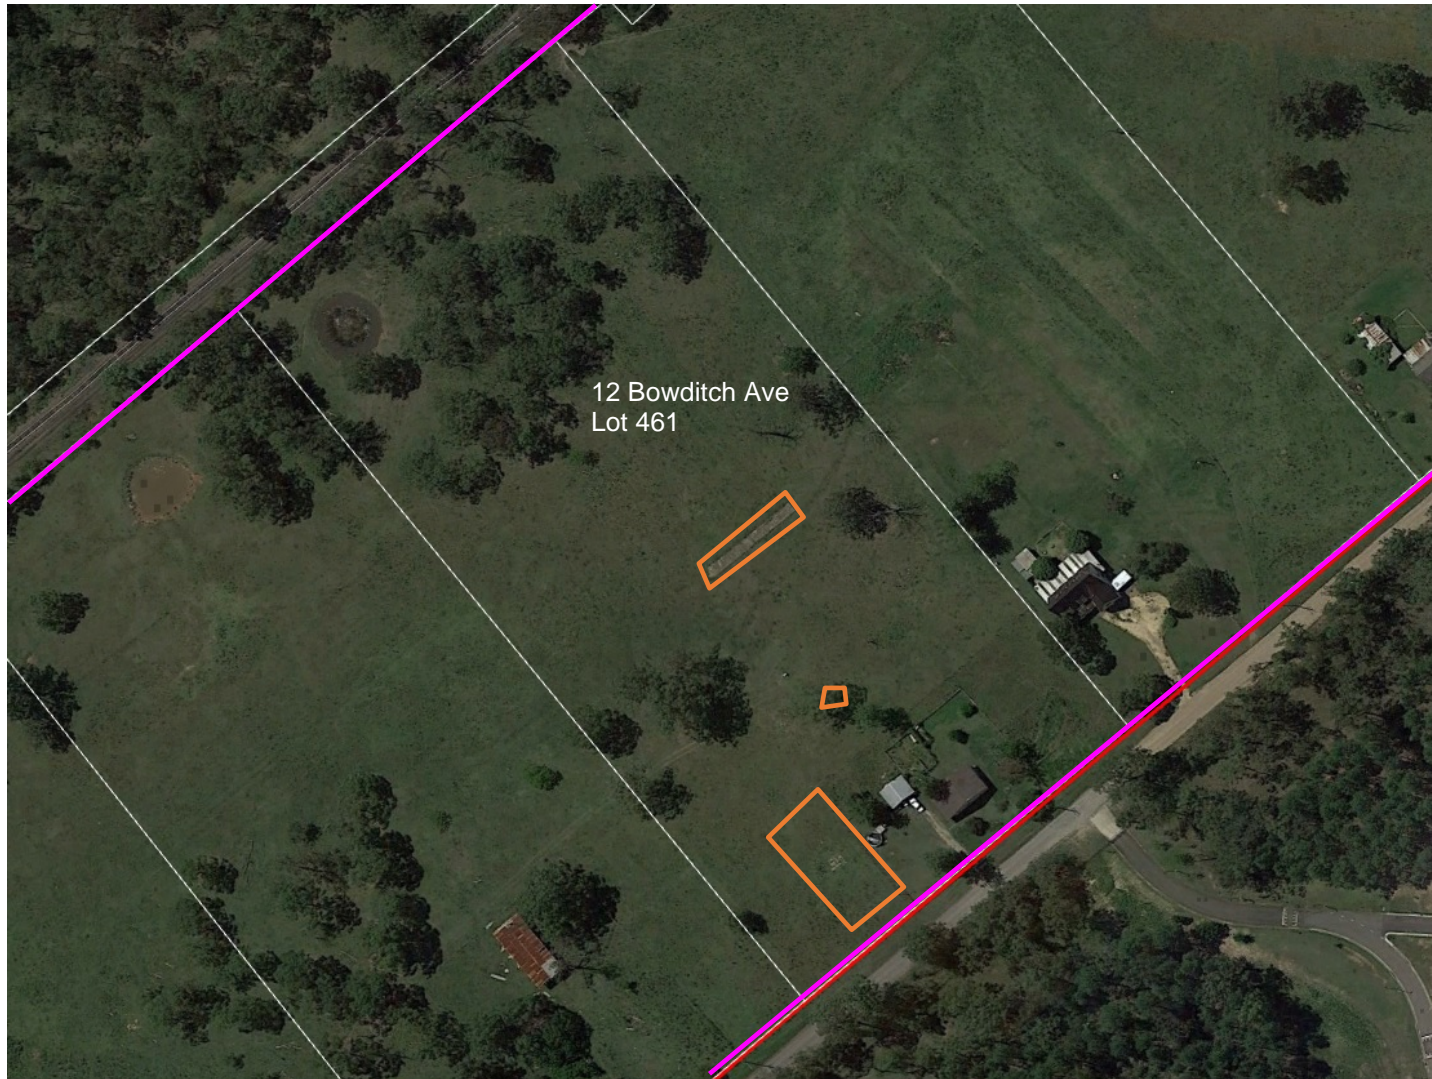
12 Bowditch Ave
Lot 461

- Site Boundary
- ACM fragments observed over footprints of two former structures and septic tank in Phase 2 ESA. Remediation completed 2015. Validation required.

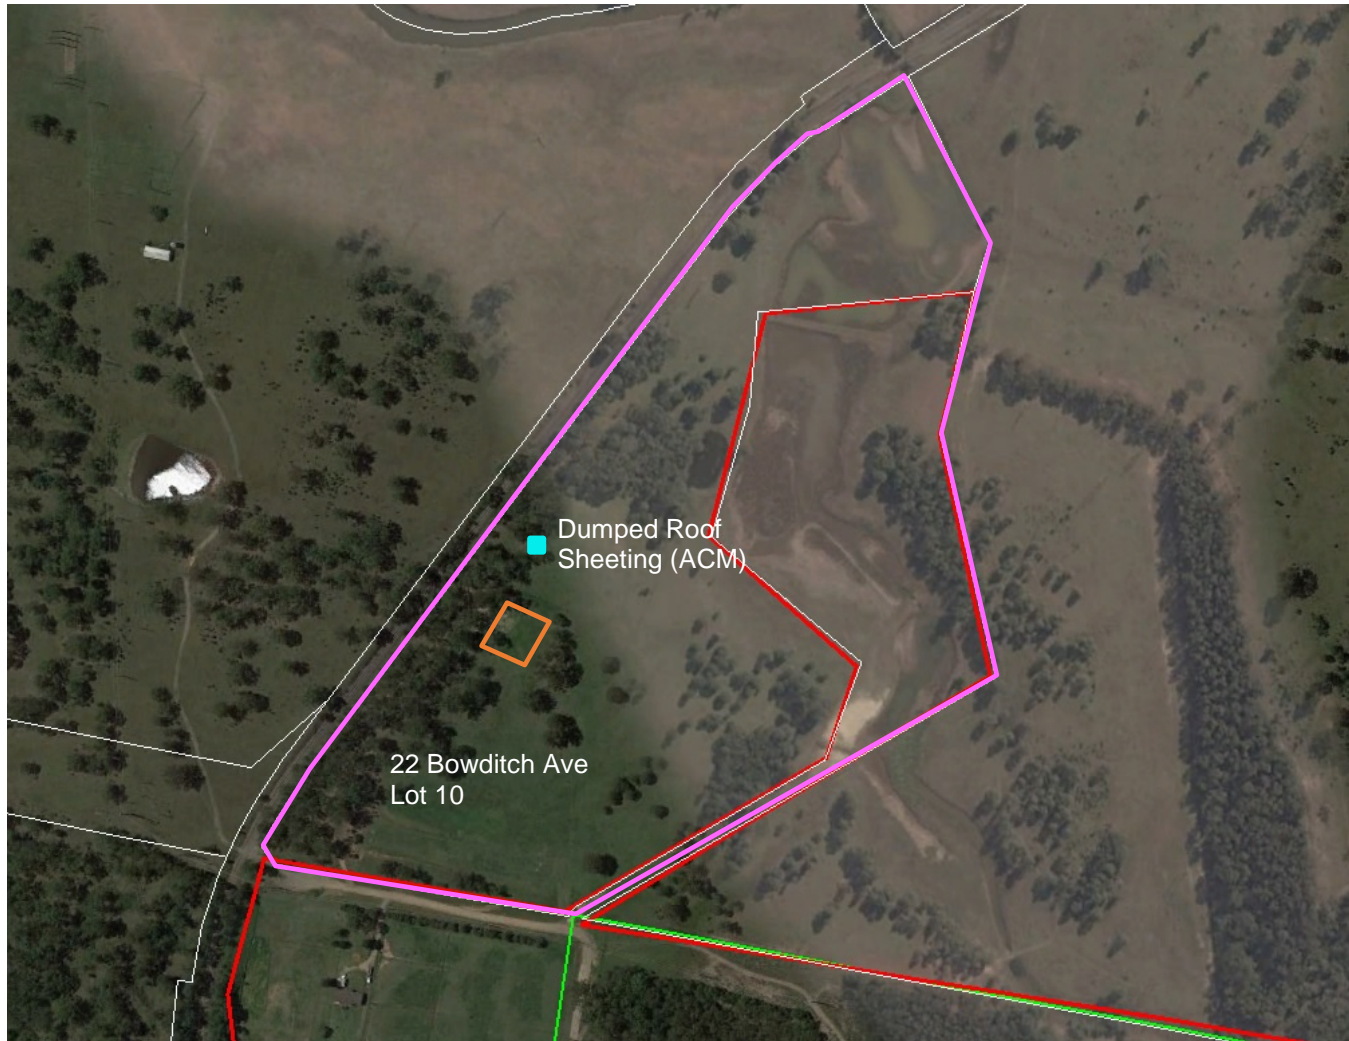
- Parcel 14 Site Boundary
- Dumped Roof Sheeting (ACM).
Removed July 2015. Clearance Certificate provided August 2015 by Banksia EOHS.
- House Demolition 2016.
Walkover completed Dec 2016 by Hydro/ Ramboll Environ and ACM collected. Validation required.

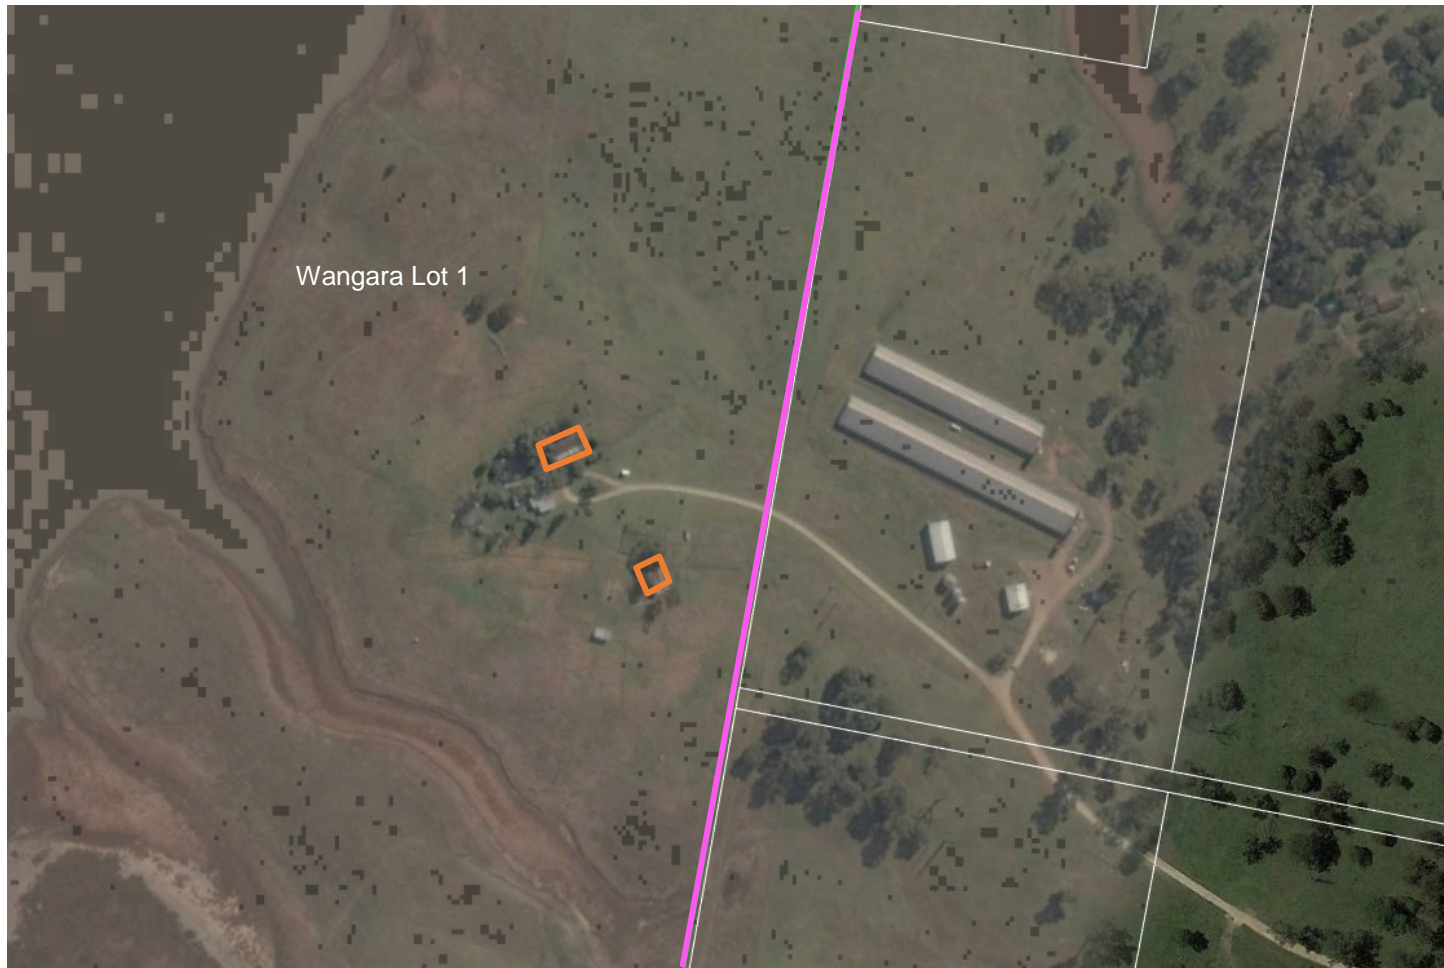
- Parcel 17 Site Boundary
- Hazardous Materials Audit identified ACM building materials in house and dairy shed. No plans to demolish house or shed.
