Document type
Site Validation Report

SITE VALIDATION REPORT

12 HORTON ROAD LOXFORD, NSW

Revision **Final**
Date **11/01/2017**
Made by **Kirsty Greenfield**
Checked by **Fiona Robinson**
Approved by **Fiona Robinson**
Description **Ramboll Environ has supervised remediation and validation works associated with an underground storage tank at 12 Horton Road, Loxford. An outline of the remedial works and validation results are presented in this Site Validation Report.**

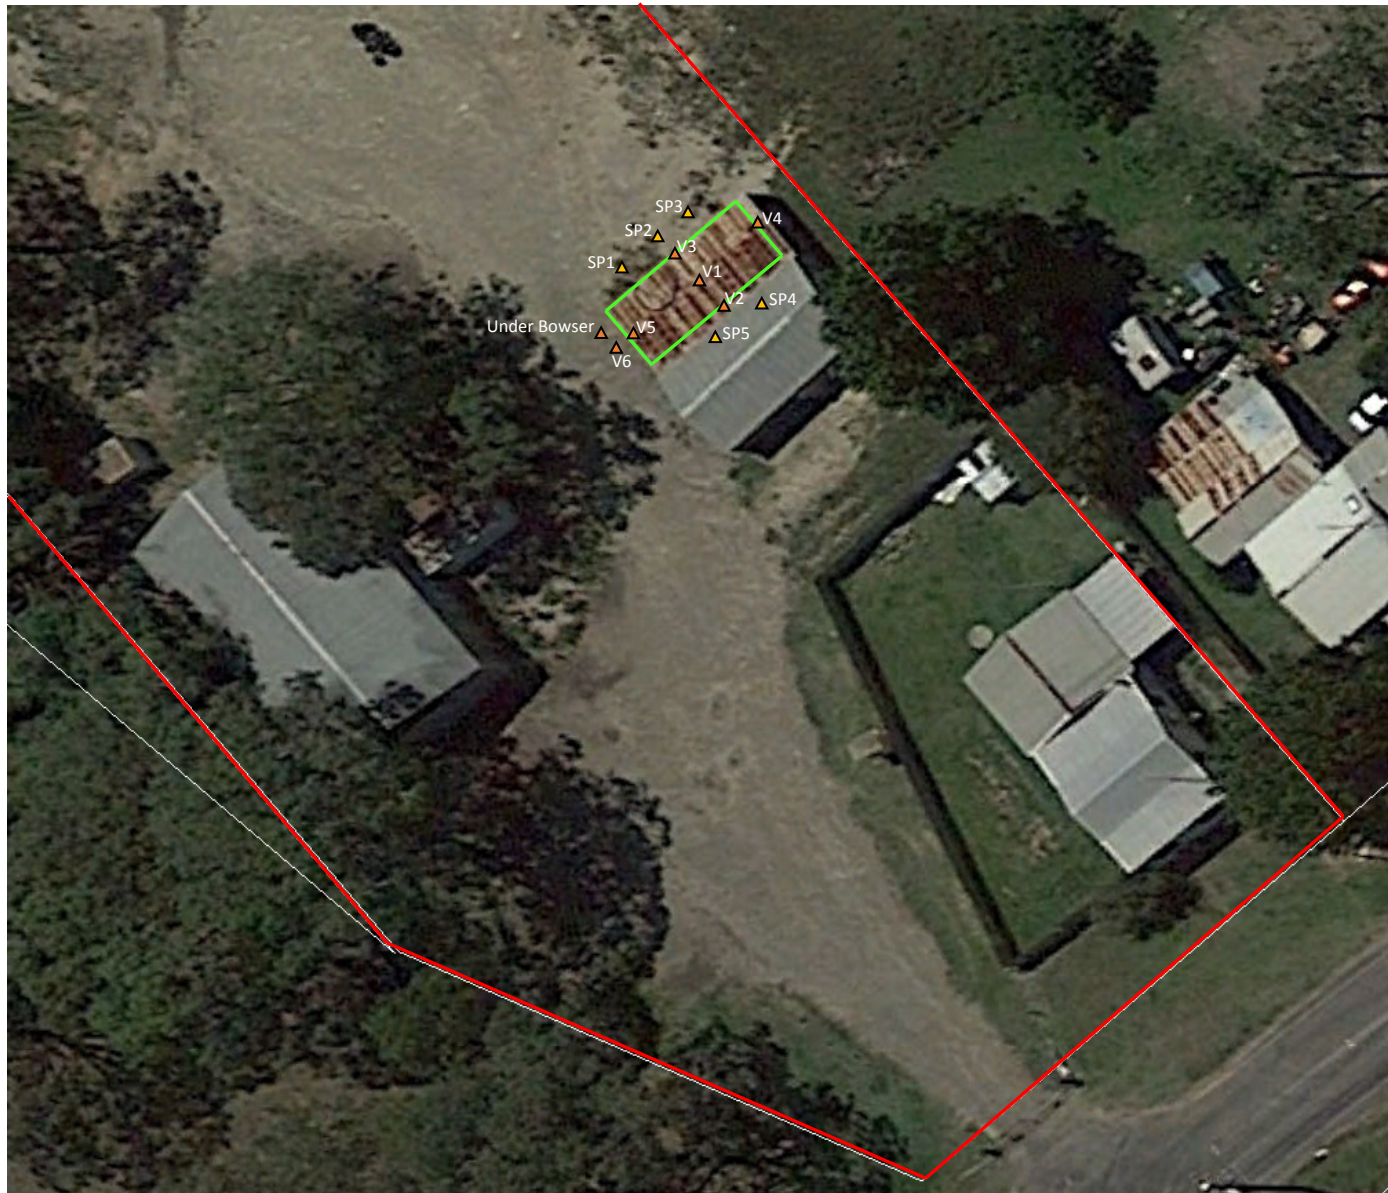
- Boundary of 12 Horton Road, Loxford
- Approximate Location of UST Excavation
- ▲ Validation Samples from UST Excavation
- ▲ Validation Samples from Stockpiles

Approximate Scale 1cm: 3m

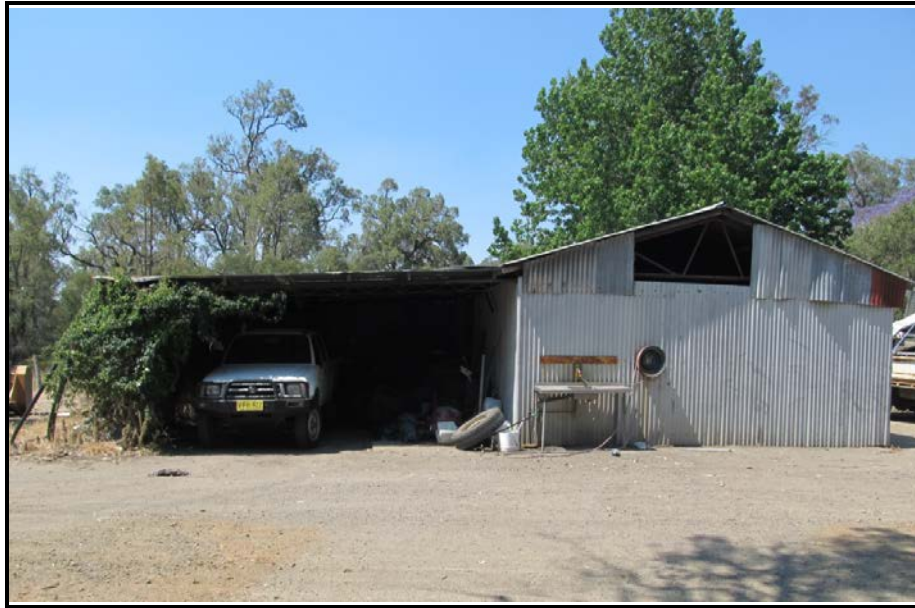
Photo 1: Photograph of the shed beneath which the UST was identified during demolition of the shed, facing north.

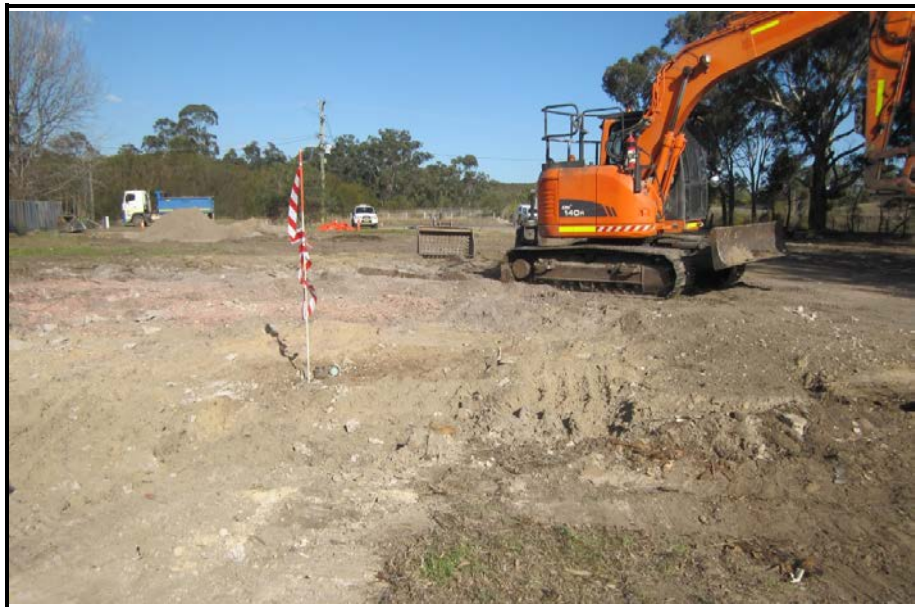
Photo 2: Flag showing location of the UST following demolition of the shed, facing east.

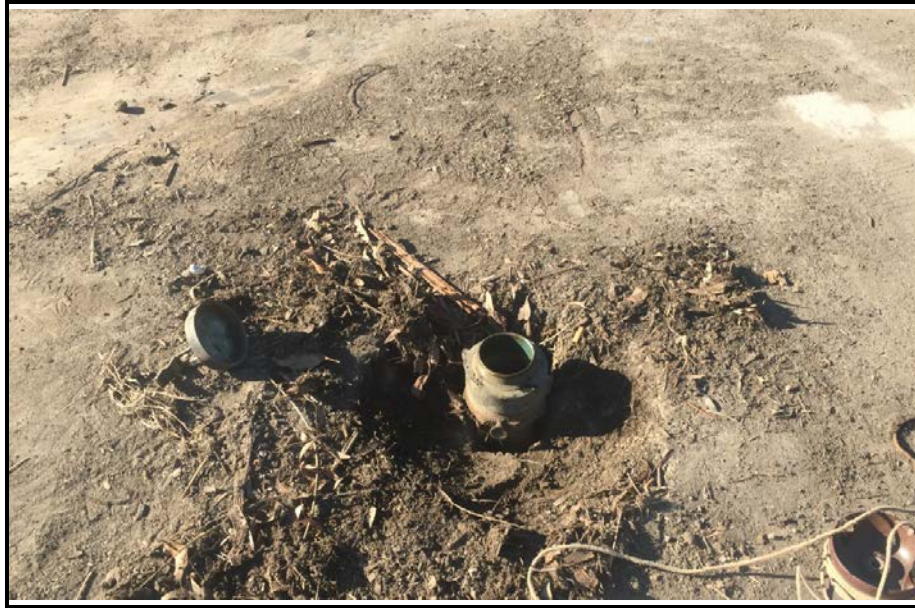
Photo 3: Photograph of the dip pipe, indicating the presence of the UST.

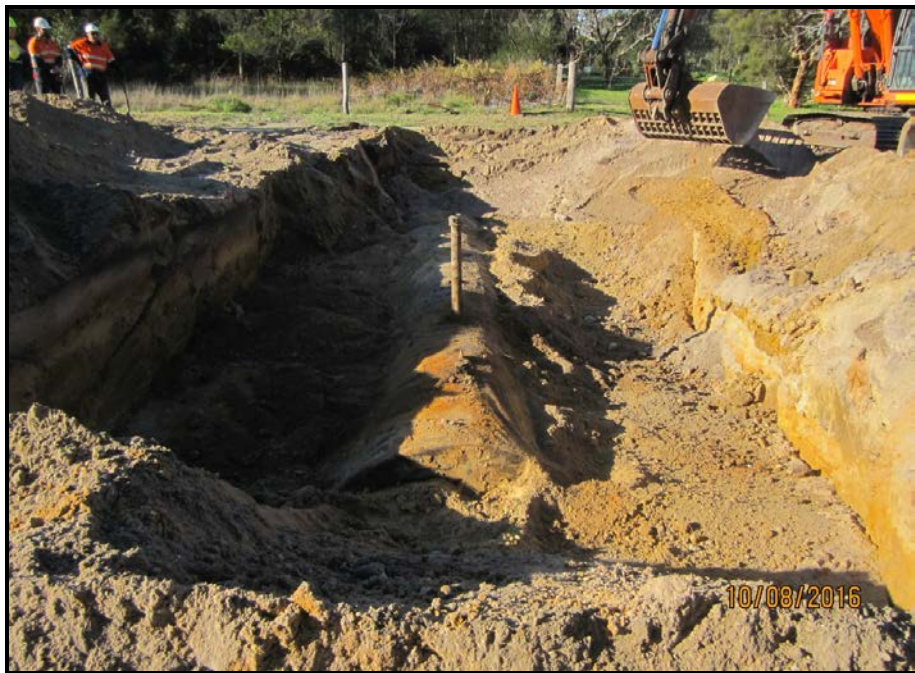
Photo 4: Photograph of the uncovered UST, facing north.

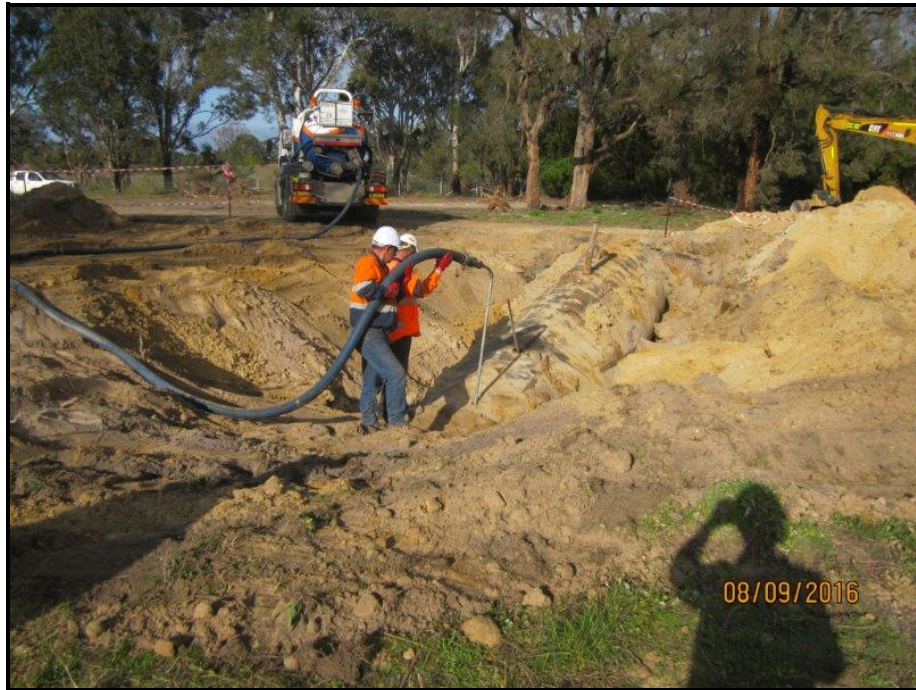
Photo 5: Photograph of the removal of liquid sludge from the UST, facing south.

- Thursday 8 September 2016
- Removal of sludge from within the UST by a liquid waste contractor. Approximately 1000L of sludge was removed.
- Removal of the UST from the excavation. The UST was lifted on to the surface of the site and remained there until it was picked up for off-site disposal. The UST was observed to be intact, with no corrosion.

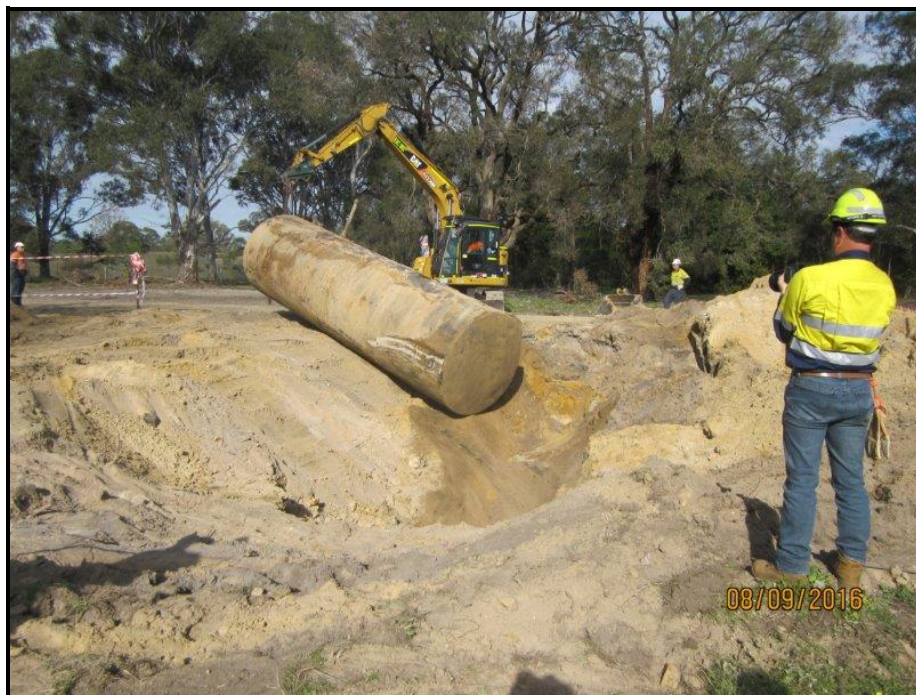
Photo 6: Photograph of the UST being removed from the ground, facing south.

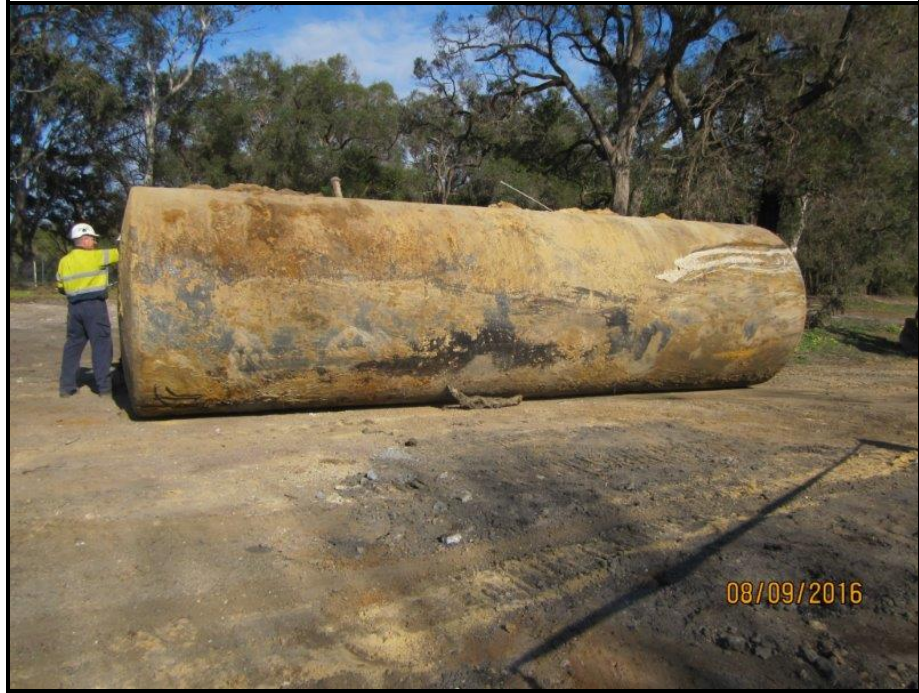
A Ramboll Environ environmental scientist was on-site during the excavation and removal of the UST. The UST was observed to be in good condition, with no corrosion evident and the UST appeared intact. There was no odour evident during the excavation of the UST. The UST was measured following excavation and found to be 7.5m long by 2.15m in diameter.

Photo 7: Photograph of the UST showing size and condition, facing south.

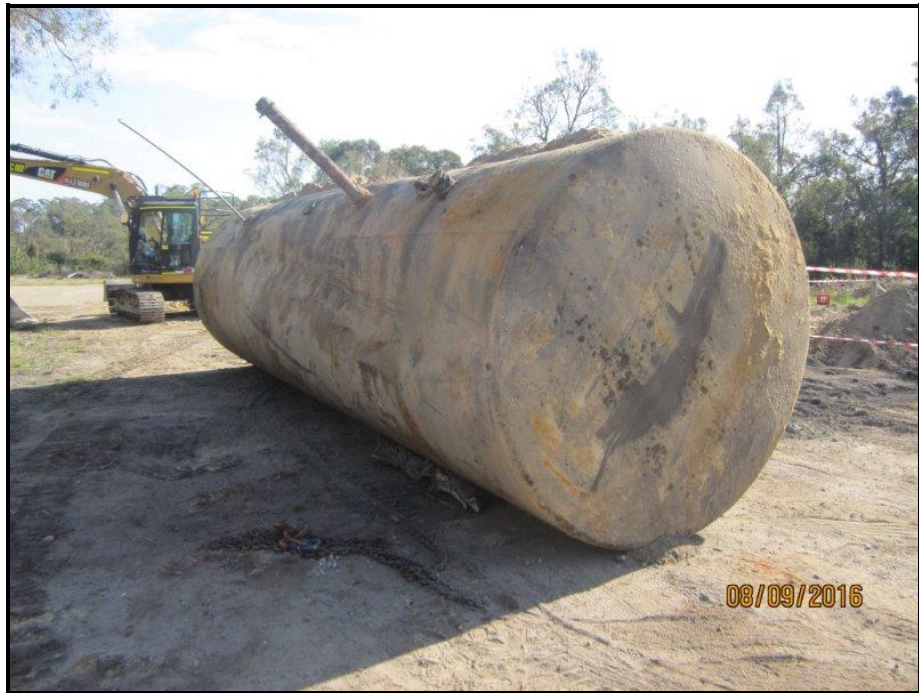
Photo 8: Photograph of the UST showing size and condition, facing north west.

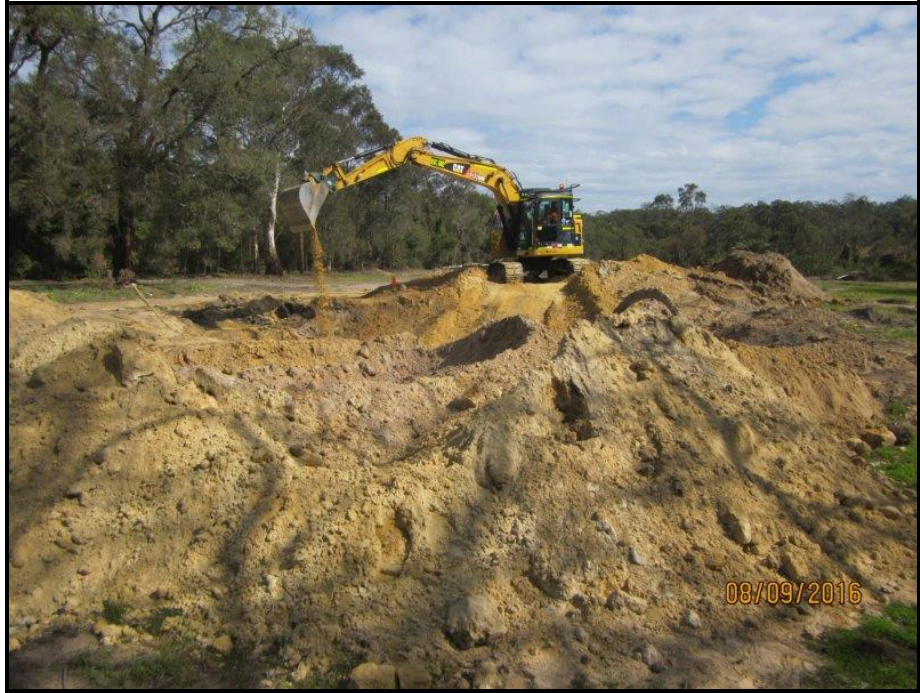
The packing sands were observed to be free of staining and odour. The walls and base of the UST excavation, which were in natural clayey sand, were observed to be free of staining and odour.

Photo 9: Photograph showing the excavation of packing sands, facing west.

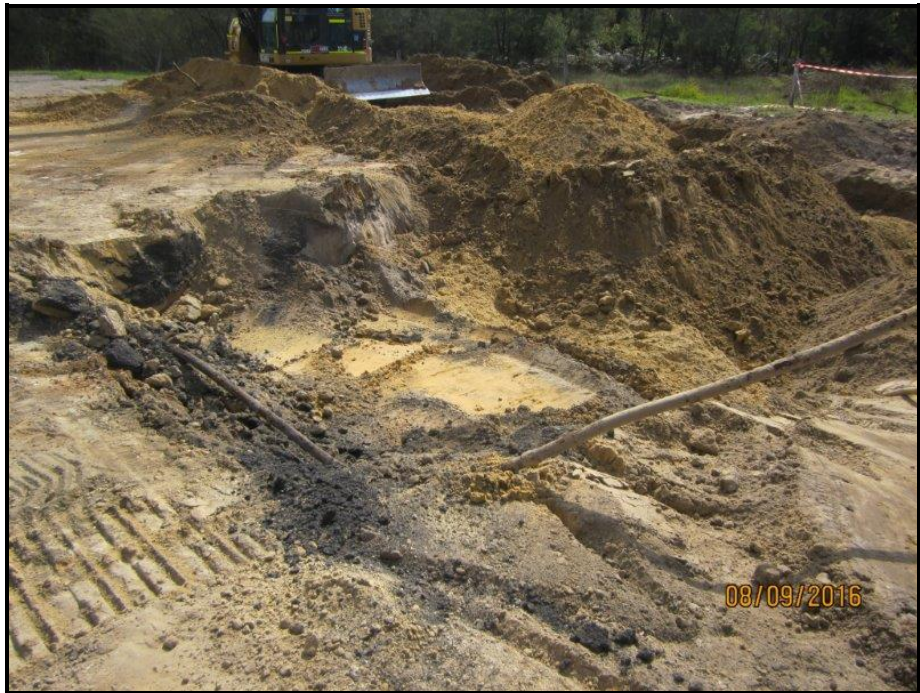
Excavation of soils beneath the location of the former bowser uncovered black fill material, which was identified as coal washery reject that had been used as the hardstand subbase. This material was not odorous.

Photo 10: Photograph of pipework to chase out and black coal washery reject subbase.

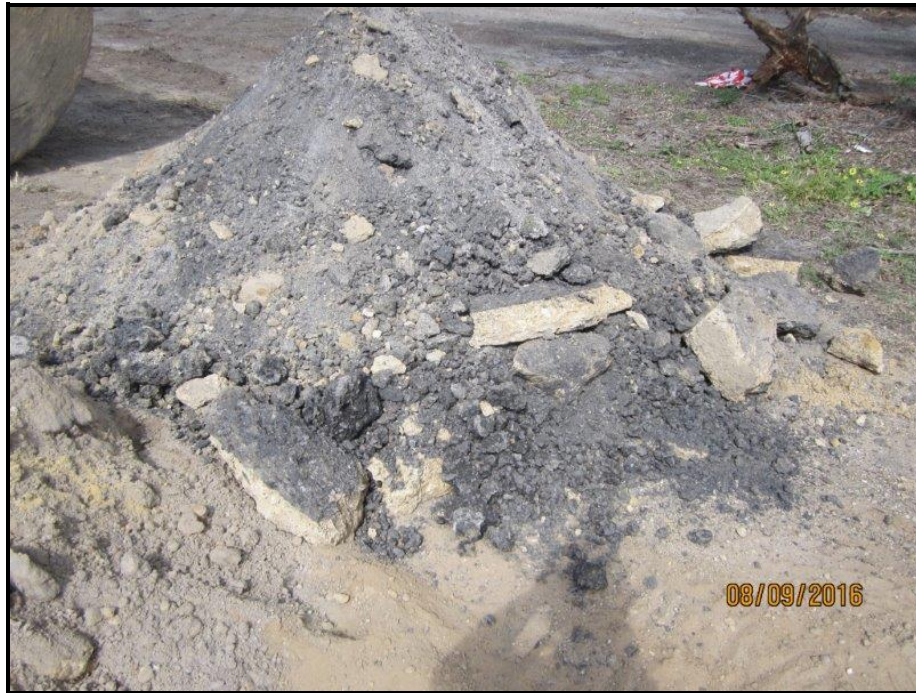
Photo 11: Photograph of black coal washery reject subbase stockpile.

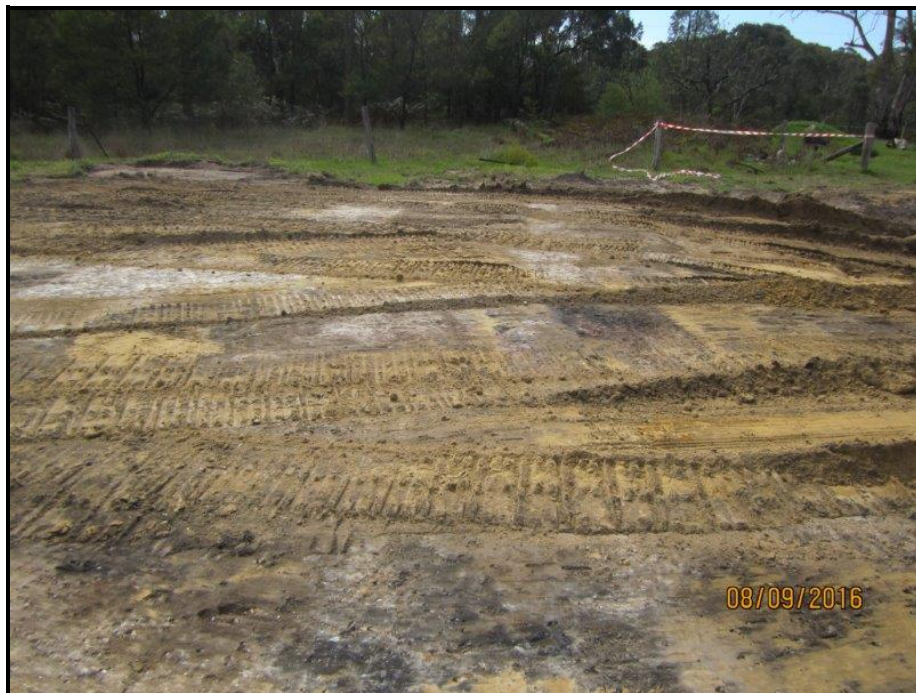
Photo 12: Photograph of backfilled and track rolled UST excavation, facing north.
