Richmond Vale Rail Trail Visual Impact Assessment

Project Number: 16_005
Richmond Vale Rail Trail

Version	Date issued	Description	Author	Approved by
A	22.12.2016	Visual Impact Assessment	Vanessa Colclough Jason Hildridge	Vanessa Colclough
B	14.06.2017	Revised Visual Impact Assessment	Vanessa Colclough Jason Hildridge	Vanessa Colclough

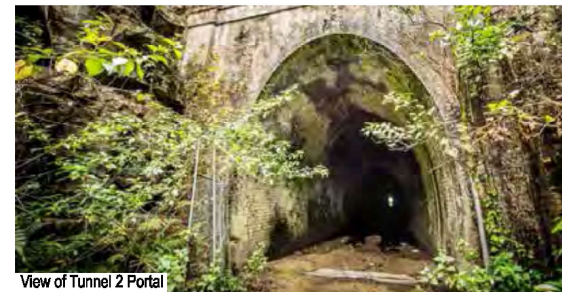
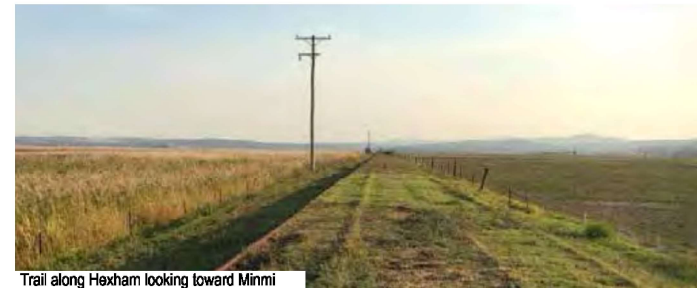
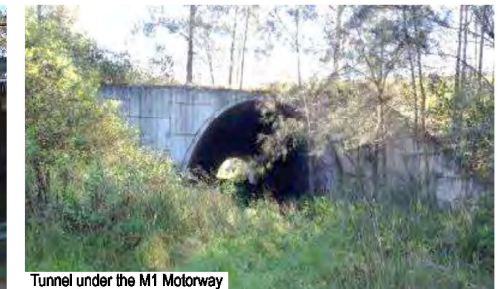
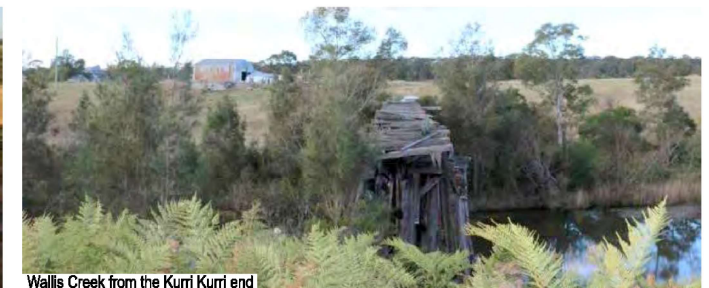
Figure 2 – Existing bridges, tunnels and trail
Source: GHD 2016

There are various structures along the trail including timber bridges and tunnels as well as broad open spaces that will contribute to the visual interest of the users of the trail. Refer Figure 2.

View of Tunnel 2 Portal

Wallis Creek Bridge

Trail along Hexham looking toward Minmi

View of Tunnel 1 Portal

Underpass near the Log of Knowledge Park

Tunnel under the M1 Motorway

Small bridge along the trail

Wallis Creek from the Kurri Kurri end

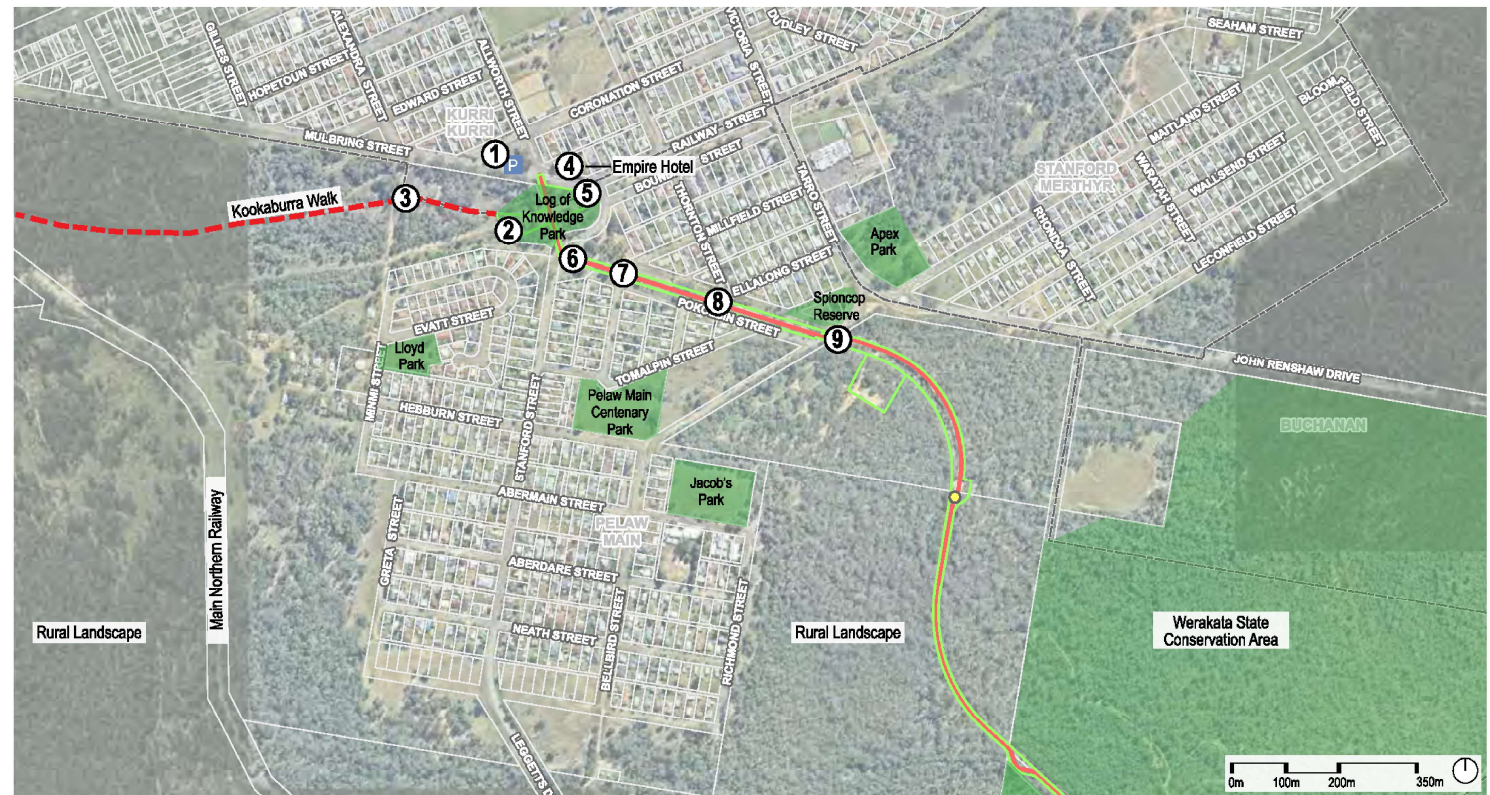
Figure 4 – Zone 1 Landscape character
Source: Bana - GHD 2018

Landform	Generally flat throughout the area. The trail is raised from the surrounding land along Pokolbin Street. Informal drainage is located either side of the trail.
Land use/built environment	Surrounding development includes older style single storey dwellings and the two storey Empire Hotel. Log of Knowledge Park incorporates some older play equipment and seating. Kookaburra Walk is located to the west of the park. The trail is located in bushland to the east of Pokolbin Street and goes through the Werakata State Conservation Area.
Vegetation	Vegetation within Kurri Kurri and Pelaw Main and incorporates mainly an Open Woodland. Land to the east of Pokolbin Street is heavily vegetated and is identified as a rural landscape zone and forms part of the Werakata State Conservation Area.
Landscape features	The broad open areas including the wide streets and open space areas throughout Kurri Kurri and Pelaw Main. The Werakata State Conservation Area and surrounding bushland.

Infrastructure	Stanford Street raises over the trail along the Log of Knowledge Park. A concrete pathway connects the Park to Pokolbin Street under the Stanford Street road bridge. Pokolbin Street runs along the southern extent of the trail in Pelaw Main. An existing formed and unlined parking area is located adjoining the northern boundary of the Park. An existing pedestrian refuge is located on Mulbring Street.
Major economic components	The Empire Hotel is located opposite the Log of Knowledge Park on Mulbring Street. The trail is located in part of the Werakata State Conservation Area. State conservation areas are reserved to protect and conserve areas that: <ul style="list-style-type: none"> Contain significant or representative ecosystems, landforms or natural phenomena or places of cultural significance Provide opportunities for sustainable visitor or tourist use and enjoyment, the sustainable use of buildings and structures, or research Providing opportunities for uses permitted under other provisions of the NPW Act.

Spatial quality of zone	The trail from its commencement to the east of Pokolbin Street is fairly open and will be visible from the surrounding areas. The trail east of Pokolbin Street is enclosed by the existing vegetation and is not visible from the surrounding areas.

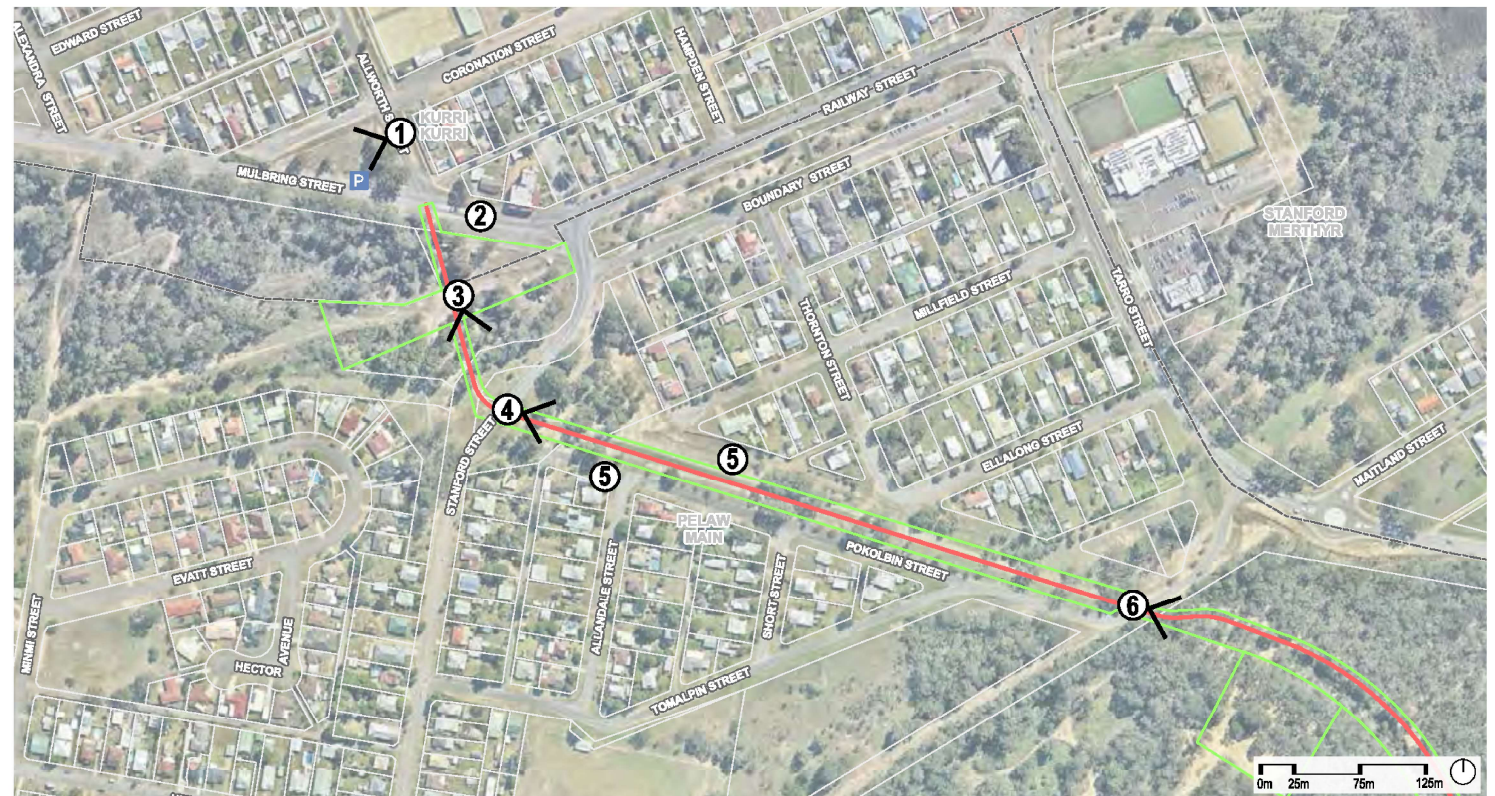
Figure 5 – Zone 1 View point Locations
Source: Bana - GHD 2018

The key viewpoints for zone 1 are shown on Figures 5 and 6. Table 3 analyses the visual impact on these view points.

View	Description of setting	Visual sensitivity	Sensitivity due to:	Magnitude of visual effect	Visual Impact	Comments
1	A vacant parcel of land on Coronation, Mulbring and Allworth Streets with some larger trees.	Moderate	The dwellings address Coronation Street and the vacant parcel of land currently have views of wide open spaces and vegetation.	Moderate	Moderate	The provision of a carpark on this vacant land would have a moderate impact on the dwellings that face onto the land with a park like setting. The design of the carpark would need to consider access and visual amenity to the residents. Alternatively, the carpark could be located within the existing carpark adjoining the Log of Knowledge Park. The visual impact would therefore be negligible.
2	The land opposite the Log of Knowledge Park includes single storey residential dwellings and the two storey Empire Hotel. These buildings face onto Mulbring Street, the Log of Knowledge Park and existing carpark. However, some of the dwellings have large front fences, which would restrict its views to the park.	Negligible	The infrastructure is already in place and would be upgraded as part of the proposed works.	Negligible	Negligible	As outlined, the infrastructure is already in place and would be updated as part of the proposal and therefore have little impact on the surrounding land uses.

3	View across Log of Knowledge Park to the Stanford Street road bridge.	Low	The infrastructure is already in place and would be upgraded as part of the proposed works.	Negligible	Negligible	The infrastructure is already in place. The upgrade to this section, particularly the thoroughfare under the road bridge would have a positive impact by opening up the area and making it safer for its users. The upgrade of facilities and implementation of interpretative and way finding signage would also be beneficial to the residents and users of the trail as it would assist in ensuring the users are knowledgeable of the public areas and minimise impacts on the surrounding dwellings.
4	View from the Stanford Street road bridge to the trail along Pokolbin Street.	Negligible	There is no pedestrian access on the road bridge. The only users are drivers and passengers of vehicles. The view is not towards the trail and the main views are to the south and north along Stanford Street. Further, the existing trees along the trail would reduce any visual impact.	Negligible	Negligible	The visual impact is negligible.

5	Dwellings adjoining the southern side of the trail along Pokolbin Street alignment and to the northern side of the trail at this location.	Low	The trail is located on land that is raised above the adjoining land. Whilst there is no infrastructure currently in place, low key facilities including the trail and interpretative signage would have a low impact on the surrounding land uses as most dwellings do not face onto this open space. Further, trees are located along the corridor and would assist in minimising any visual impact.	Low	Low	It is considered that the provision of a trail and interpretative signage along this section would have a low impact based on retention of the existing vegetation and that suitable materials would be used to reduce any visual impact. Further, dwellings generally do not face onto this open space area.
6	The entry into the bushland and conservation area to the east of Pelaw Main.	Negligible	The entry from Pokolbin Street into the bushland is visible from the surrounding road network. The trail within the bushland and conservation area is visible for the users, however it is not visible from the surrounding area due to the extent of vegetation. Vegetation removal is not proposed.	Negligible	Negligible	The entry into the bushland should be easily recognisable. The design should use measures that will assist in way finding. Vegetation will not be removed. Vegetation removal through the bushland and conservation area further to the east should be minimised to enhance the experience of the user. Materials should also be considered that are appropriate within the bushland and conservation areas.

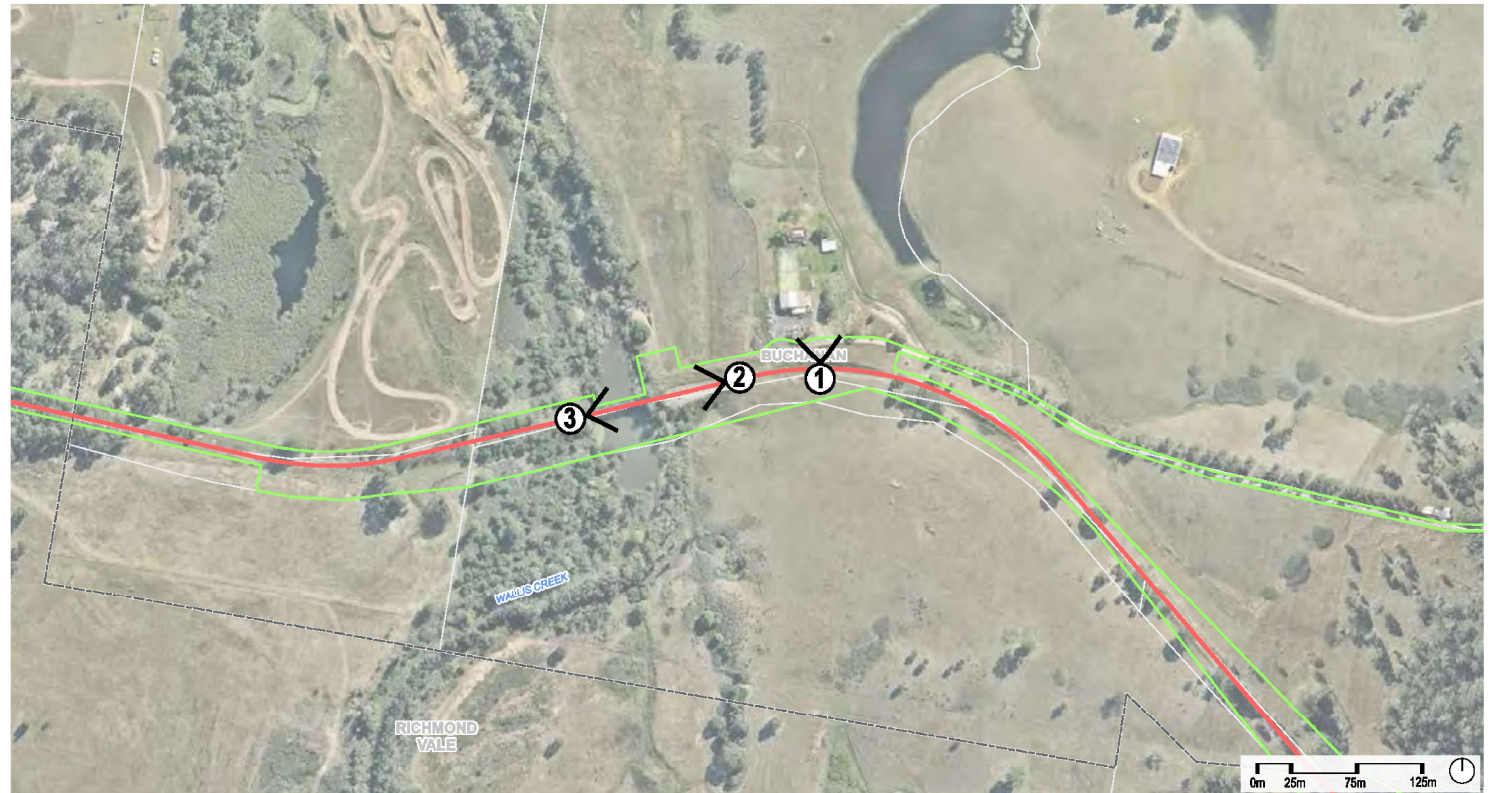
Figure 8 – Zone 2 View point Locations
Source: Base - GHD 2016

The key viewpoints for zone 2 are shown on Figures 8 and 9. Table 4 analyses the visual impact on these view points.

View	Description of setting	Visual sensitivity	Sensitivity due to:	Magnitude of visual effect	Visual Impact	Comments
1	View from the trail to the rural dwelling.	Moderate	The proximity of the trail to the properties and dwelling and the possibility of a moderate to intensive use of the trail.	Moderate	Moderate	It is assumed that removal of vegetation along the trail will be minimised and therefore not impact visually on the users or the adjoining land uses. However, the trail is within close proximity to rural land uses and a dwelling and the use of the trail by the public may reduce the visual amenity.
2	View of the trail on the eastern approach to Wallis Creek.	High	The removal of vegetation along Wallis Creek. The removal of the Wallis Creek timber bridge and provision of a new bridge.	High	High	The removal of vegetation along the creek and the replacement of the Wallis Creek bridge with a new bridge will impact on the visual character in this area in the short term. The existing Wallis Creek bridge could be retained to assist in maintaining the visual interest. Whilst it is acknowledged that the timber bridge is unable to be repaired it would create visual interest and forms part of the heritage of the trail. The design of the new bridge should consider the landscape character and be an appropriate structure that will enhance the area and provide visual interest.

3	View of the trail on the embankment of Wallis Creek.	High	The removal of vegetation along Wallis Creek. The removal of the Wallis Creek timber bridge and provision of a new bridge.	High	High	The removal of vegetation along the creek and the replacement of the Wallis Creek bridge with a new bridge will impact on the visual character in this area in the short term. The existing Wallis Creek bridge could be retained to assist in maintaining the visual interest. Whilst it is acknowledged that the timber bridge is unable to be repaired it would create visual interest and forms part of the heritage of the trail. The design of the new bridge should consider the landscape character and be an appropriate structure that will enhance the area and provide visual interest.

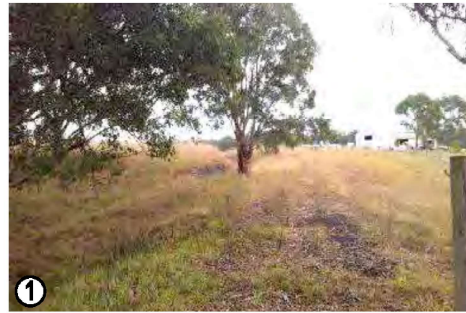
Figure 9 – Key viewpoints

Trail looking towards the Burk property / approach to Wallis Creek
Source: GHD 2016

Eastern approach of Wallis Creek Bridge
Source: GHD 2016

Wallis Creek Bridge from the western embankment
Source: GHD 2016

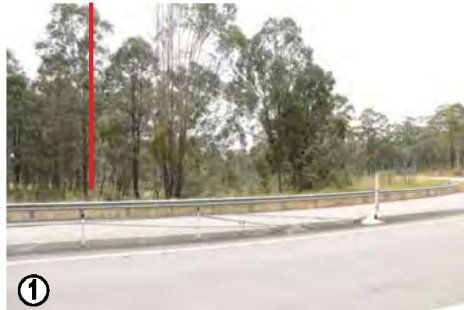
Figure 11 – Zone 3 View point locations

The key viewpoints for zone 3 are shown on Figures 11 and 12. Table 5 analyses the visual impact on these view points. The red line identifies the location of the trail in the image.

View	Description of setting	Visual sensitivity	Sensitivity due to:	Magnitude of visual effect	Visual Impact	Comments
1	View from George Booth Drive towards the trail.	Low	The trail will require the removal of some vegetation.	Low	Low	Removal of vegetation will change the vegetated view driving along George Booth Drive at the crossing of the trail. Vegetation removal should be limited to minimise the impact.
2	View of the trail and proposed carpark to the east.	Low	The trail will require the removal of vegetation, however it is mostly weeds. The reinstatement of the trail will enhance this area.	Low	Low	Removal of weeds will improve the area. This area is not visible from George Booth Drive and is only visible to the users and the owner of the adjoining property. The treatment of the carpark area should be of suitable materials and planting to minimise the impact on the surrounding area.
3	View of the trail to the west from the proposed carpark.	Low	The trail will require the removal of some vegetation.	Low	Low	Removal of vegetation will change the vegetated view along the trail. The trail should incorporate the vegetation where possible.

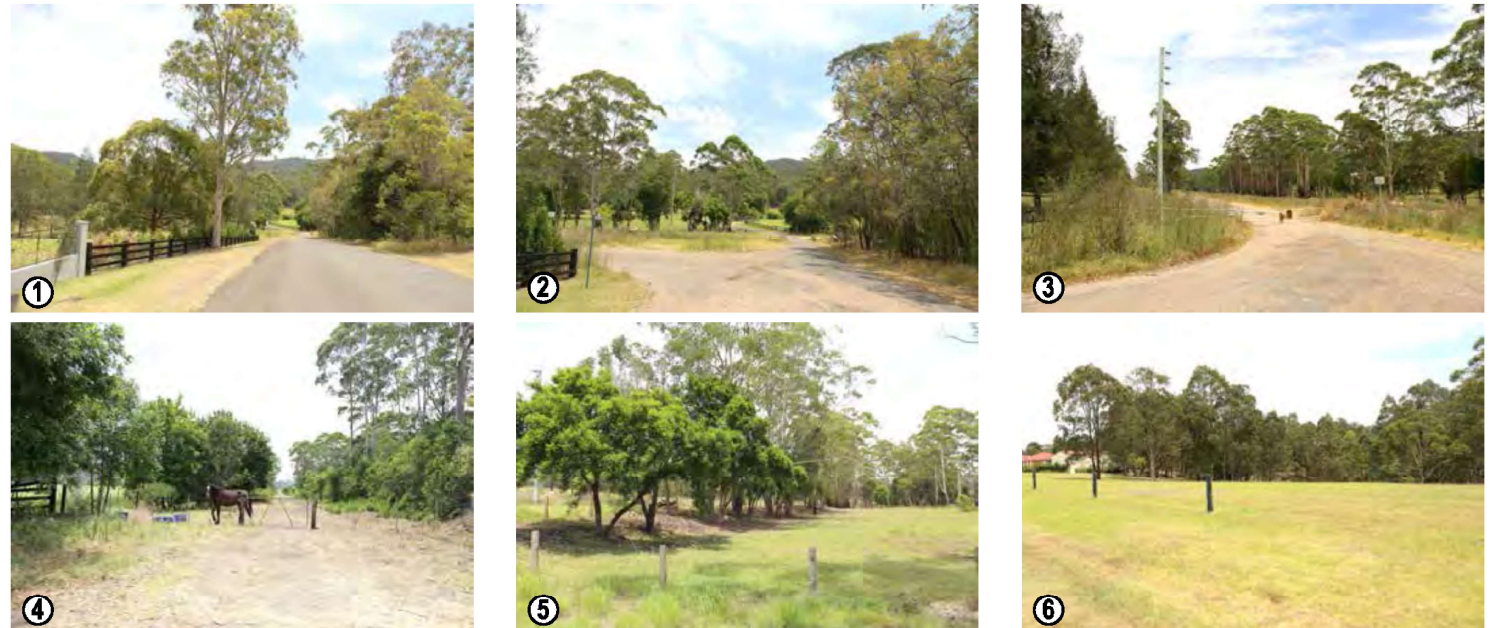
Figure 15 – Key viewpoints

The key viewpoints for zone 4 are shown on Figures 14 and 15. Table 6 analyses the visual impact on these view points.

View	Description of setting	Visual sensitivity	Sensitivity due to:	Magnitude of visual effect	Visual Impact	Comments
1	View from Dog Hole Road towards the trail adjoining rural property.	Negligible	The trail is along an existing path that will not require removal of vegetation.	Negligible	Negligible	The trail that is visible occurs only along the existing formed road and therefore has a negligible impact.
2	View from Dog Hole Road towards the trail.	Negligible	No loss of vegetation and the trail will incorporate removal of weeds.	Negligible	Negligible	Beneficial visual impact by improvements to the trail.
3	View along the trail to the west of Dog Hole Road.	Low	The existing trail is rural in nature with mature vegetation along either side.	Low	Low	The treatment of the trail should consider the rural nature of this area. Further, the mature vegetation either side of the trail visually screens it from the adjoining rural residential land holdings.

4	View along the trail to the east of Jacobs Lane.	Low	The existing trail is rural in nature with mature vegetation along either side.	Low	Low	The treatment of the trail should consider the rural nature of this area. Further, the mature vegetation either side of the trail visually screens it from the adjoining rural residential land holdings.
5	View of the proposed car park north of the trail and south of Blue Gum Creek off Jacobs Lane.	Moderate	Potential loss of vegetation and the formation for a carpark.	Moderate	Moderate	This location is proposed for a carpark. Whilst the vegetation has been modified and there is a cleared area, it is located adjoining Blue Gum Creek. It would be more appropriate to locate the carpark on the southern side of the trail off Dog Hole Road (refer image 2) where the area is more disturbed and does not adjoin the creek. The visual impact of this would be less than the current location. This location could be utilised for other facilities such as a low key picnic area.

6	View from Dog Hole Road to the south west of the trail.	Negligible	Vegetation will not be removed and the trail is not visible from the surrounding properties.	Negligible	Negligible	The mature vegetation either side of the trail and vegetation within properties visually screens the trail from the adjoining rural residential properties.

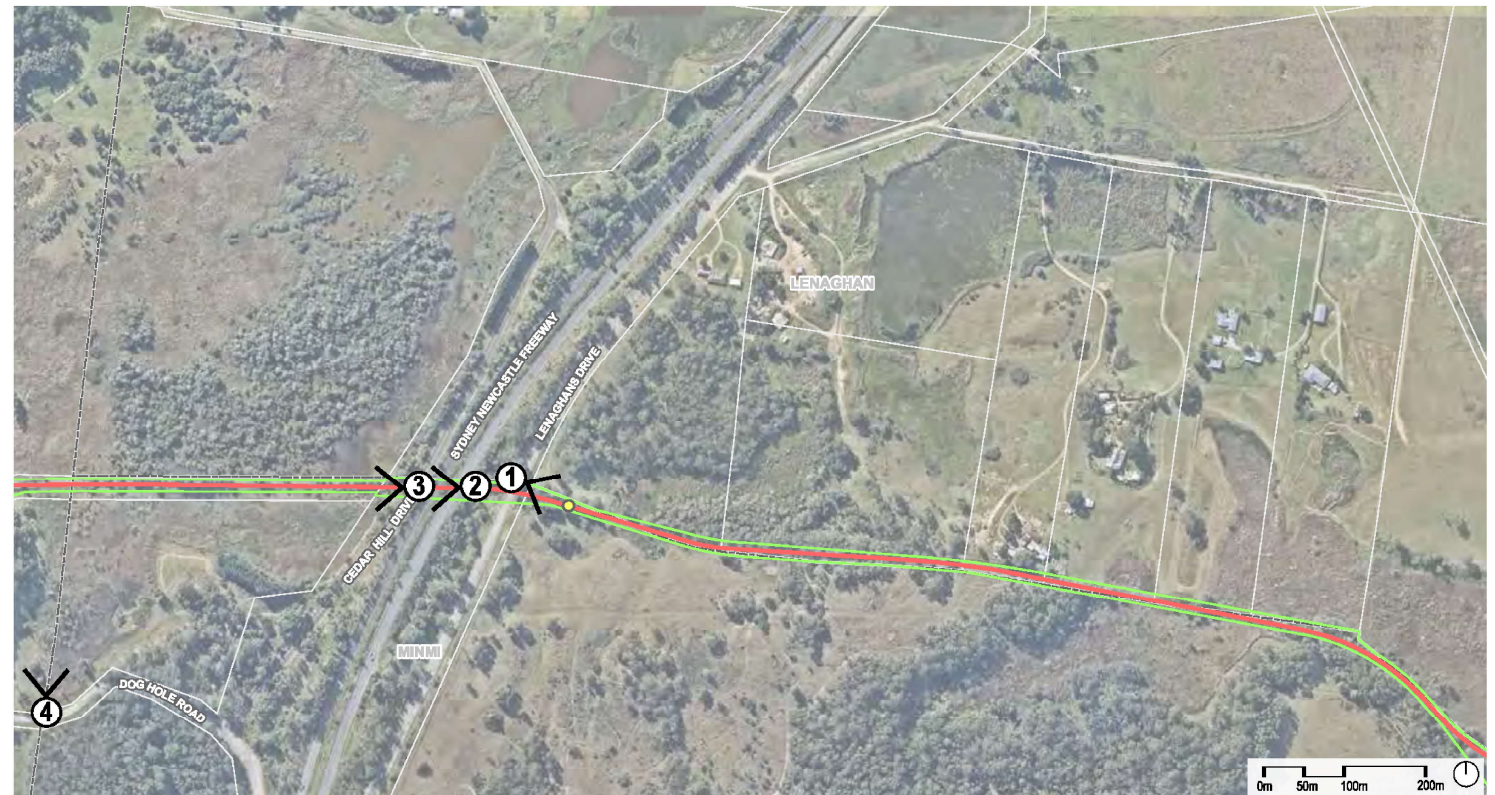
Figure 17 – Zone 5 View point locations
Source: Base - GHD 2018

The key viewpoints for zone 5 are shown on Figures 17 and 18. Table 7 analyses the visual impact on these view points.

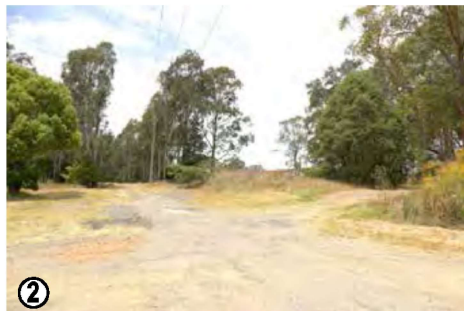
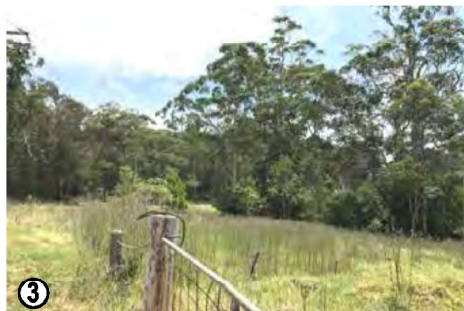
Figure 21 – Key viewpoints

The key viewpoints for zone 6 are shown on Figures 20 and 21. Table 8 analyses the visual impact on these view points.

View	Description of setting	Visual sensitivity	Sensitivity due to:	Magnitude of visual effect	Visual Impact	Comments
1	View of trail north of Minmi.	Low	Loss of vegetation.	Low	Low	The visual impact will be dependent on the extent of removal of vegetation. It is assumed very little vegetation would be removed.
2	View of access area south of the trail.	Negligible	The area has already been modified and cleared.	Negligible	Negligible	Whilst the area may be used during construction, this area should also be considered for the carpark area instead of the location proposed as shown on Image 3.
3	View of proposed carpark area west of the trail.	Moderate	The visual impact will be dependent on the extent of removal of vegetation.	Moderate	Moderate	A more suitable location for the carpark would be the south of the trail as it has already been modified and cleared.

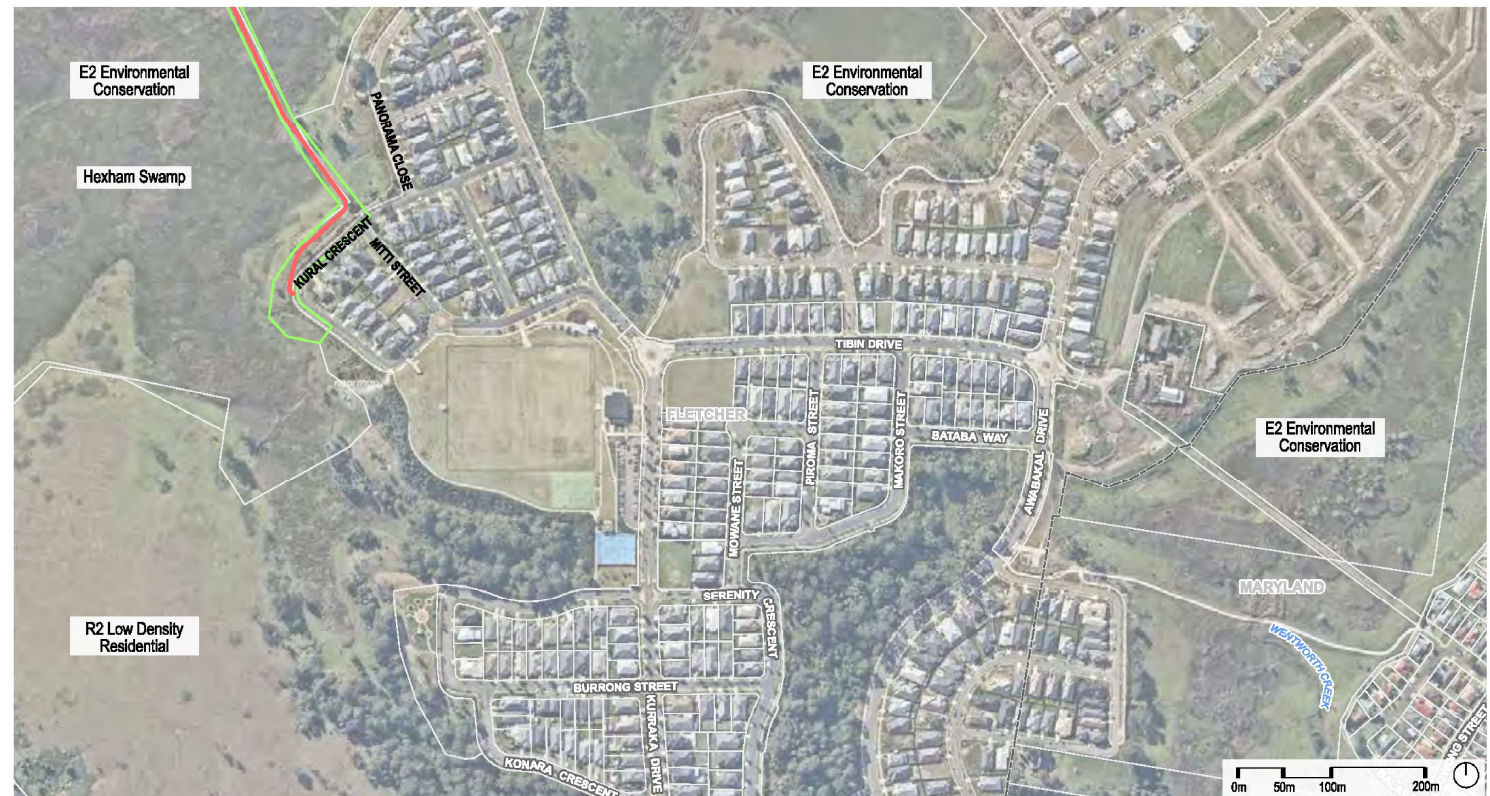
Figure 22 – Zone 7 Landscape character
Source: Base - GHD 2018

Landform	The trail will use the existing Hunter Water Corporation easement that runs through the Hexham Swamp. This land is flat through the Hexham Swamp. Fletcher residential area is elevated above the swamp.
Land use/built environment	Hexham Swamp.
Vegetation	Swamp grasses through the Hexham Swamp. Trees, shrubs and grasses on the periphery of the Fletcher residential area.
Landscape features	Hexham Swamp.
Infrastructure	The road and footpath network in the new residential area of Fletcher. Drainage swales along the road network comprising rocks and grasses.
Major economic components	Fletcher community and sporting facilities.
Spatial quality of zone	The zone is open and visible from the dwellings in Fletcher.

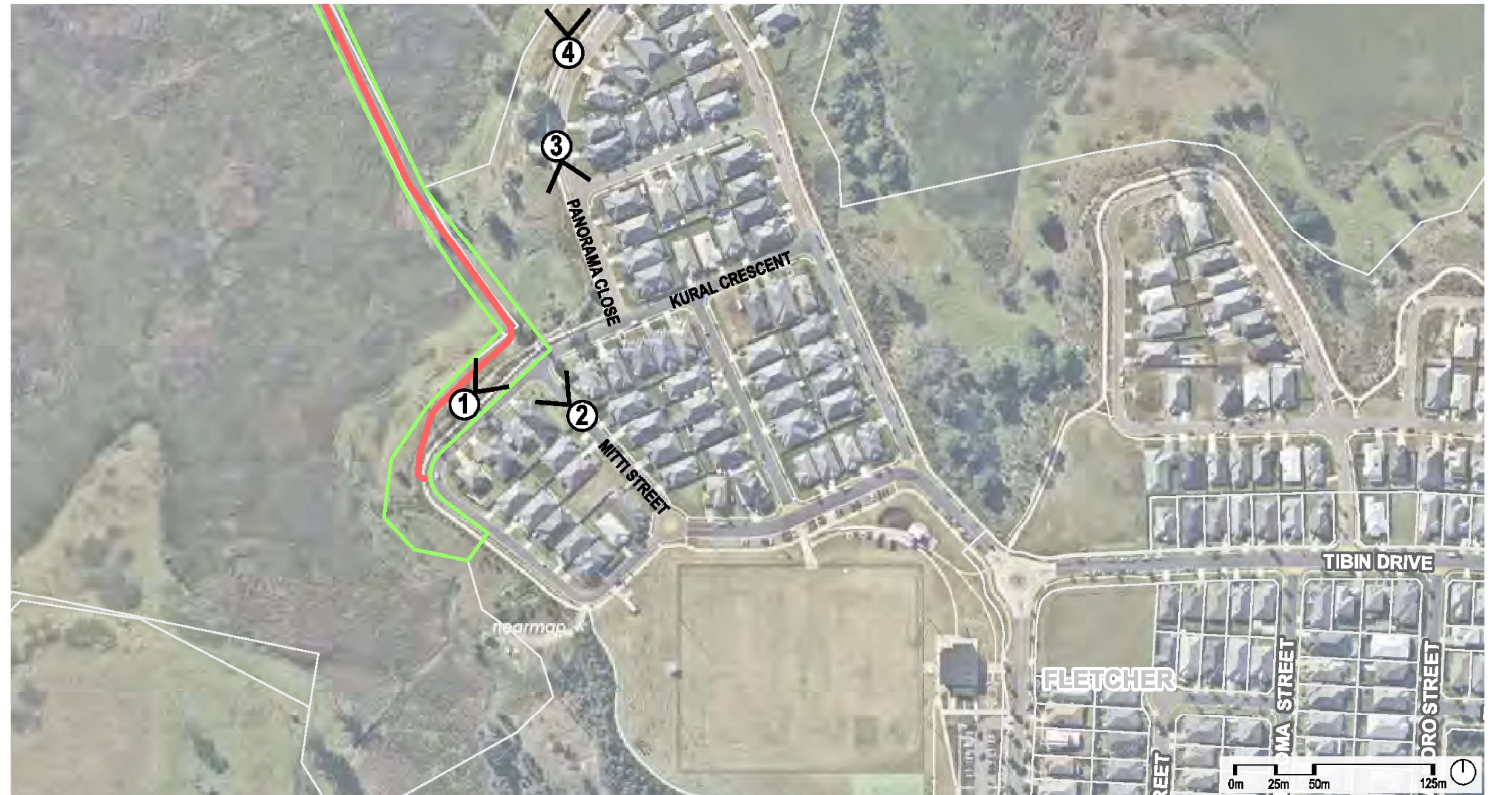
Figure 23 – Zone 7 View point locations
Source: Base - GHD 2018

The key viewpoints for zone 7 are shown on Figures 23 and 24. Table 9 analyses the visual impact on these view points.

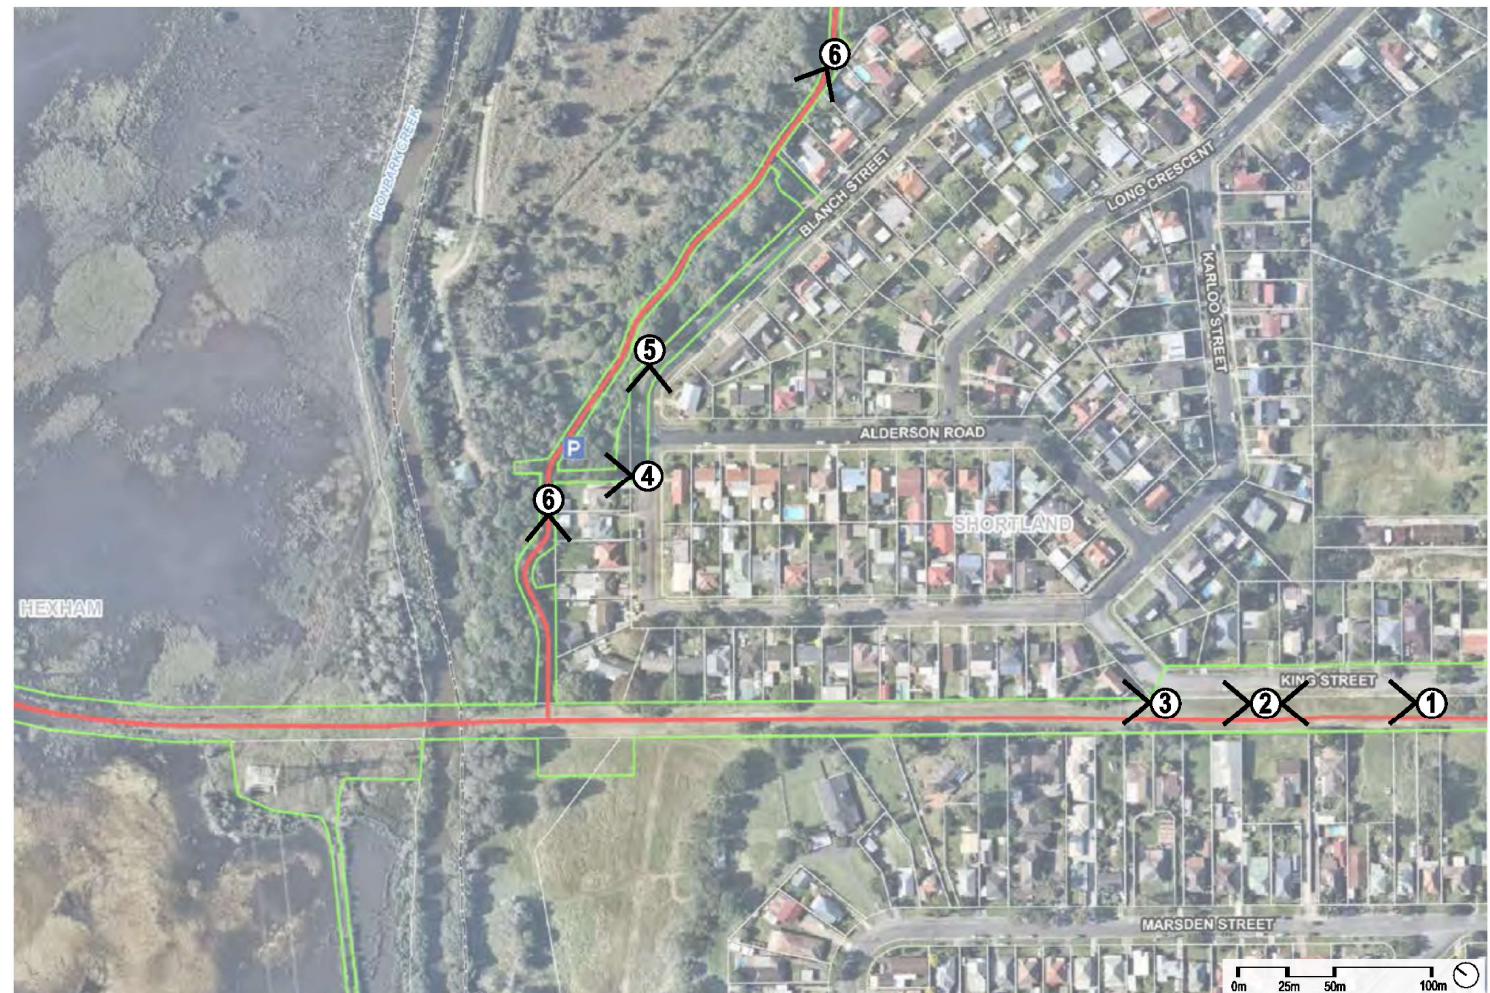
Figure 26 – Zone 8 View point locations
Source: Base - GHD 2016

The key viewpoints for zone 8 are shown on Figures 26 and 27. Table 10 analyses the visual impact on these view points.

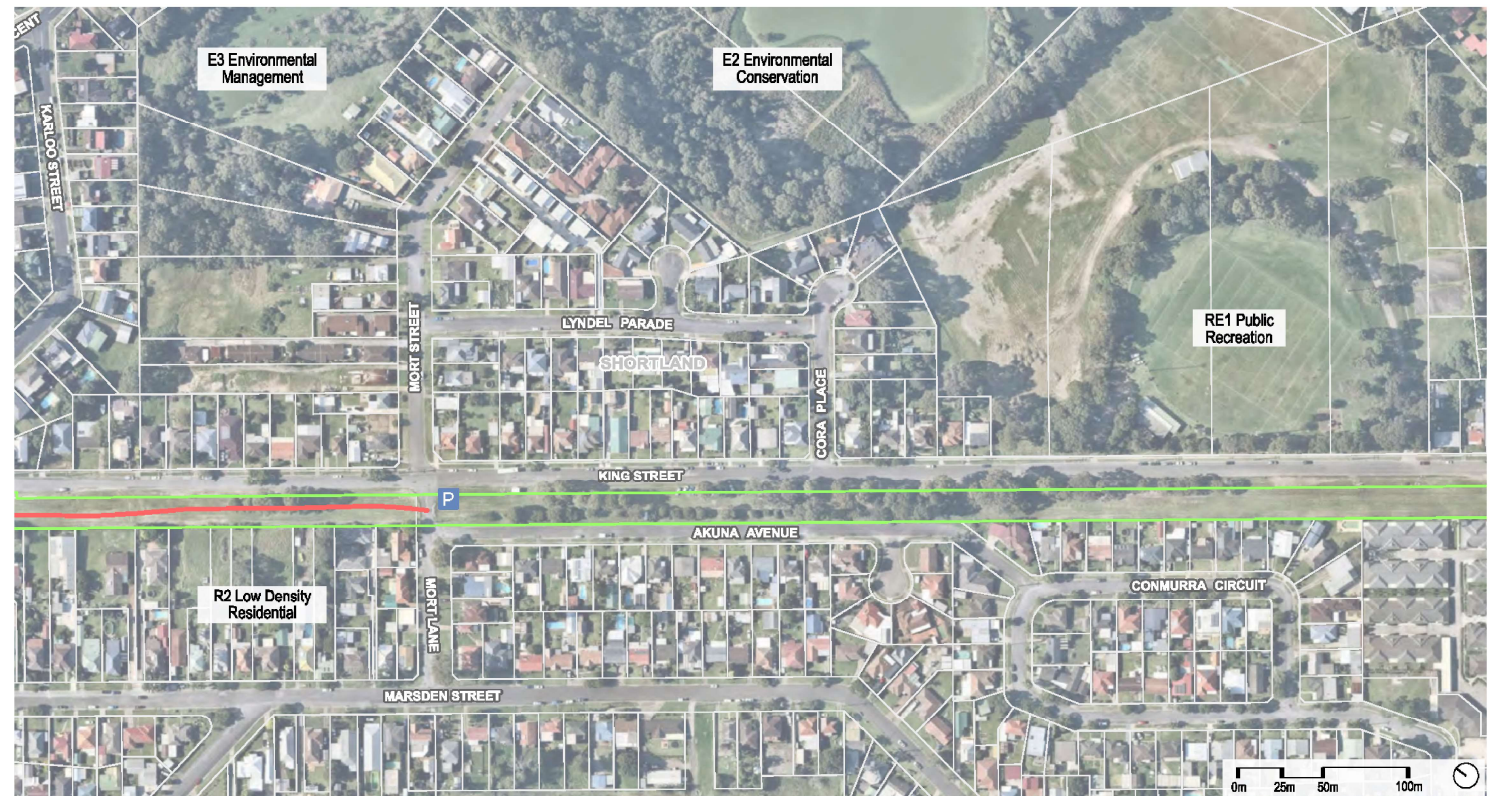
Figure 28 – Zone 9 Landscape character
Source: Base - GHD 2018

Landform	The trail is generally flat with a slight slope down to the road network.
Land use/built environment	Residential dwellings adjoining the trail.
Vegetation	The trail corridor consists of a turf and planted mature trees.
Landscape features	A wide open space area.
Infrastructure	Urban street network with and without kerb and guttering and overhead power lines.
Major economic components	The suburb of Shortland.
Spatial quality of zone	The trail corridor is generally open with minimal mature vegetation.

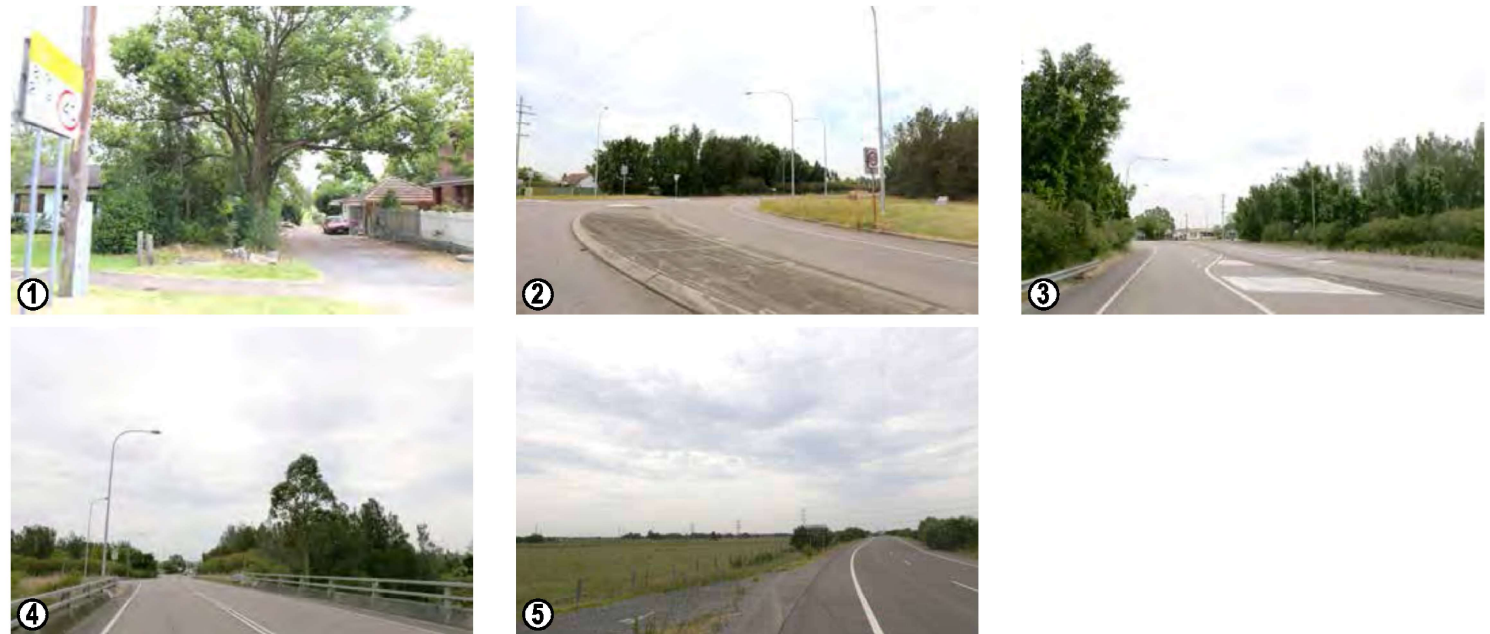
Figure 33 – Key viewpoints

The key viewpoints for zone 10 are shown on Figures 32 and 33. Table 12 analyses the visual impact on these view points.

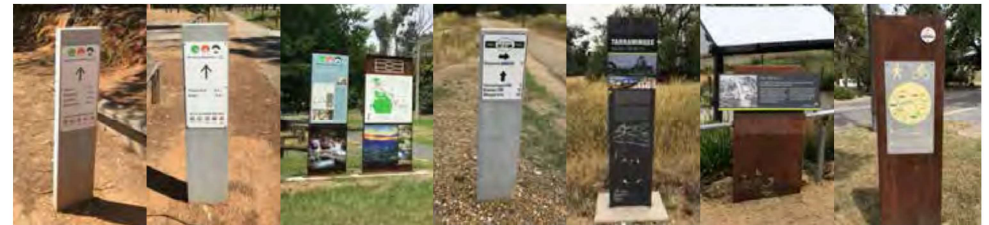
Signage to be themed and assist in wayfinding and should be educational for users - examples from Victoria
