# CESSNOCK LGA SKATE PARKS AUDIT REPORT

MAY 2020

CESSNOCK CITY COUNCIL

DOCUMENT: CESSNOCK LGA SKATE PARKS AUDIT REPORT

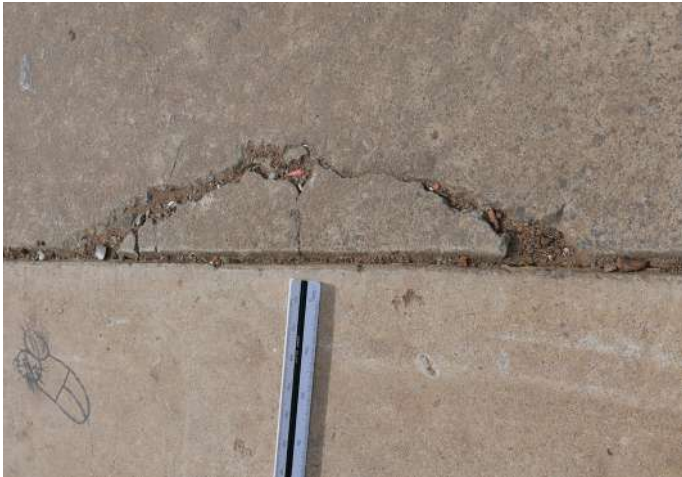
## CONDITION ASSESSMENT - MAJOR CRACKING

### MAJOR CRACKING:

There are some incidence of major cracking in a number of locations across the facility. Major cracks present a hazard on the skate area where the smaller wheels of scooters and skateboards can become lodged in the cracks while the user is travelling at speed, consequently throwing the rider off their vehicle. Unexpectedly being thrown while travelling at speed has the potential to result in serious harm to the user.

| GRETA SKATE FACILITY | | | | |
|---|---|---|---|---|
| MAJOR CRACKING | HAZARD DETERIORATION AGE | HIGH | CHASE OUT CRACK, CLEAN RECESS, FILL WITH MULTI-PURPOSE EPOXY ADHESIVE REPAIR PASTE, AND SAND BACK SMOOTH TO EXISTING SURFACE LEVELS. | 6 MONTHLY |

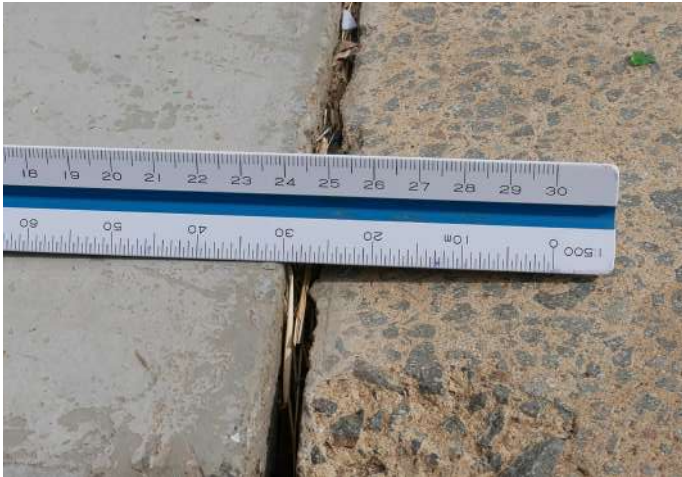
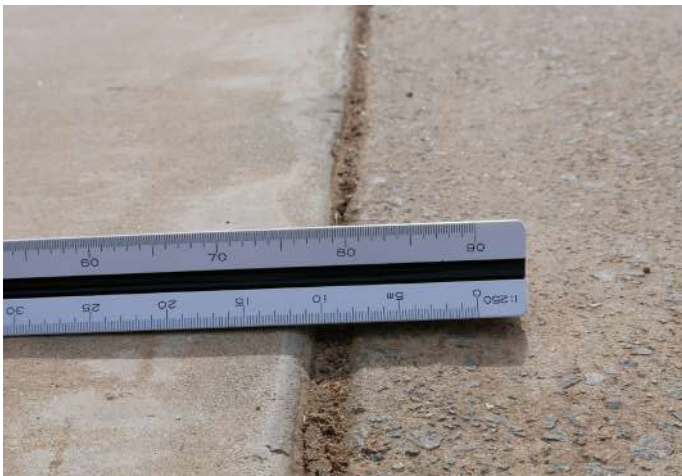
## CONDITION ASSESSMENT - DIFFERENTIAL SETTLEMENT

### DIFFERENTIAL SETTLEMENT:

Differential settlement occurs where a slab has shifted either horizontally or vertically, independent of the adjacent slabs. This results in an edge at the abutment of the two slabs, and presents an opportunity for scooter or skateboard wheels to catch on the edge. Differential settlement in this case has occurred along the connection between the original slab and the new slab, as well as at the base of the features in the southern end of the facility. These locations are where users are travelling at speed, and as such the potential for harm to users is high.

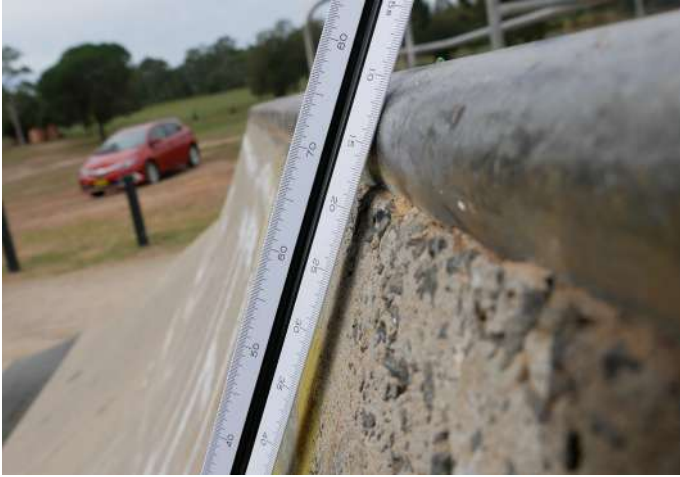
## CONDITION ASSESSMENT - COPING TOLERANCE

### **COPING TOLERANCE:**

The coping offsets around the facility are not in line with modern practices. Typically, coping should sit 10mm above ramp platforms, and sit proud 8mm off ramp transition faces. These standard offsets dimensions are set to encourage coping tricks, and to allow smooth use of the transition ramps. Across most of the facility, the coping sits close to flush with the platform level, while transition offsets vary from 3mm to approximately 5mm. This inconsistency across the facility doesn't promote user confidence in the terrain of the features.

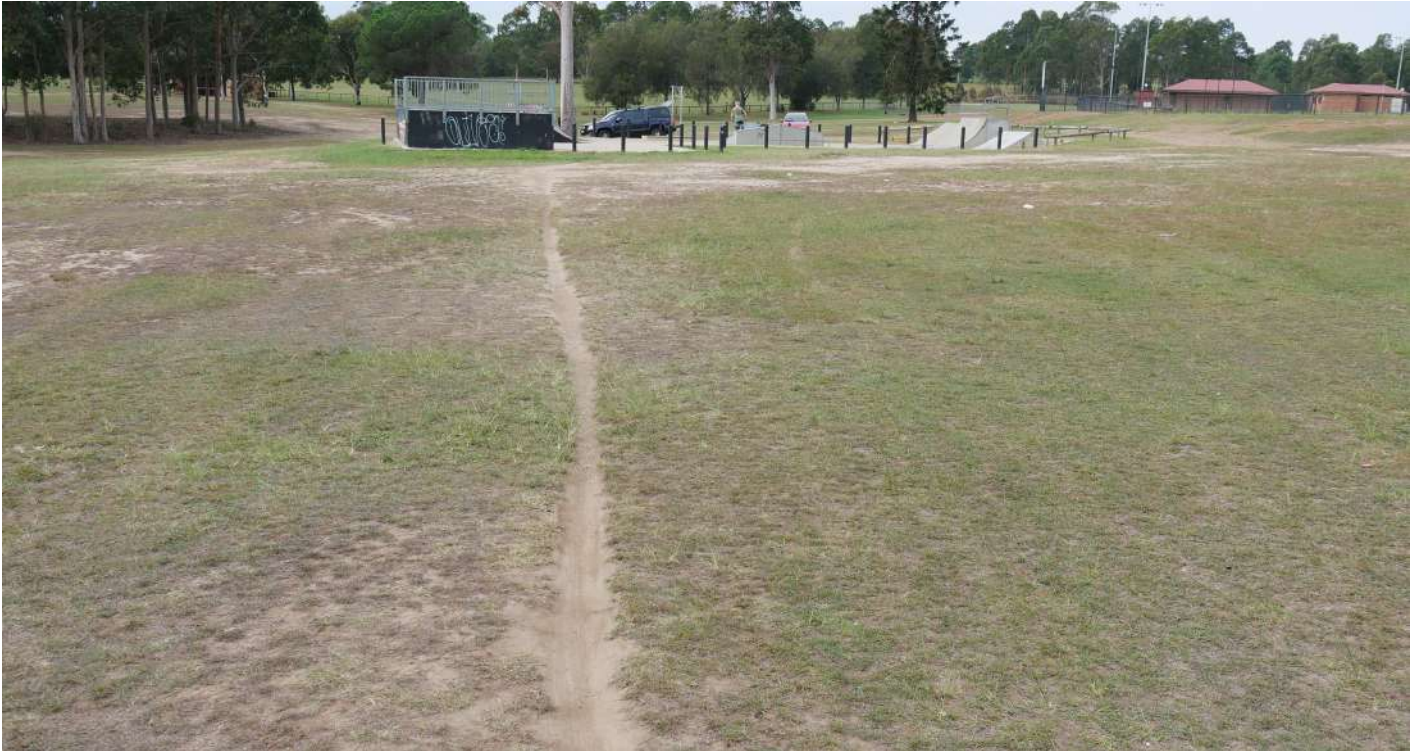
## NON EXISTENT CONNECTIVITY / DESIRE LINES

The facility is located away from the road and has no connecting pathways, forcing users to walk a considerable distance across a field to access the park. Connectivity to existing pedestrian paths further encourages users to visit the facility, and prevents dirt being tracked across the concrete slab.

## RISK RATING: LOW

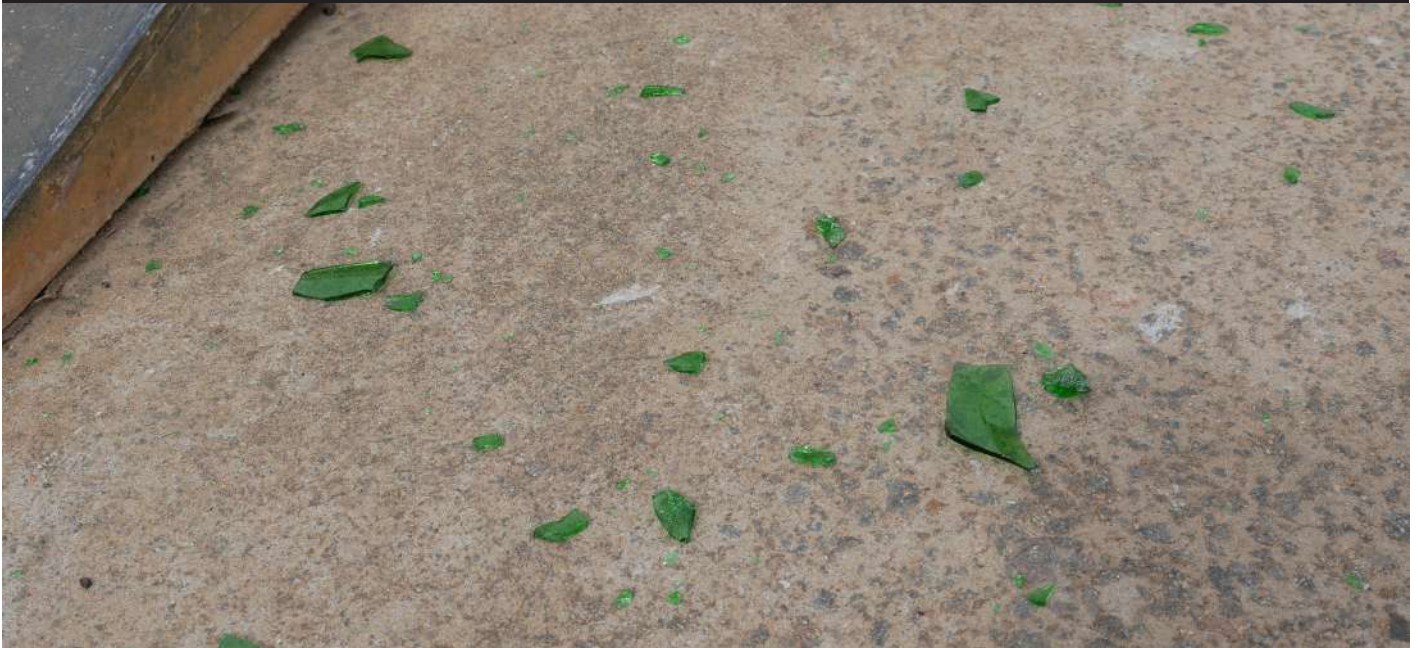
## DEBRIS AND RUBBISH BUILD UP

There are several instances of rubbish and debris strewn across the skate surface. Items on the skate surface can jam wheels of skateboards and scooters, throwing the rider off their vehicle. Further, rubbish across the facility then encourages users to dispose of their rubbish in a similar fashion. It is important to regularly maintain the facility and ensure all surfaces are kept free of debris and dirt.

## RISK RATING: HIGH

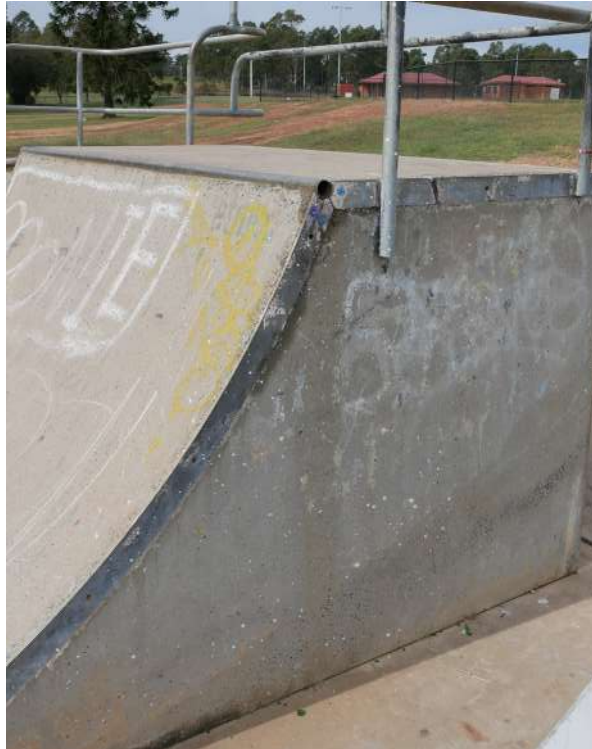
## FALL HEIGHT ISSUE ON QUARTER PIPE

A section of the ramp platform sits greater than 900mm above the base slab. If a user was to fall in this location they would be prone to sustaining potentially serious injuries. The fall height issue should be rectified immediately.

**RISK RATING: HIGH**

**FALL HEIGHT HAZARD: \$10,000 - \$15,000**

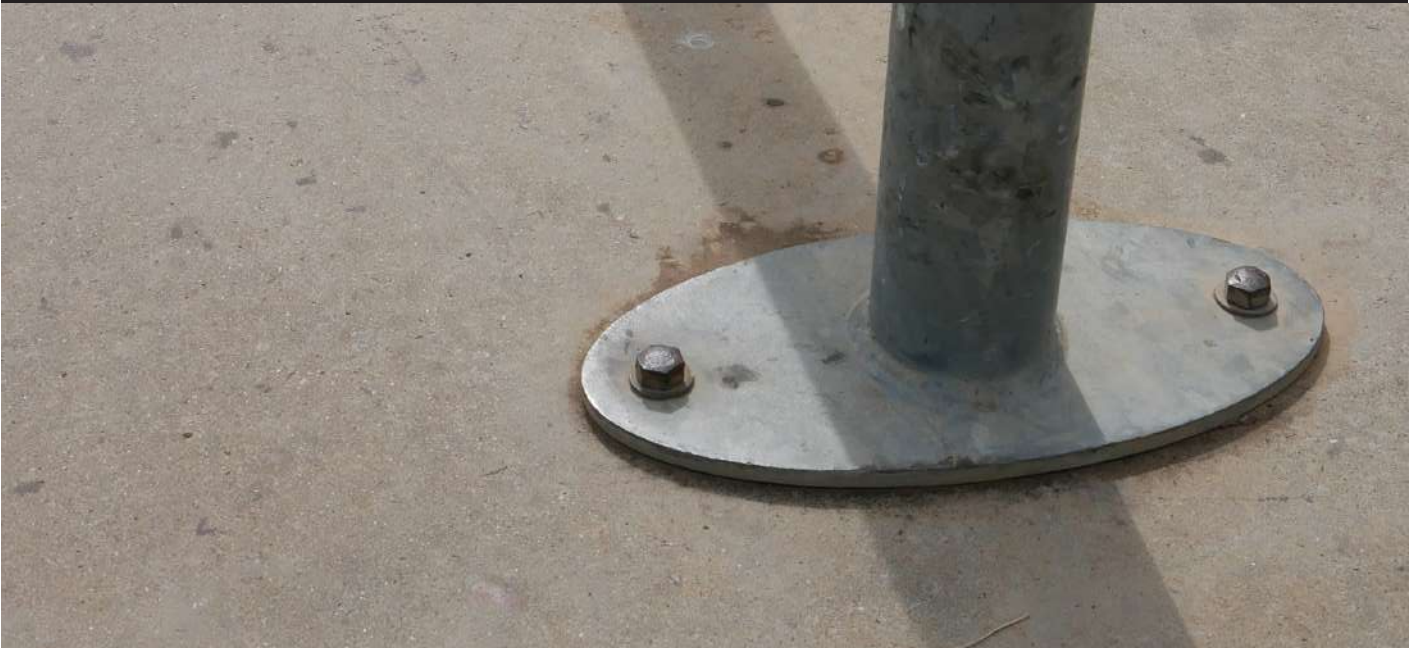
## FLAT RAIL BASE PLATES

The base plates for the flat rail are surface mounted, and as such are in the path of skateboard and scooter wheels. This affects functionality of the rail as the base plates alter the approach of the rail for users, while also acting as potential wheel stops.

**RISK RATING: LOW**

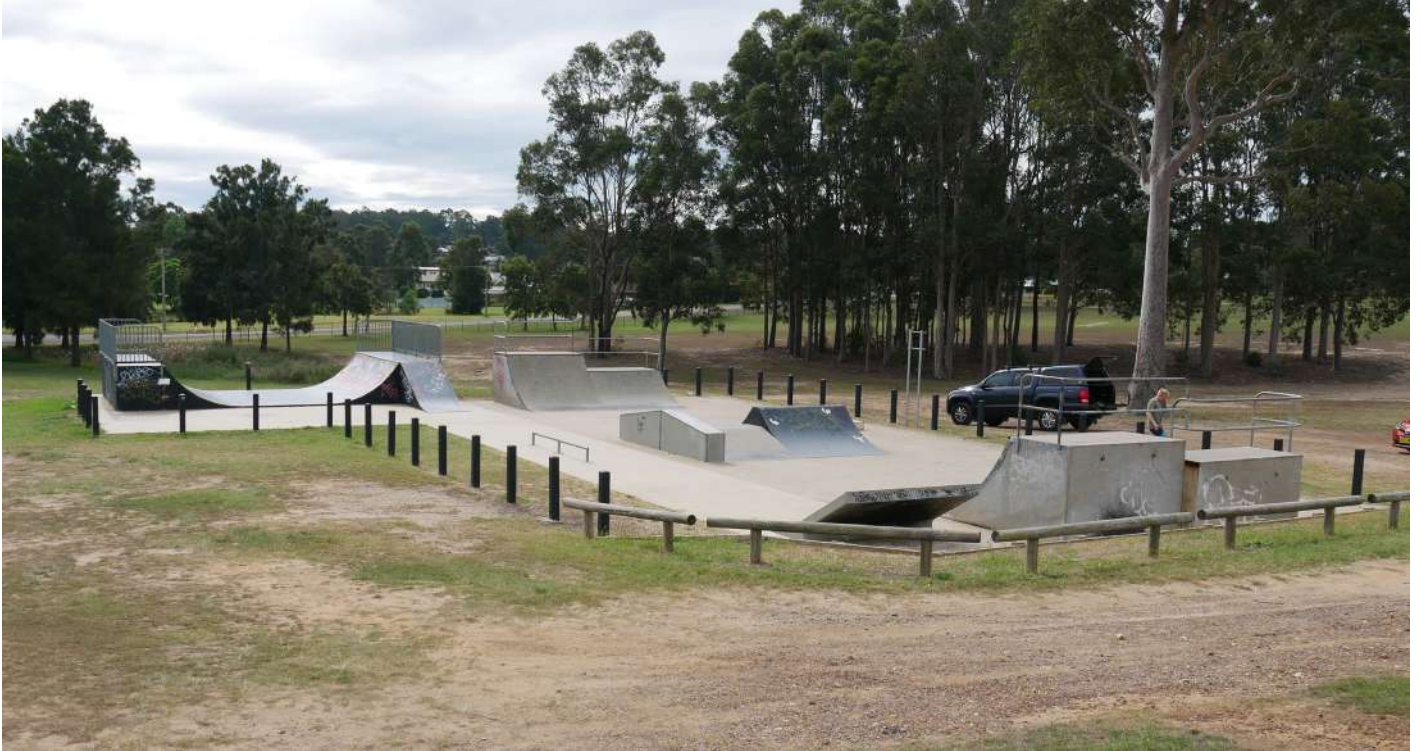
## NON EXISTENT AMENITIES

The facility is located centrally in a large park, and there is no provision of general amenities such as rubbish bins, drinking fountains, refuge seating, or rain / shade shelter.

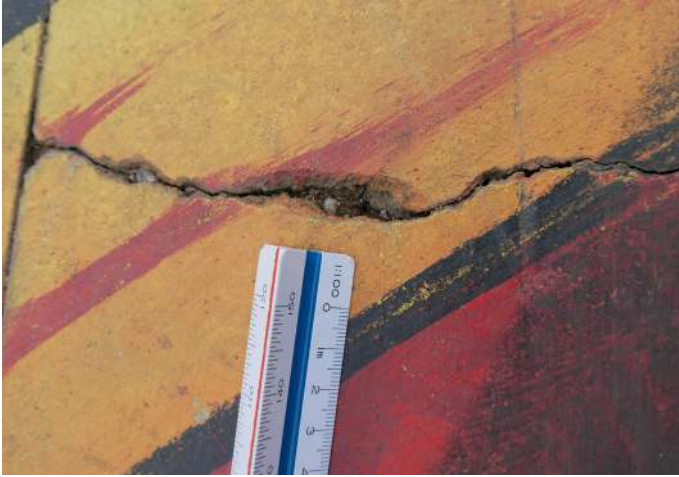
## CONDITION ASSESSMENT - MAJOR CRACKING

### MAJOR CRACKING:

There are some incidence of major cracking across the facility. Major cracks present a hazard on the skate area where the smaller wheels of scooters and skateboards can become lodged in the cracks while the user is travelling at speed, consequently throwing the rider off their vehicle. Unexpectedly being thrown while travelling at speed has the potential to result in serious harm to the user.

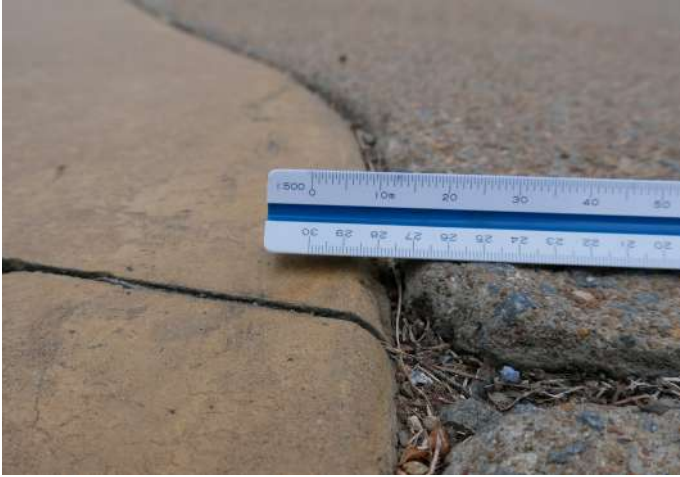
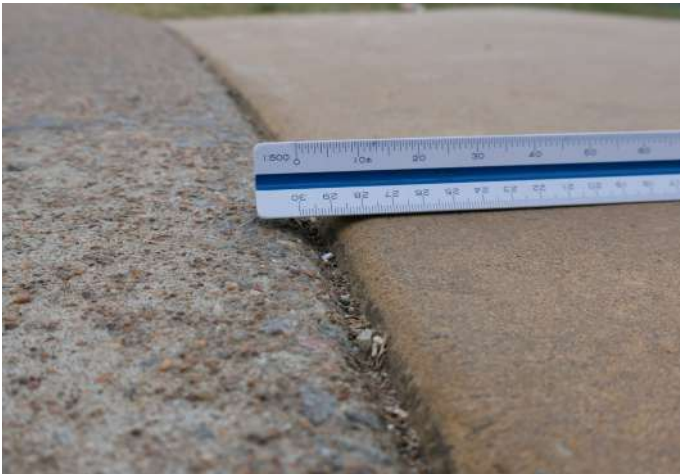
## CONDITION ASSESSMENT - DIFFERENTIAL SETTLEMENT

### DIFFERENTIAL SETTLEMENT:

Differential settlement occurs where a slab has shifted either horizontally or vertically, independent of the adjacent slabs. This results in an edge at the abutment of the two slabs, and presents an opportunity for scooter or skateboard wheels to catch on the edge. Differential settlement in this case has occurred along the connection between the original slab and the new slab, as well as at the base of the features in the southern end of the facility. These locations are where users are travelling at speed, and as such the potential for harm to users is high.

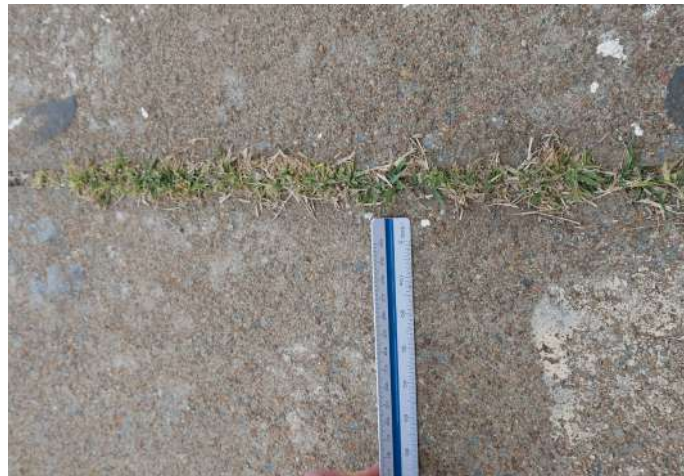
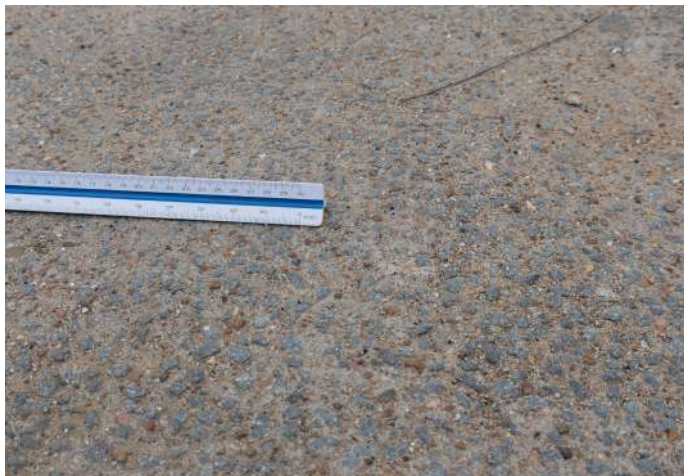
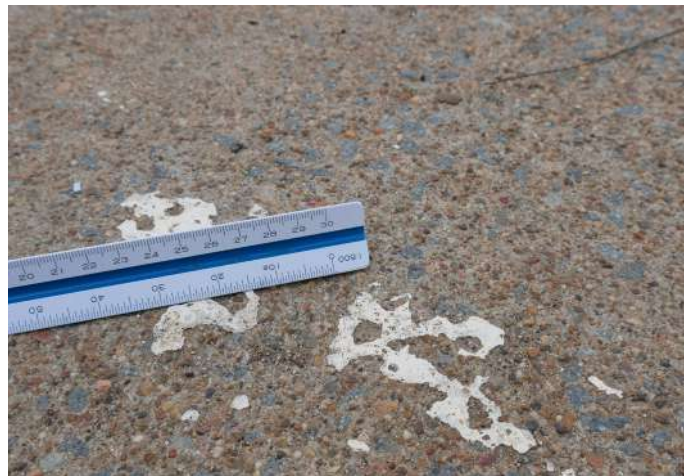
## CONDITION ASSESSMENT - ROUGH SKATE SURFACE AREA

### ROUGH SKATE SURFACE AREA:

In a number of locations, the snake run slab has become weathered and worn, exposing the aggregate in the concrete. Furthermore, there are instances of large clumps of concrete across the surface of the snake run. It is imperative that skate surfaces are smooth, as rough areas result in a bumpy and jarring sensation when ridden over, while also presenting an abrasive surface that can cause harm when a user comes into contact. Rough surfaces also affect the speed that a rider is able to travel across the surface of the concrete. This is a high priority item and should be addressed immediately

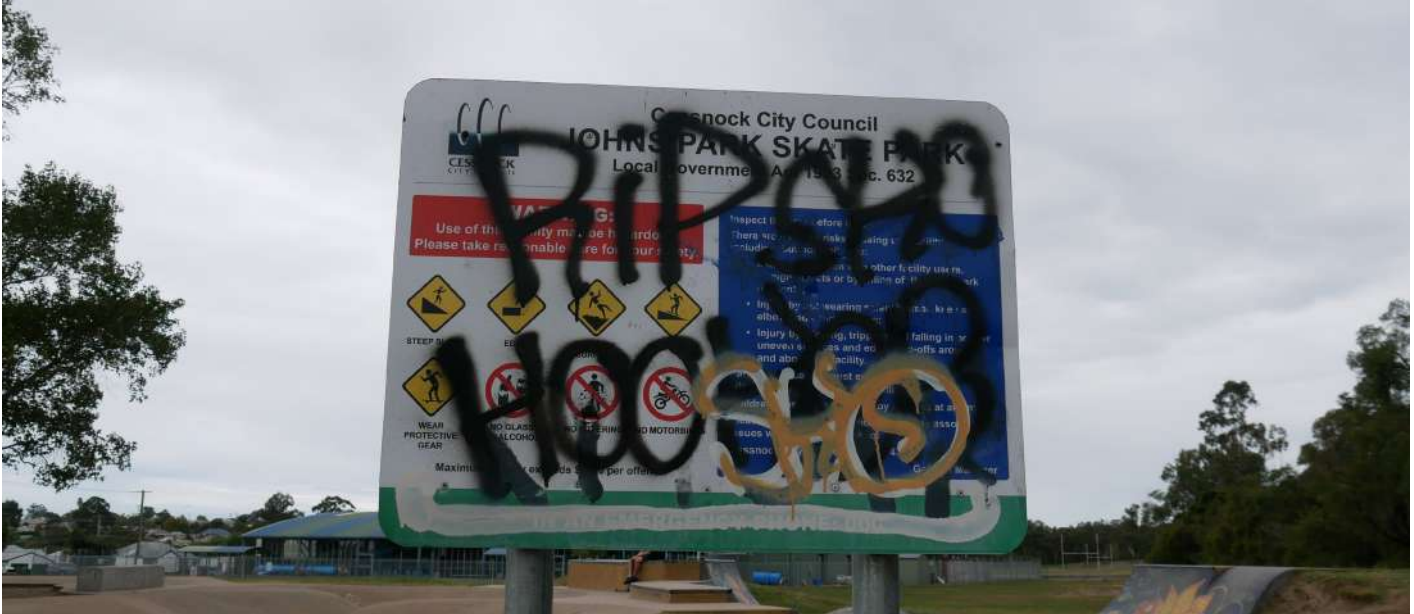
### VANDALISED SAFETY SIGNAGE

The panel for the safety signage is currently heavily vandalised. Safety signs contain essential information such as emergency numbers, locations of emergency services, and the address of the facility. It is critical to have this information readily available in the case of an emergency. This should be rectified immediately.

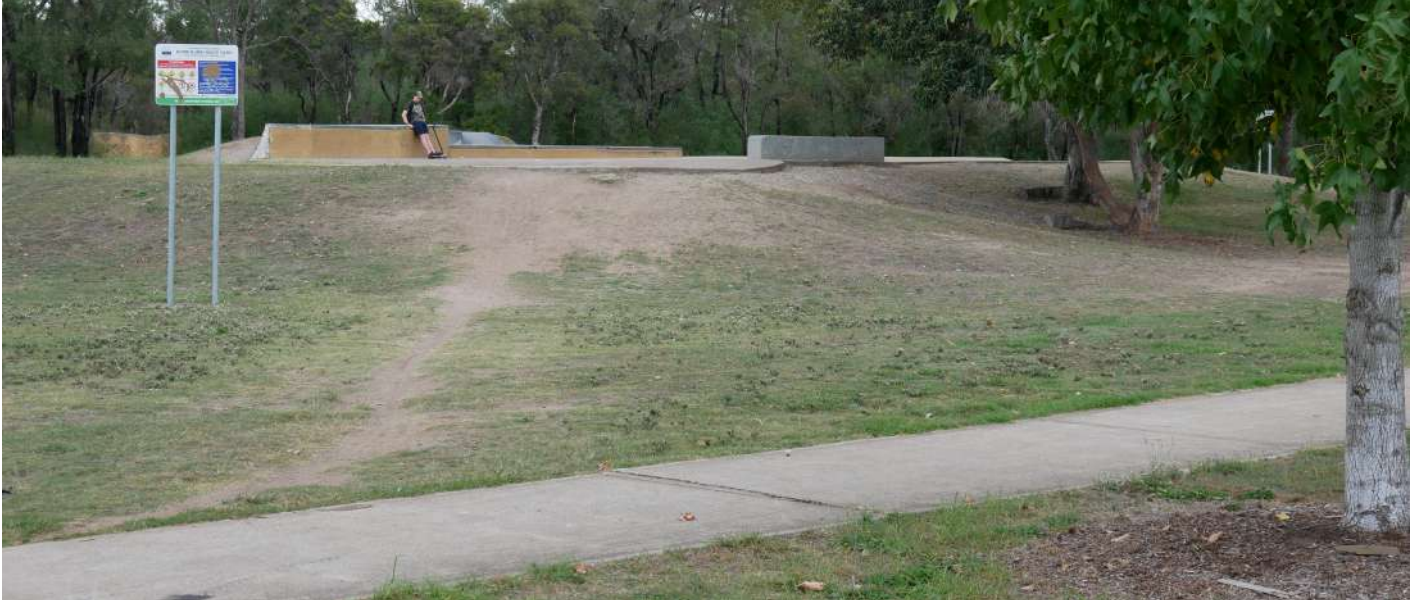
## LIMITED CONNECTIVITY / DESIRE LINES

The facility is located away from the road and has just one connecting pathway, linking the southern side of the facility to Northcote Street. Users approaching from the Northern side are deviating from the concrete pathway and walking up the grass bank to access the facility. This encourages dirt and debris to become strewn across the skate surface.

## RISK RATING: LOW

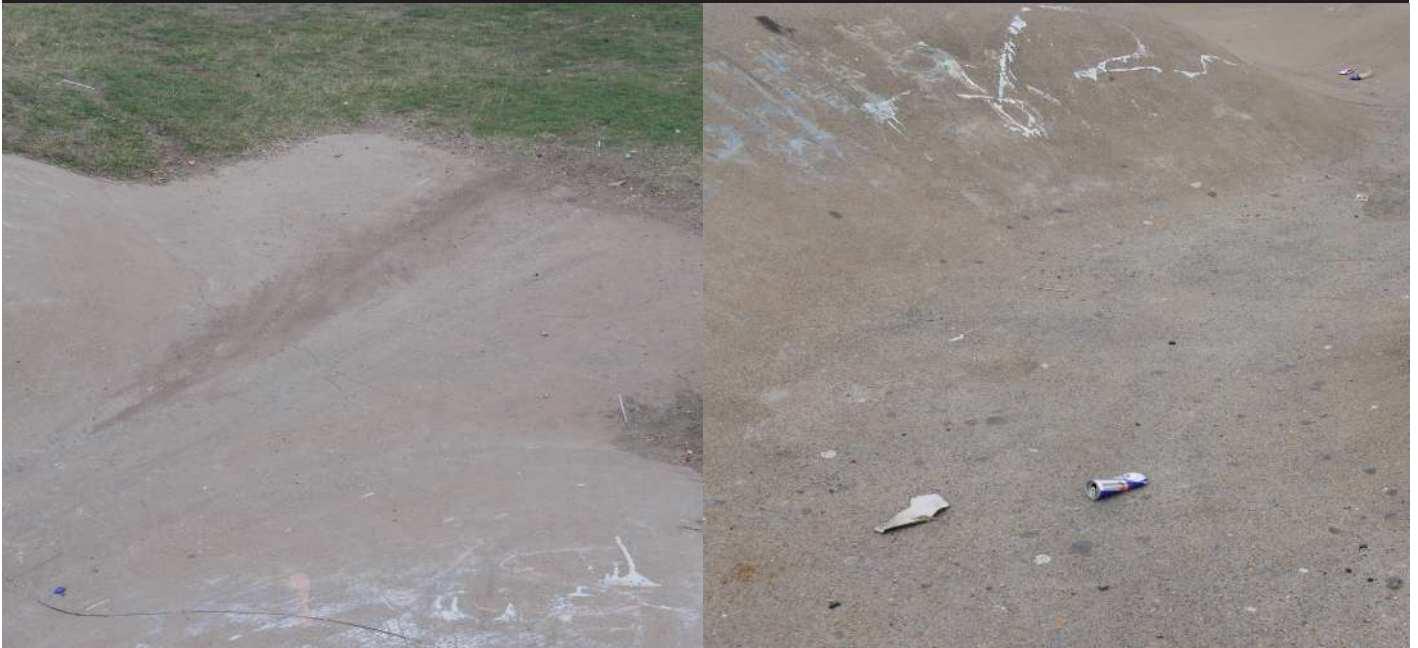
## DIRT AND DEBRIS ON SKATE SURFACE

There are several instances of rubbish and debris strewn across the skate surface. Items on the skate surface can jam wheels of skateboards and scooters, throwing the rider off their vehicle. Further, rubbish across the facility then encourages users to dispose of their rubbish in a similar fashion. It is important to regularly maintain the facility and ensure all surfaces are kept free of debris and dirt.

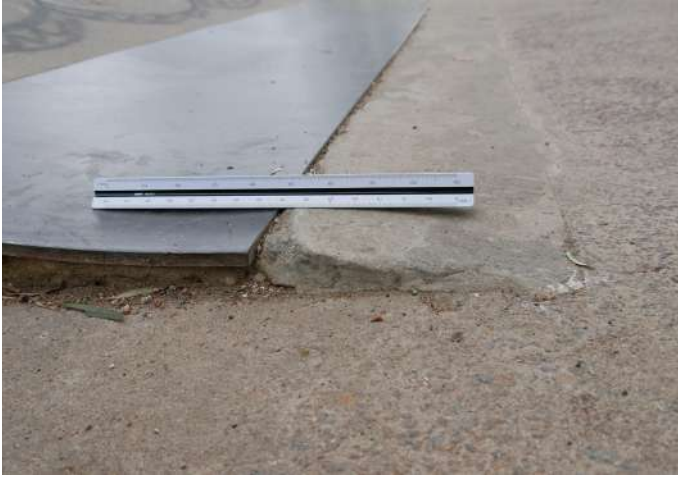
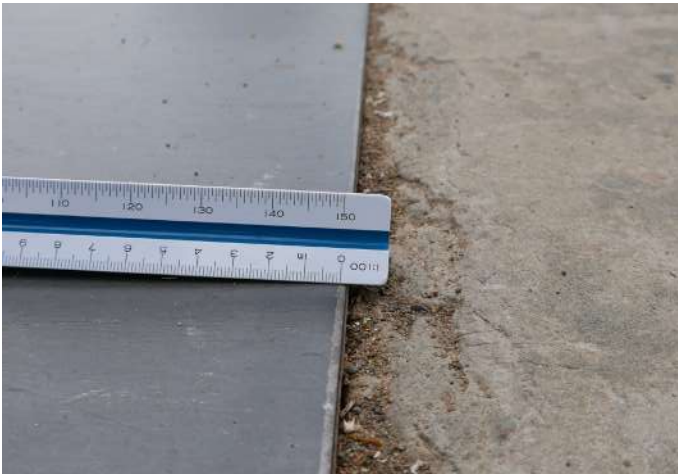
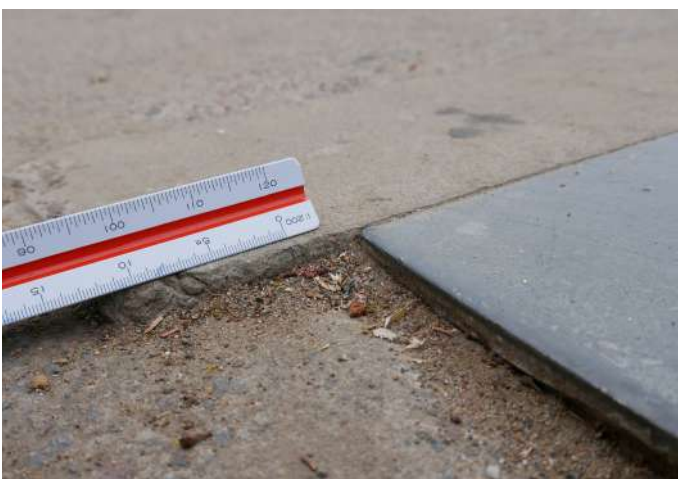
## CONDITION ASSESSMENT - CONCRETE TO SKATE STEEL JOIN

### CONCRETE TO SKATE STEEL JOIN:

The construction method of a number of the features across the facility has seen a combination of both metal and steel used. Due in part to both the age of the facility as well as quality of construction, there are a number of metal edges and gaps across the facility, largely located in or around faces of transition. Transitions are areas where users are travelling at high speeds, and the edges and gaps in these areas present opportunities for smaller skateboard and scooter wheels to become lodged, subsequently throwing riders from their vehicles.

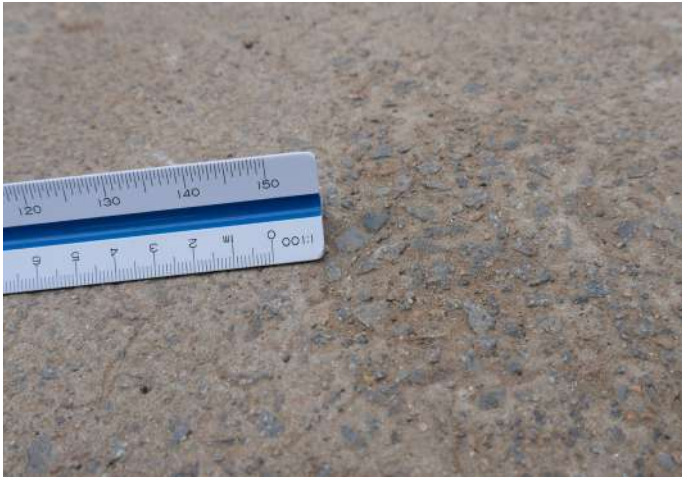
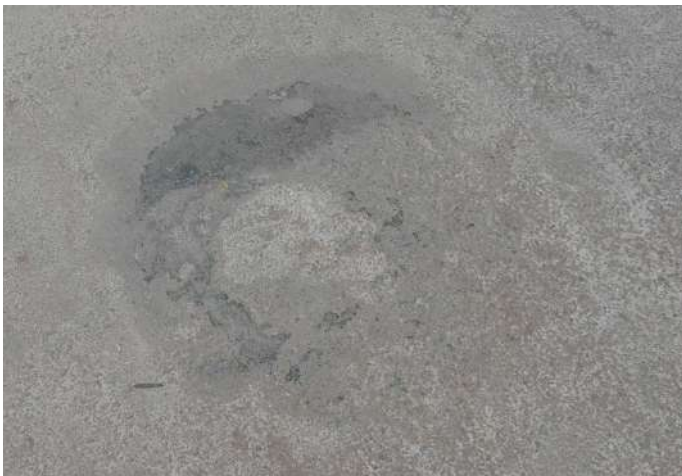
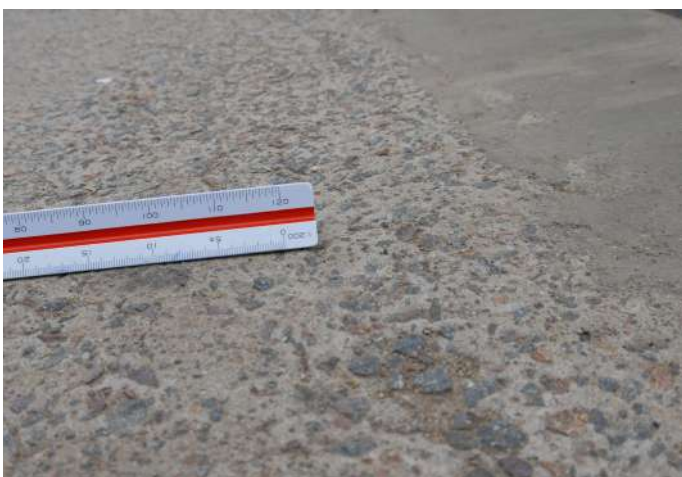
## CONDITION ASSESSMENT - ROUGH SKATE SURFACE AREA

### ROUGH SKATE SURFACE AREA:

In a number of locations, the skate slab has become weathered and worn, exposing the aggregate in the concrete. Furthermore, there are locations where repairs and patches to the slab have been undertaken, which are in turn degrading. It is imperative that skate surfaces are smooth, as rough areas result in a bumpy and jarring sensation when ridden over, while also presenting an abrasive surface that can cause harm when a user comes into contact. This is a high priority item and should be addressed immediately

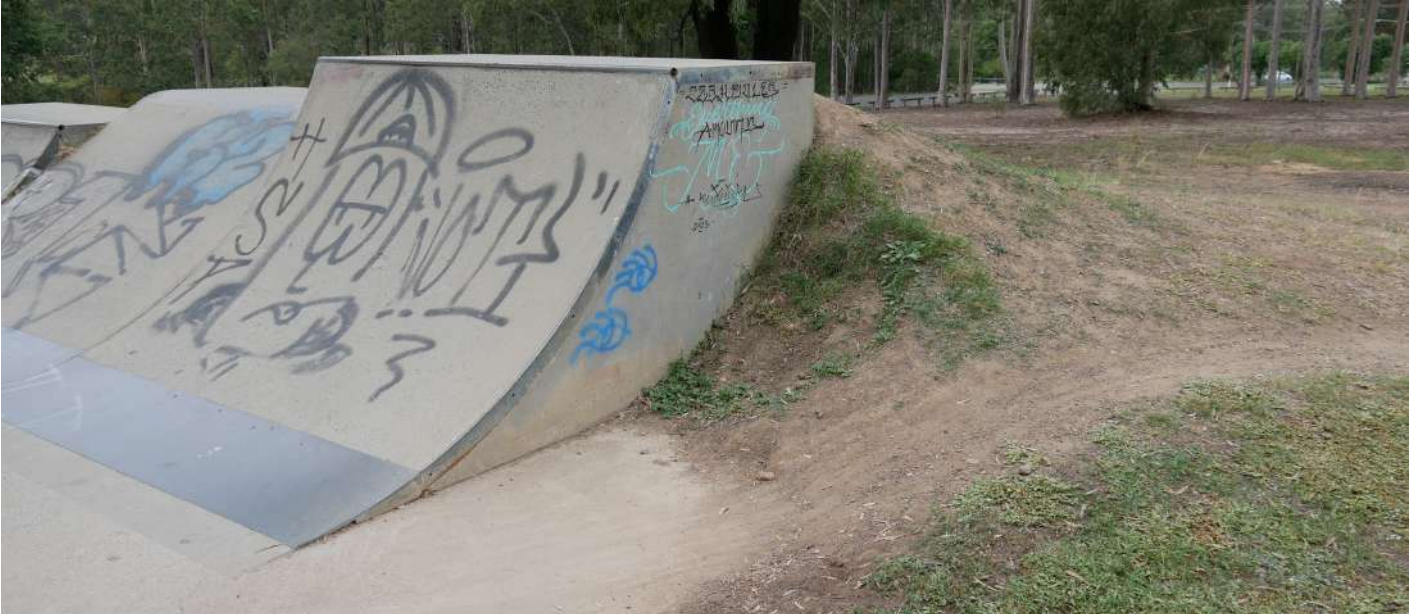
## FALL HEIGHT ISSUE

A section of the ramp platform sits greater than 900mm above the base slab. If a user was to fall in this location they would be prone to sustaining potentially serious injuries. The fall height issue should be rectified immediately.

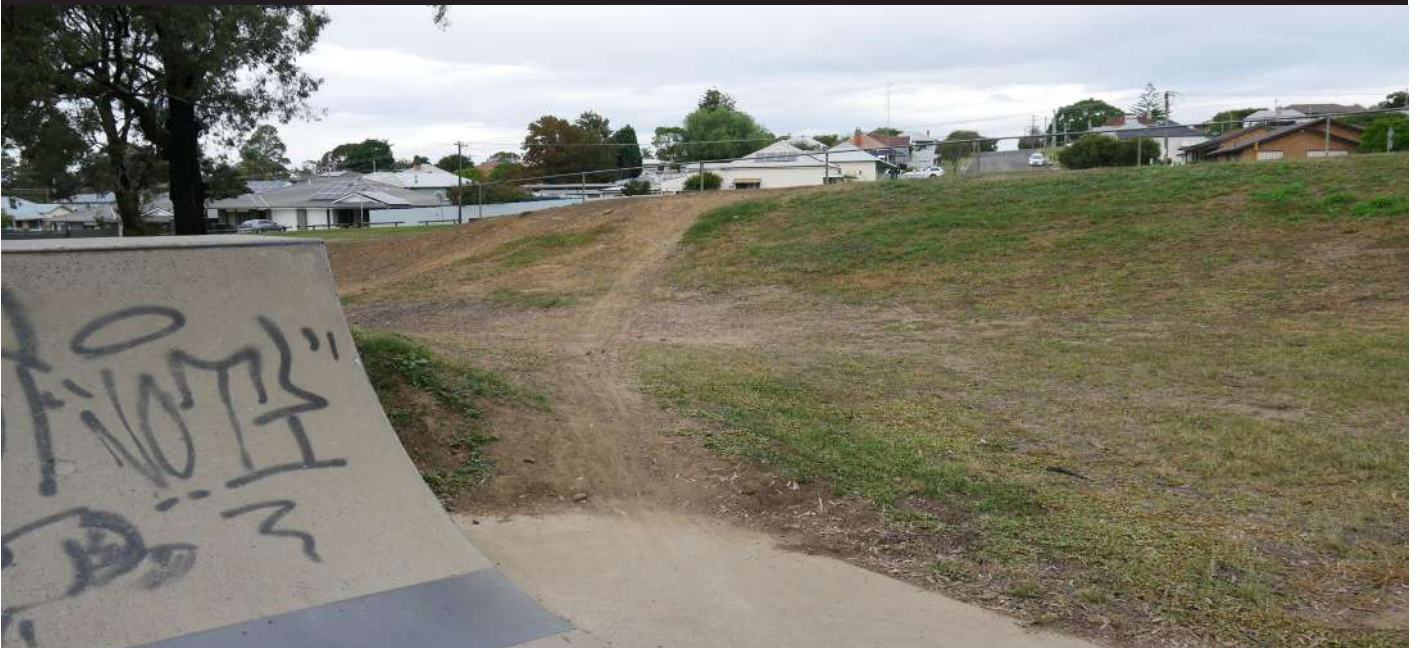
## NON EXISTENT CONNECTIVITY / DESIRE LINES

The facility is located away from the road and has no connecting pathways, forcing users to walk a considerable distance across a field to access the park. Connectivity to existing pedestrian paths further encourages users to visit the facility, and prevents dirt being tracked across the concrete slab.

## RISK RATING: LOW

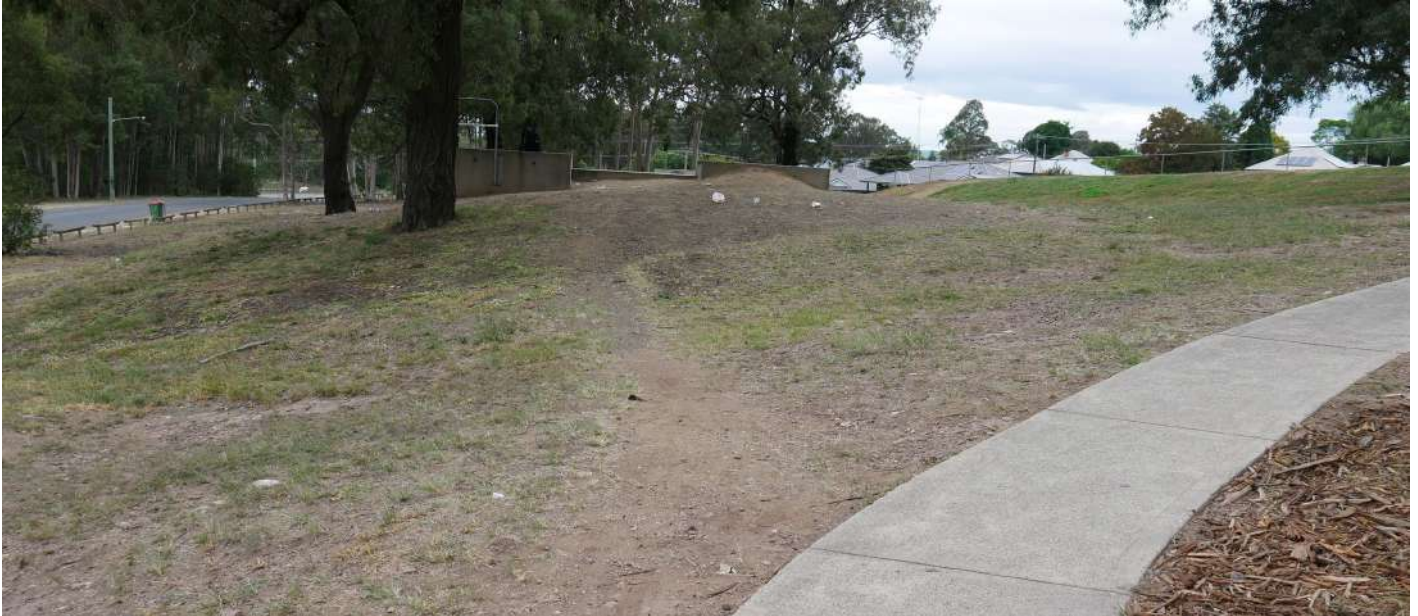
## NON EXISTENT CONNECTION PATHS / DESIRE LINES

See previous page.

**RISK RATING: LOW**

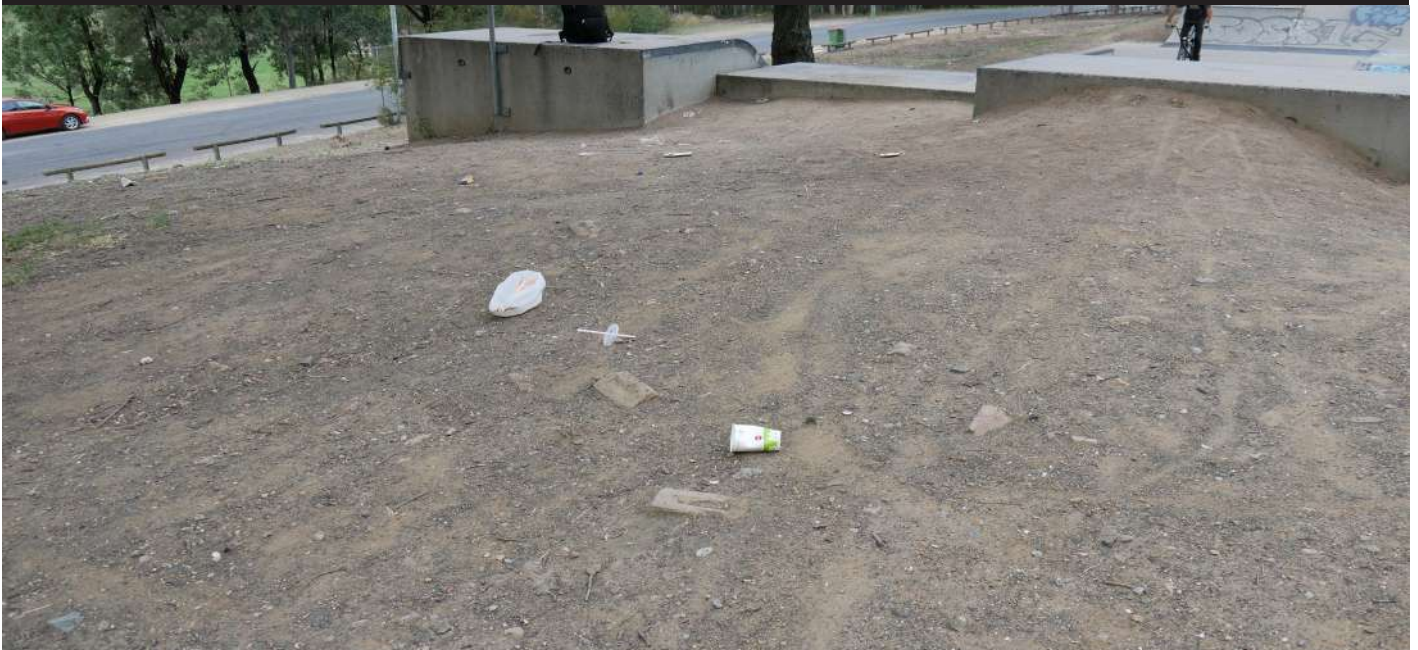
## LITTER PRESENT AROUND SITE

There are several instances of rubbish and debris strewn across the area around the facility. Rubbish across the facility encourages users to dispose of their rubbish in a similar fashion. It is important to regularly maintain the facility and ensure all surfaces are kept free of debris and dirt.
